North Carolina Museum of Art

MUSEUM PARK VISION PLAN

Prepared by Andropogon Associates, Ltd.
with contributions from Biohabitats, Inc., and WK Dickson
December 2021

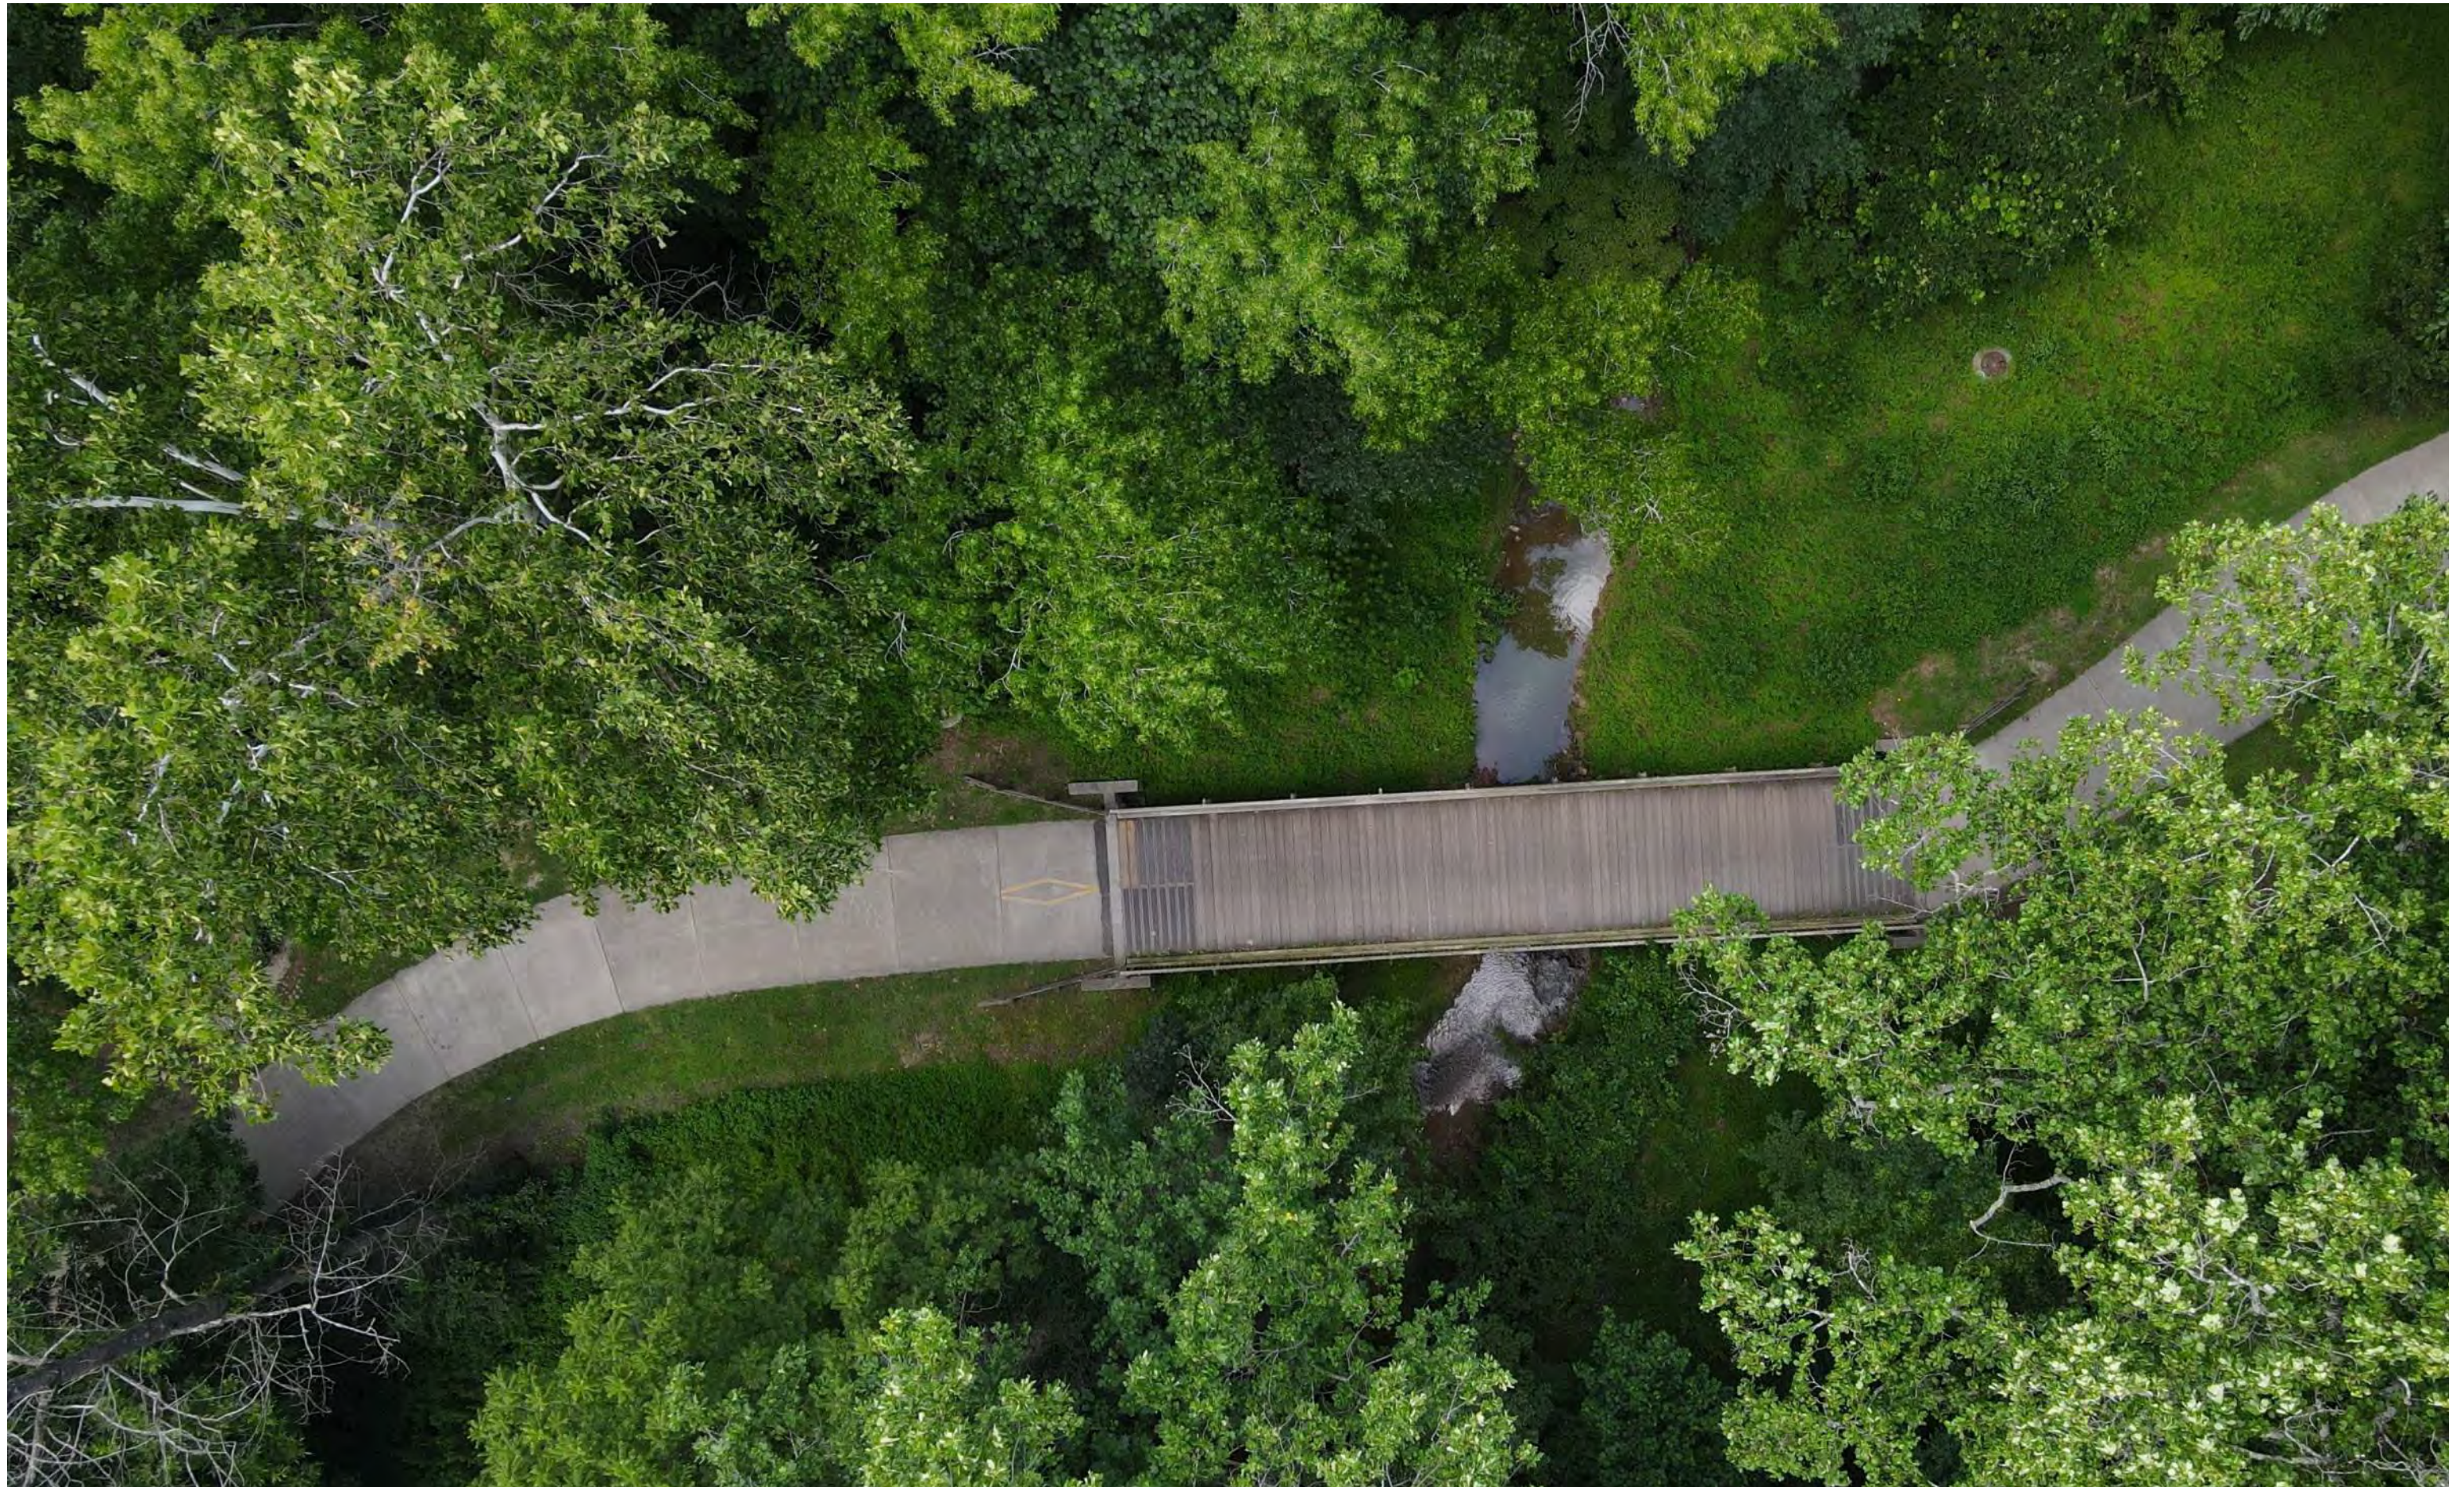
Existing greenway bridge at confluence of House Creek and unnamed tributary; Photo: Luke Mehaffie

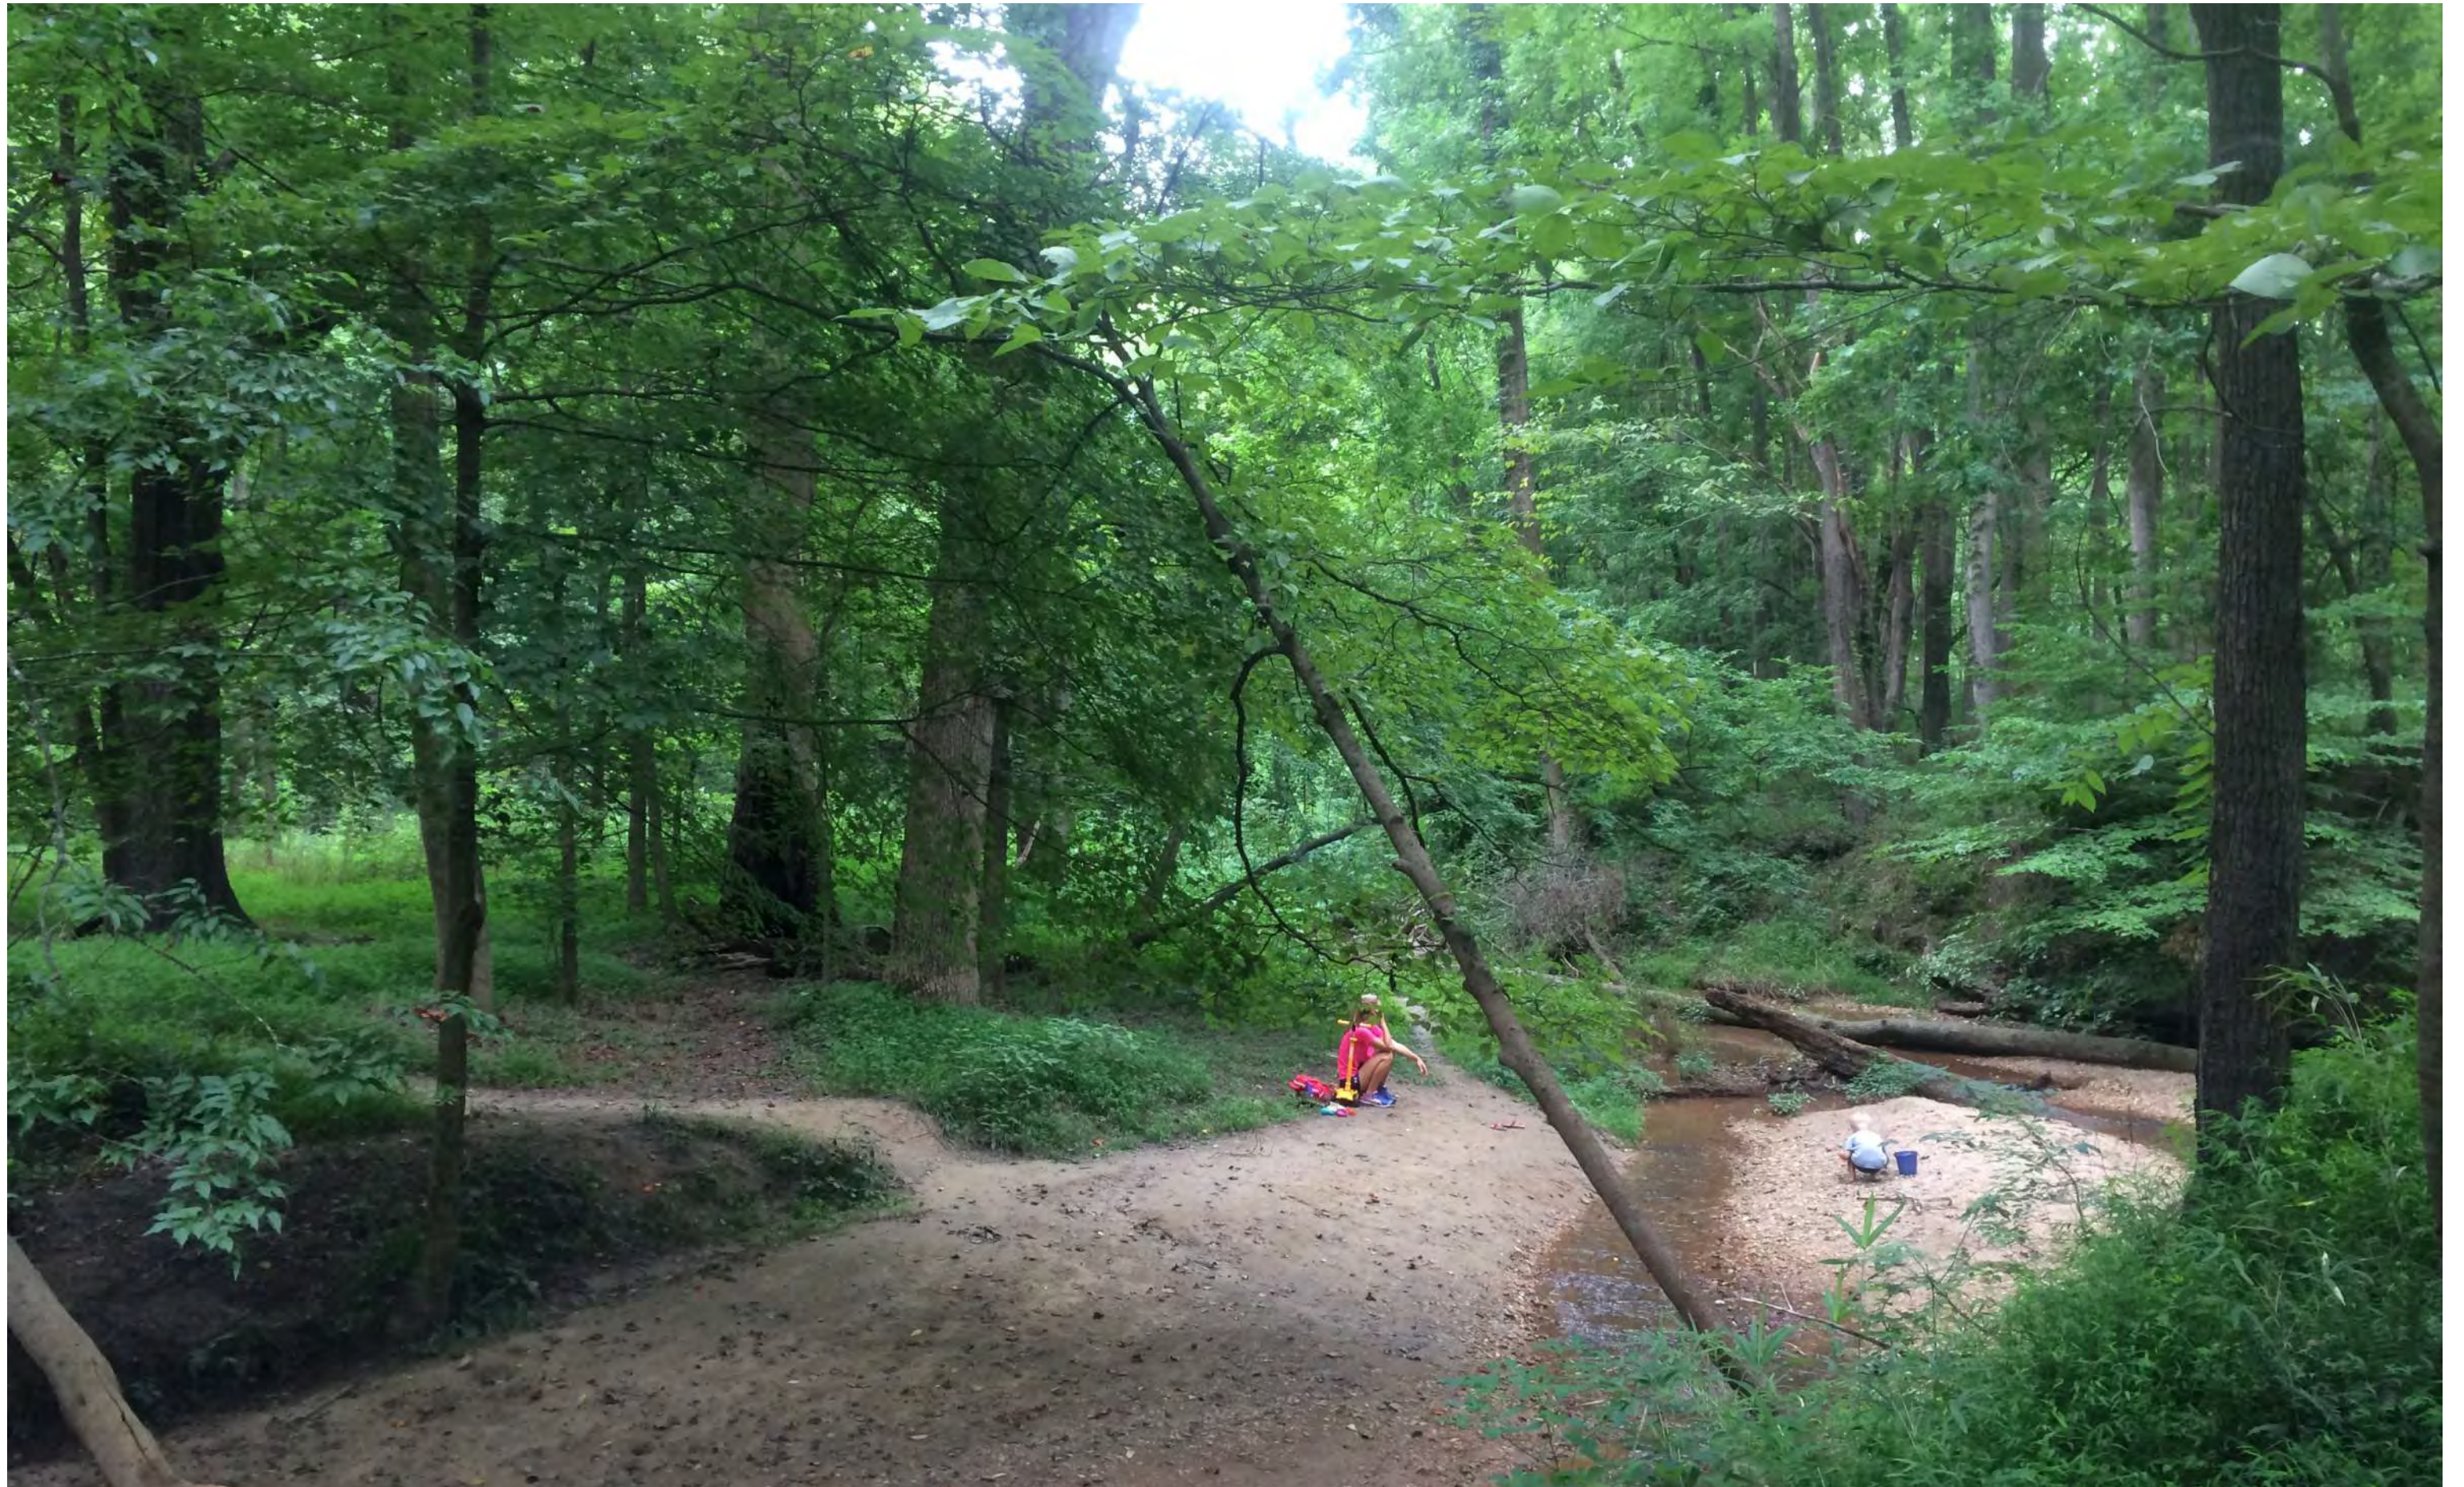
Sediment deposited from eroded banks along House Creek; Photo: Andropogon

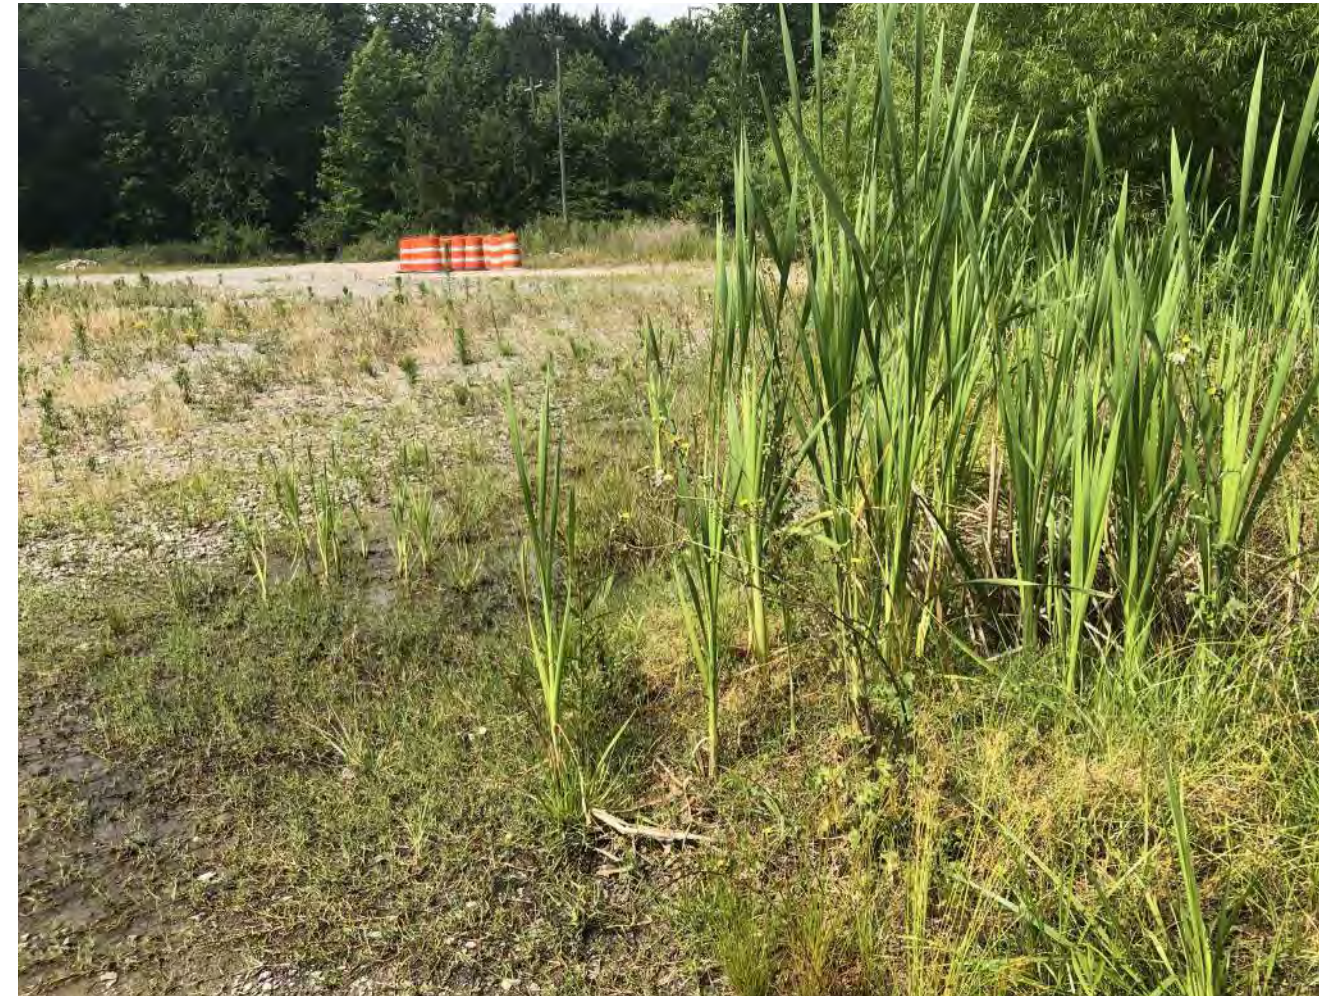
*Wetland indicator species at potential spring near overflow parking area;
Photo: Andropogon*

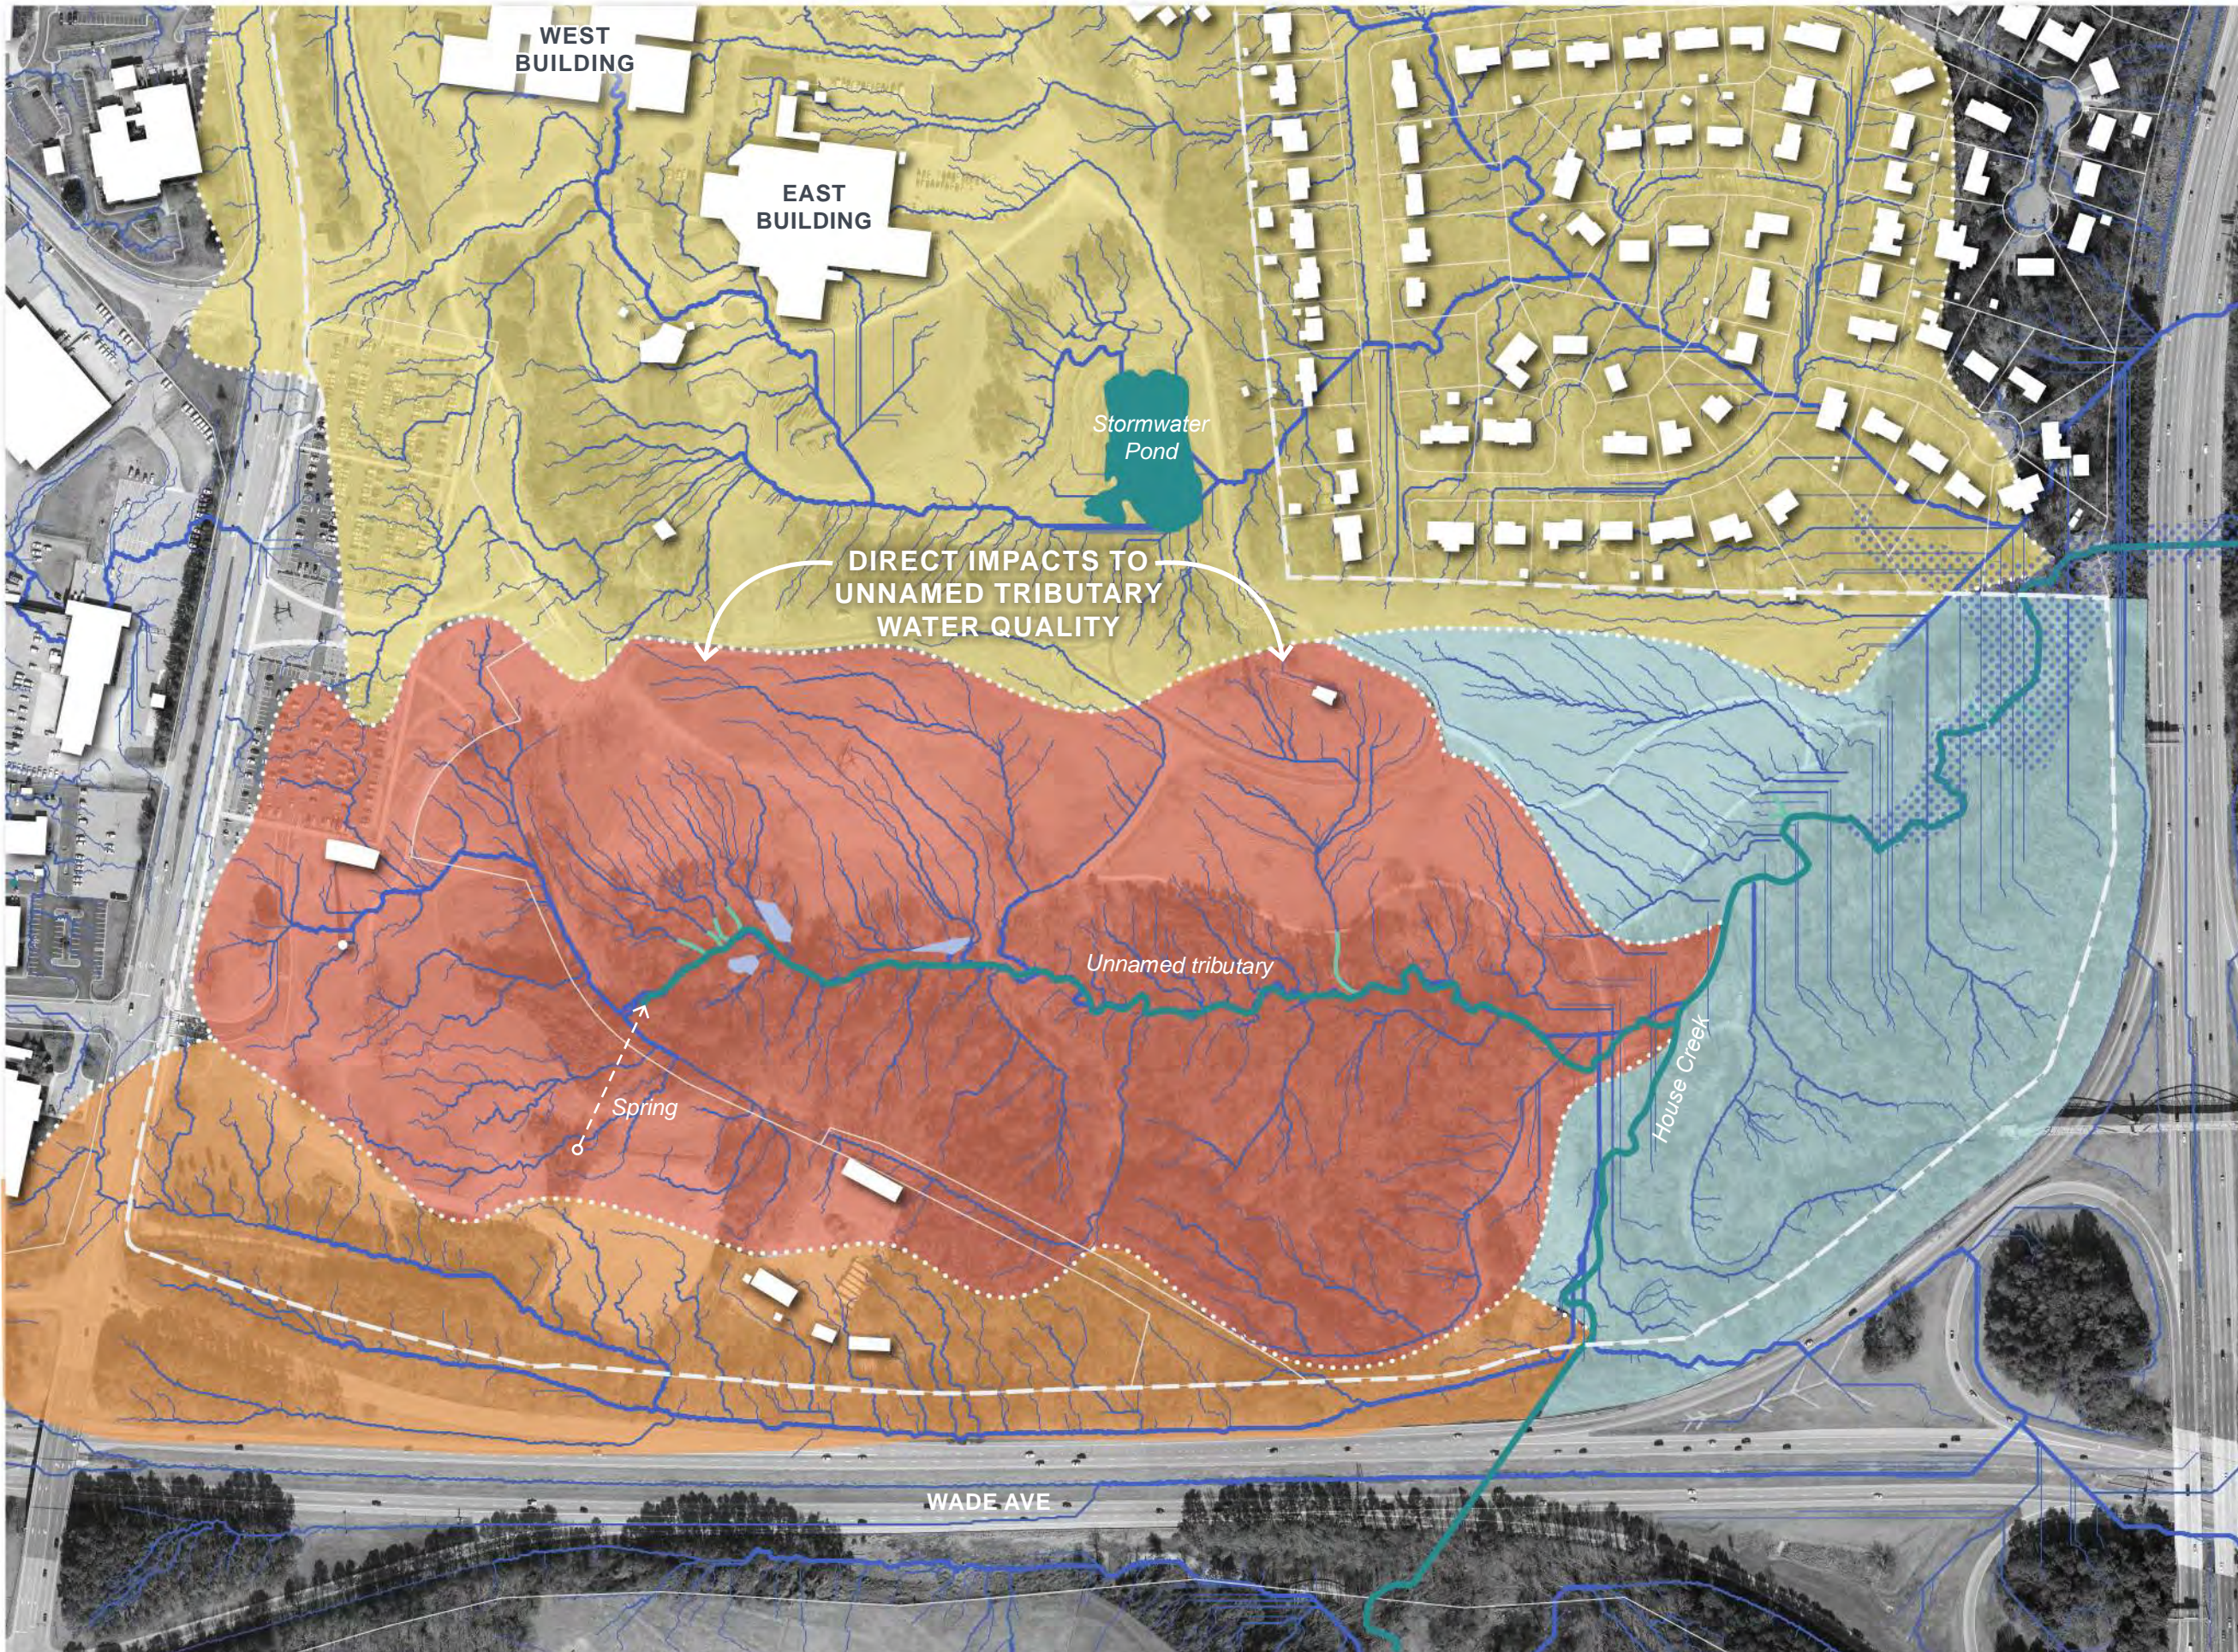
SITE HYDROLOGY

Water in the second basin of the study area drains directly into House Creek. This zone includes the eastern portion of the Lower Meadow and the entirety of the East Woods. House Creek is severely impaired in this area, and the impacts of erosion along the stream banks are very visible from the preserve trails. Channelized stormwater along aggregate paths in the Lower Meadow are also carrying sediment into the stream channel. This basin includes the only FEMA-mapped 100-year floodplain on the site, which is located at the lower-most reach of House Creek within the NCMA property.

A third basin collects runoff from the southwest corner of the Museum property, including portions of the overflow parking area and the maintenance yard. This basin drains into a ditch along the side of Wade Avenue, which eventually meets House Creek as it enters the site from the culvert beneath Wade Avenue.

-   Stream Channel
-   Drainage Channel
-   Significant Drainage Entering Stream
-   Surveyed Wetland
-   House Creek Direct Drainage Area
-

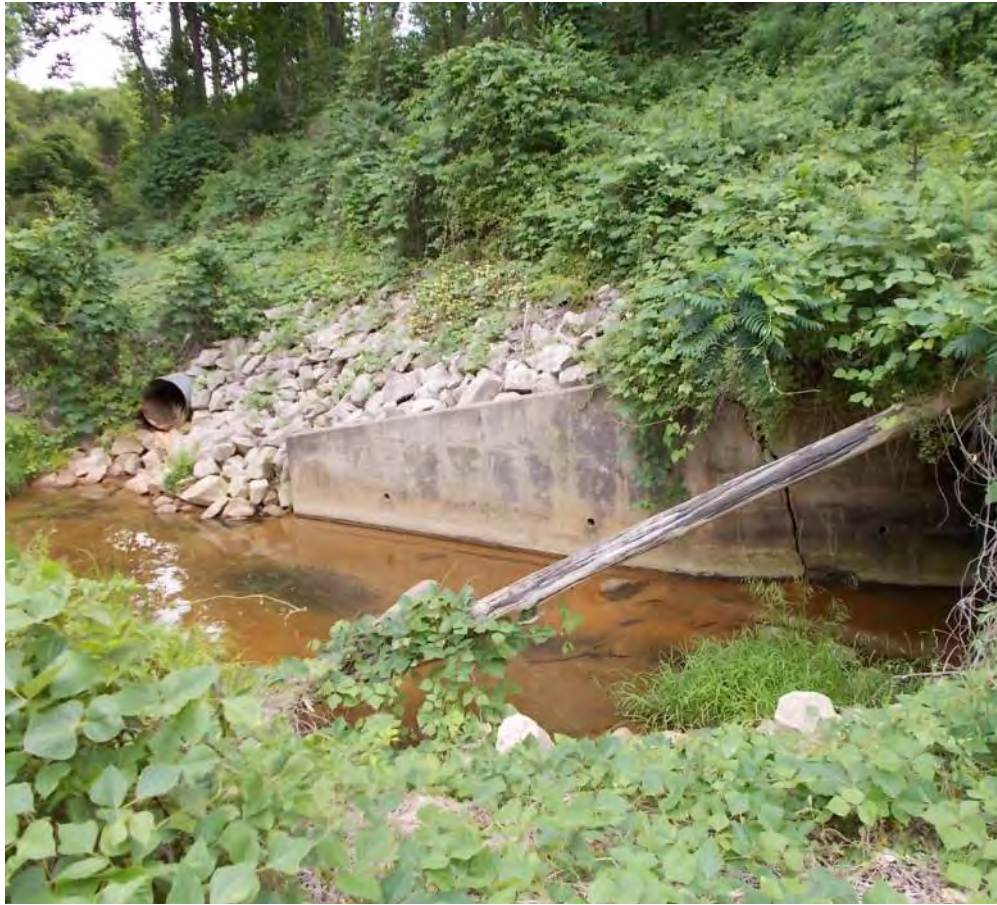
House Creek entering the NCMA from Wade Ave culvert (May)

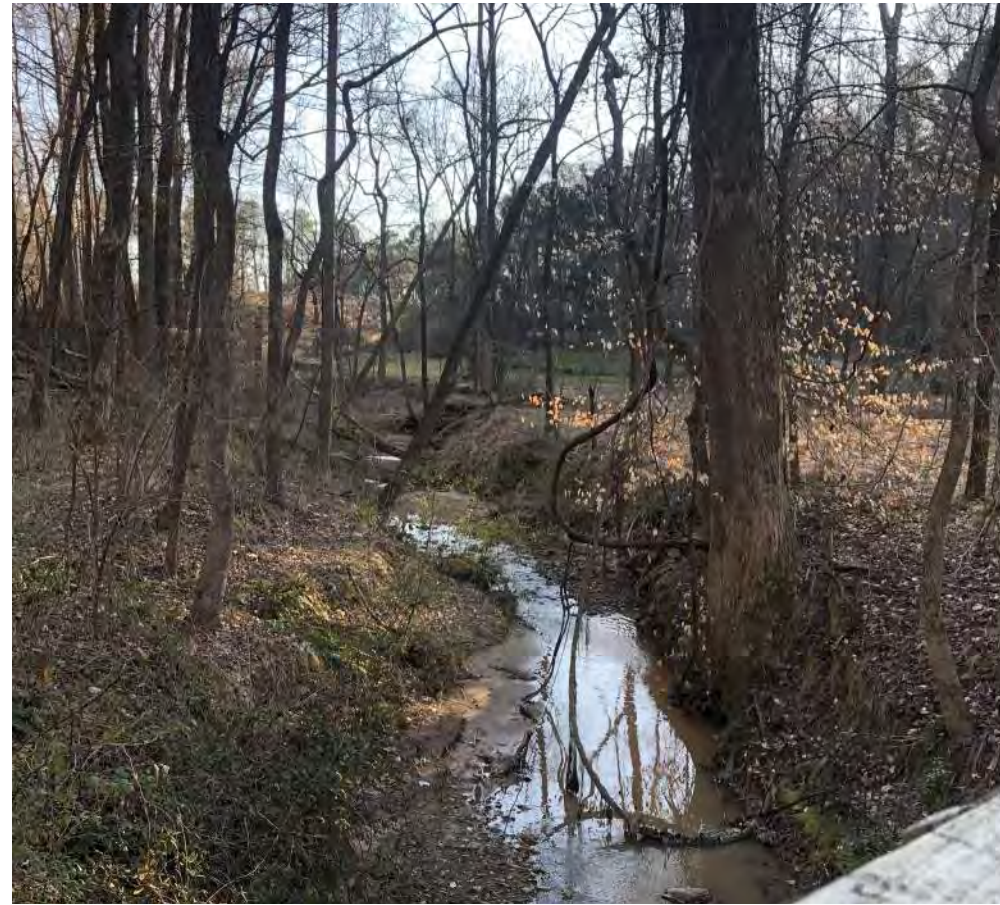
Looking upstream (south) from greenway bridge (February)

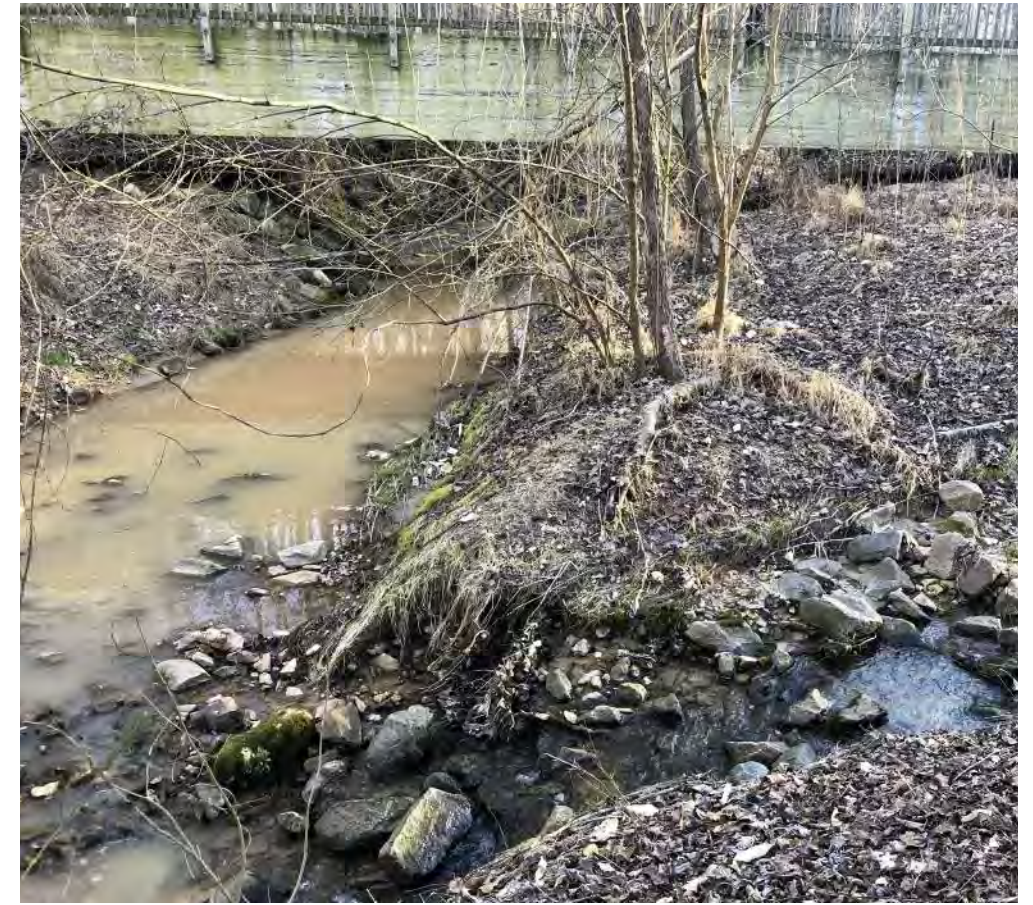
Sediment in House Creek at confluence with tributary (February)

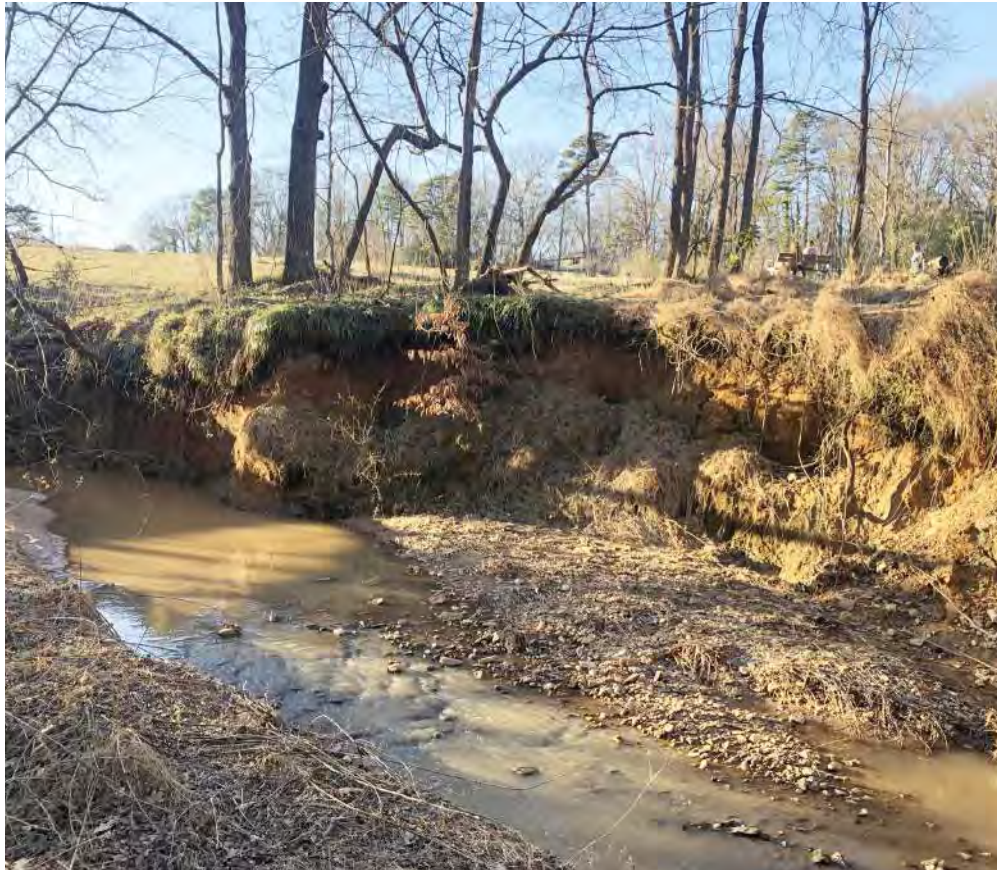
Erosion below seating area and trail in Lower Meadow (February)

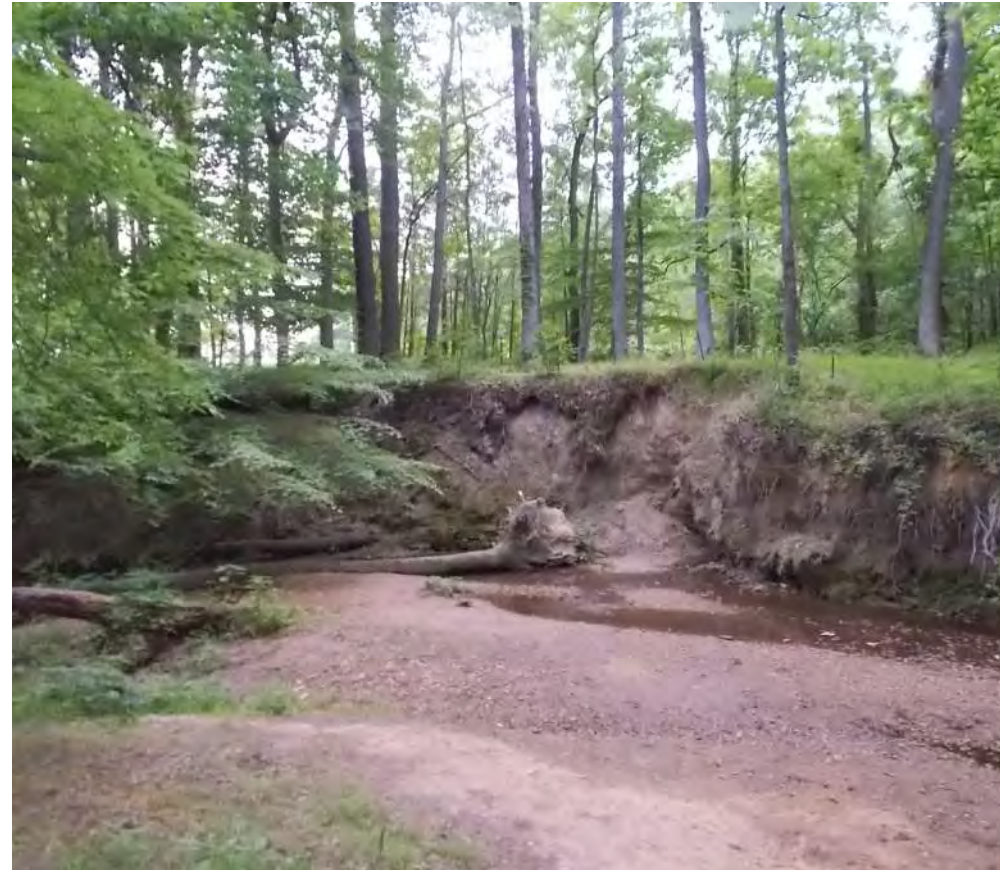
Tree loss due to erosion of stream banks (May)

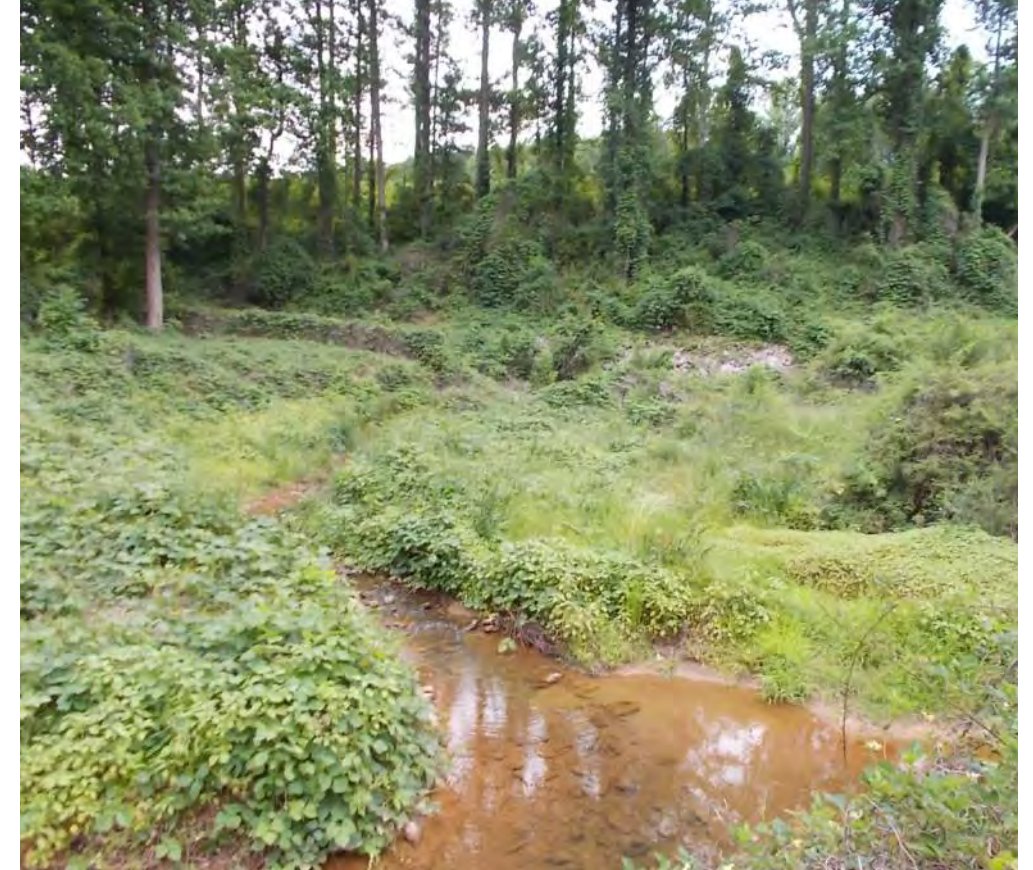
Invasive plants at 100-year floodplain near I-440 culvert (May)

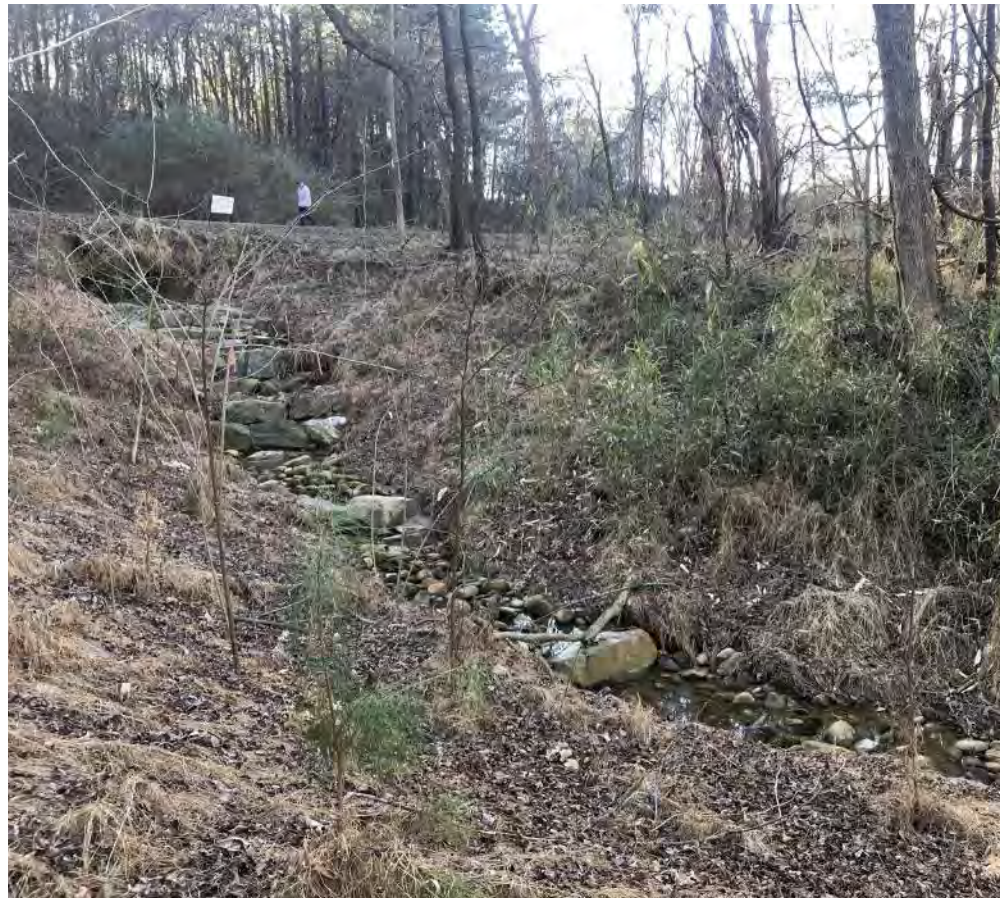
Headwaters, just below the Blue Loop trail (February)

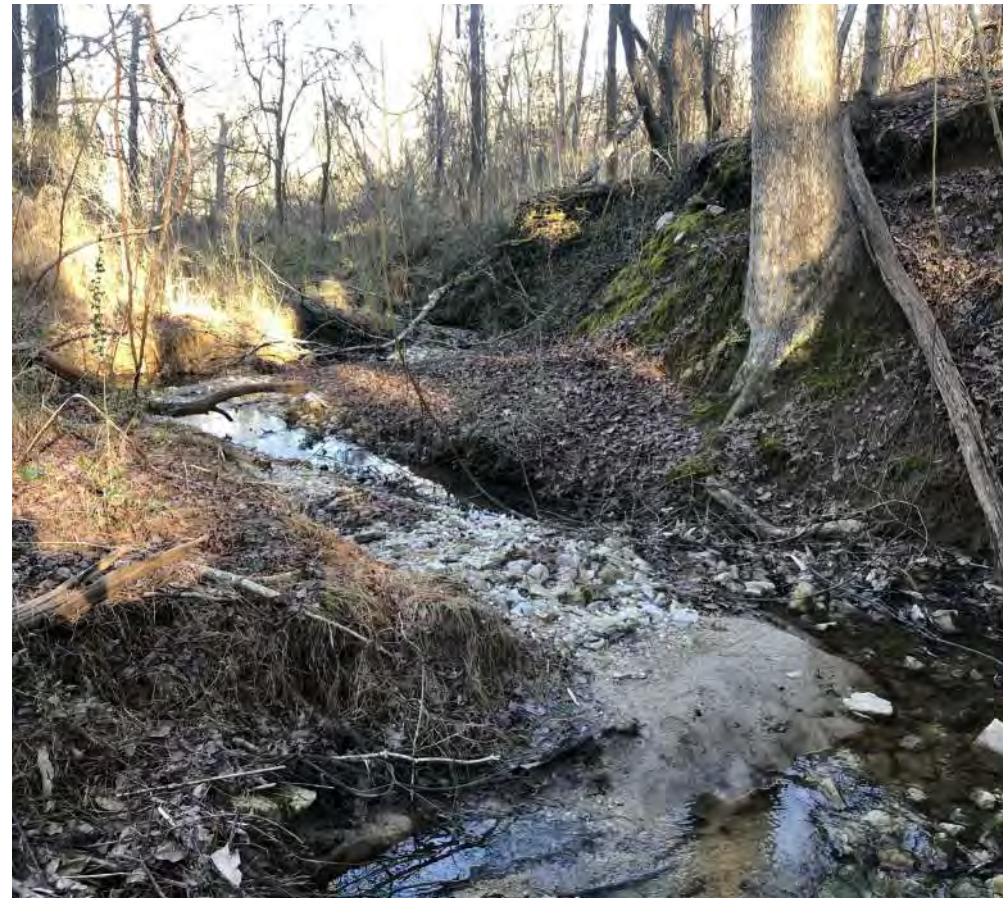
Sediment deposits just downstream from headwaters (February)

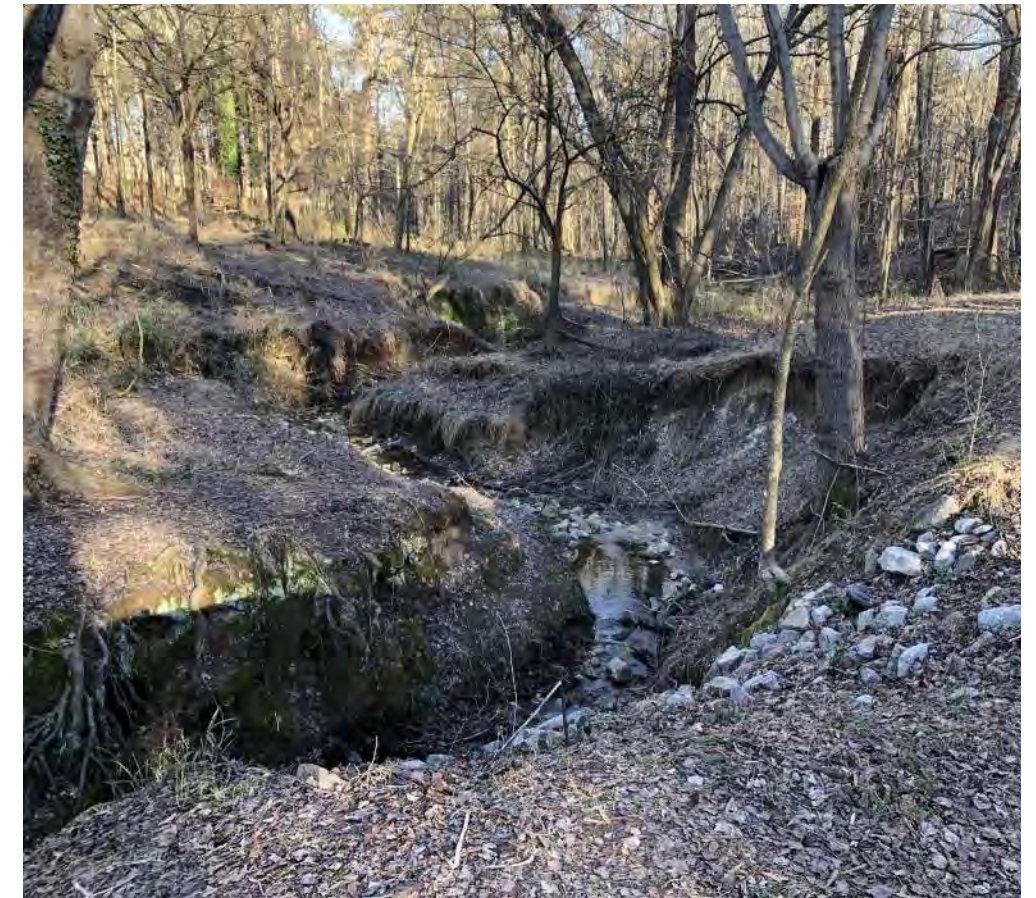
Erosion just downstream from Blue Loop crossing (February)

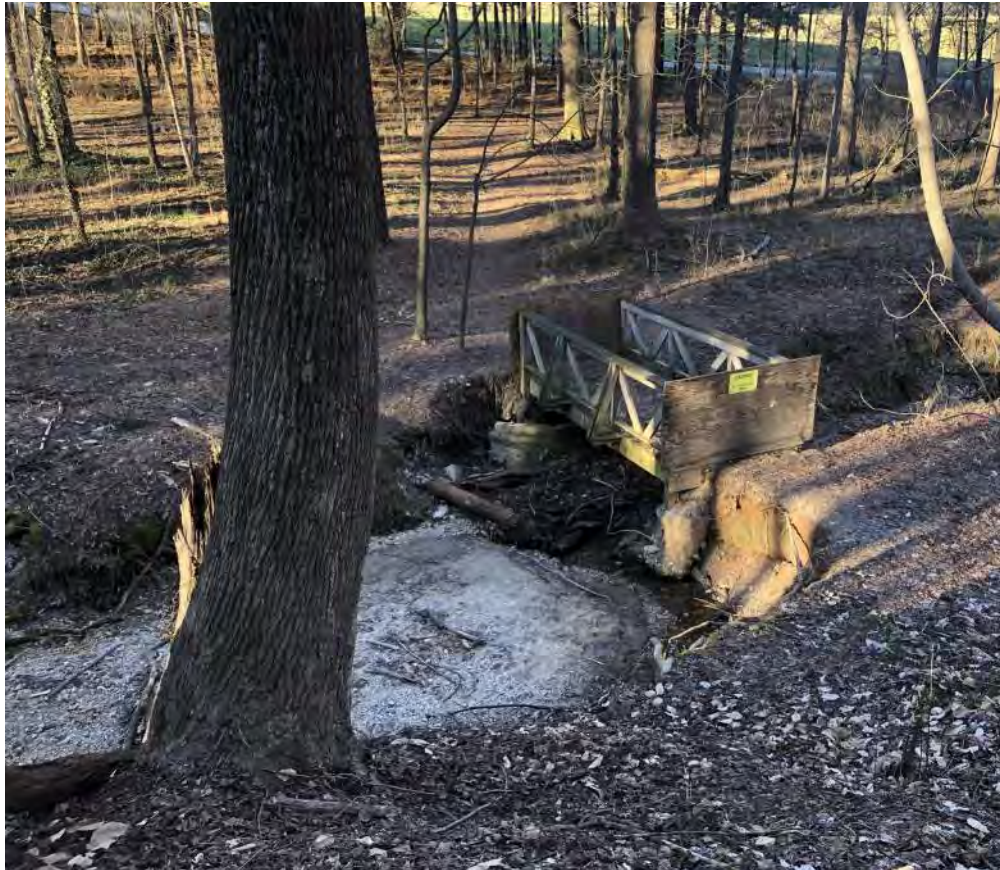
Blown-out bridge at forest path crossing (February)

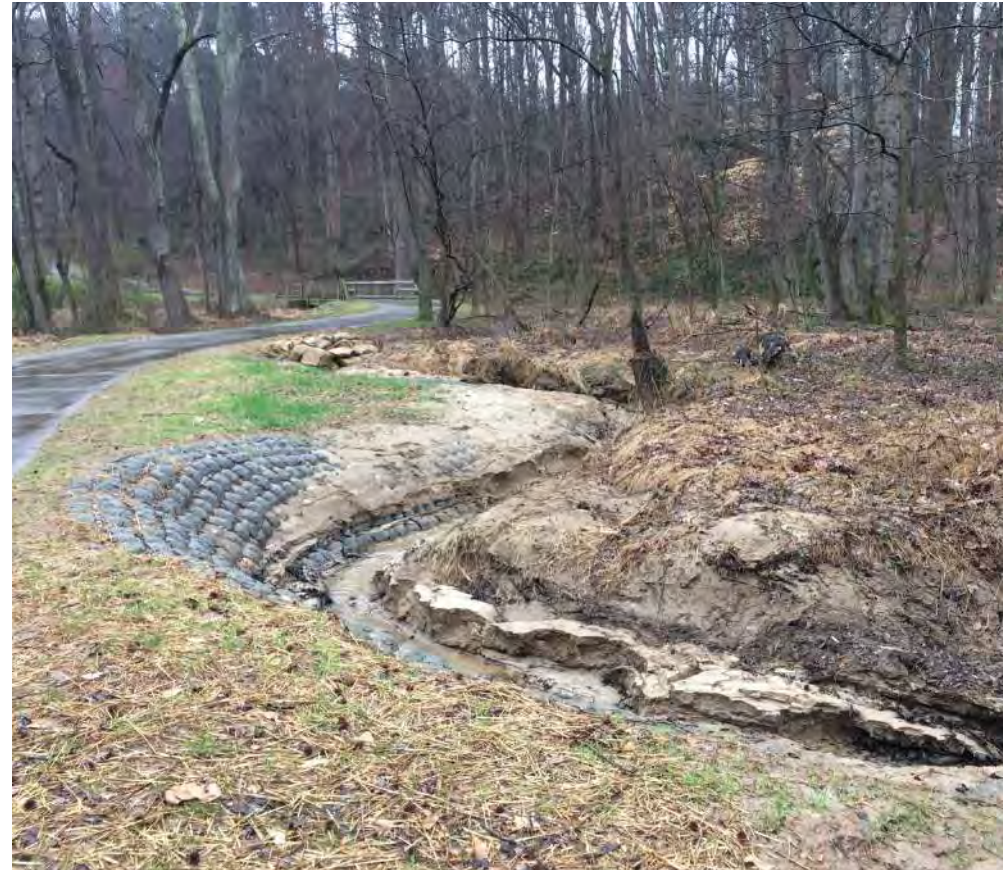
Bank reinforcement at greenway trail (February)
