North Carolina Museum of Art

MUSEUM PARK VISION PLAN

Prepared by Andropogon Associates, Ltd.
with contributions from Biohabitats, Inc., and WK Dickson
December 2021

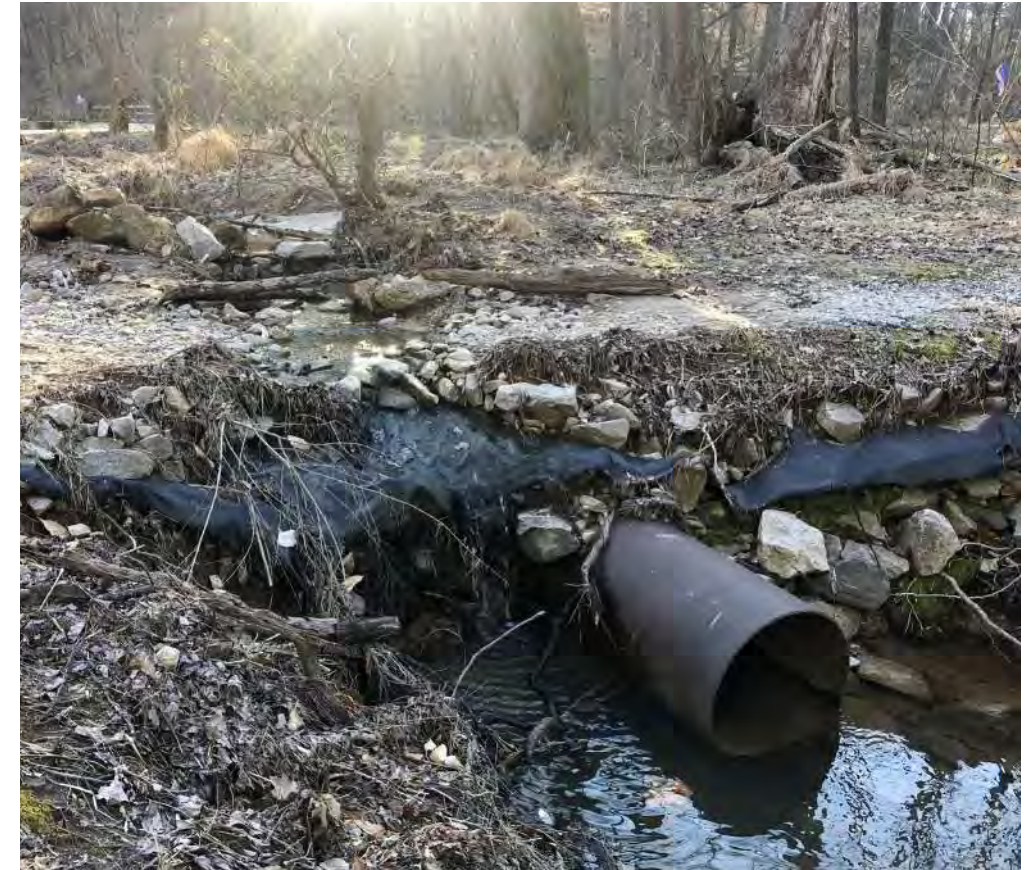
Buried culvert near confluence (February)

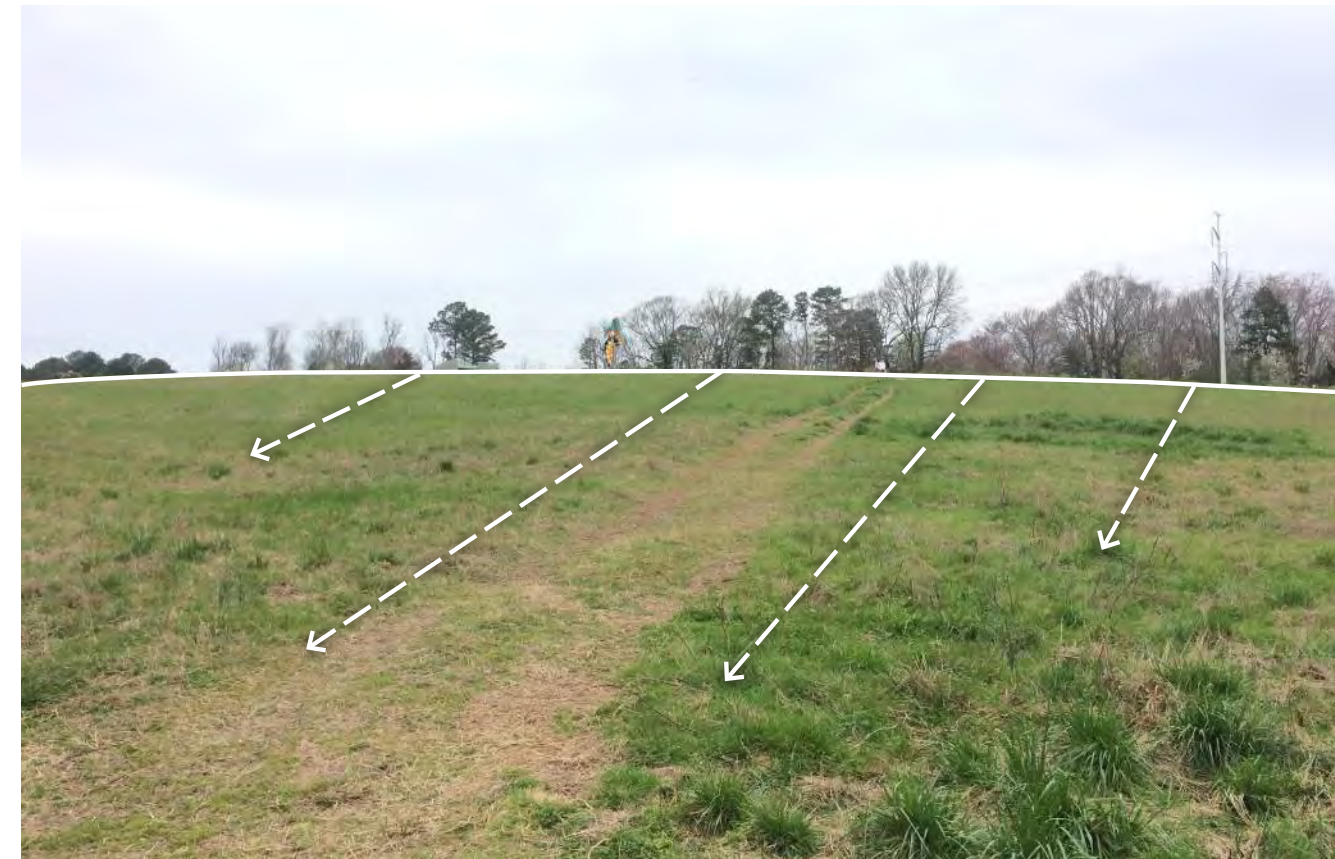
Sloped hillside in Lower Meadow; Photo: Andropogon

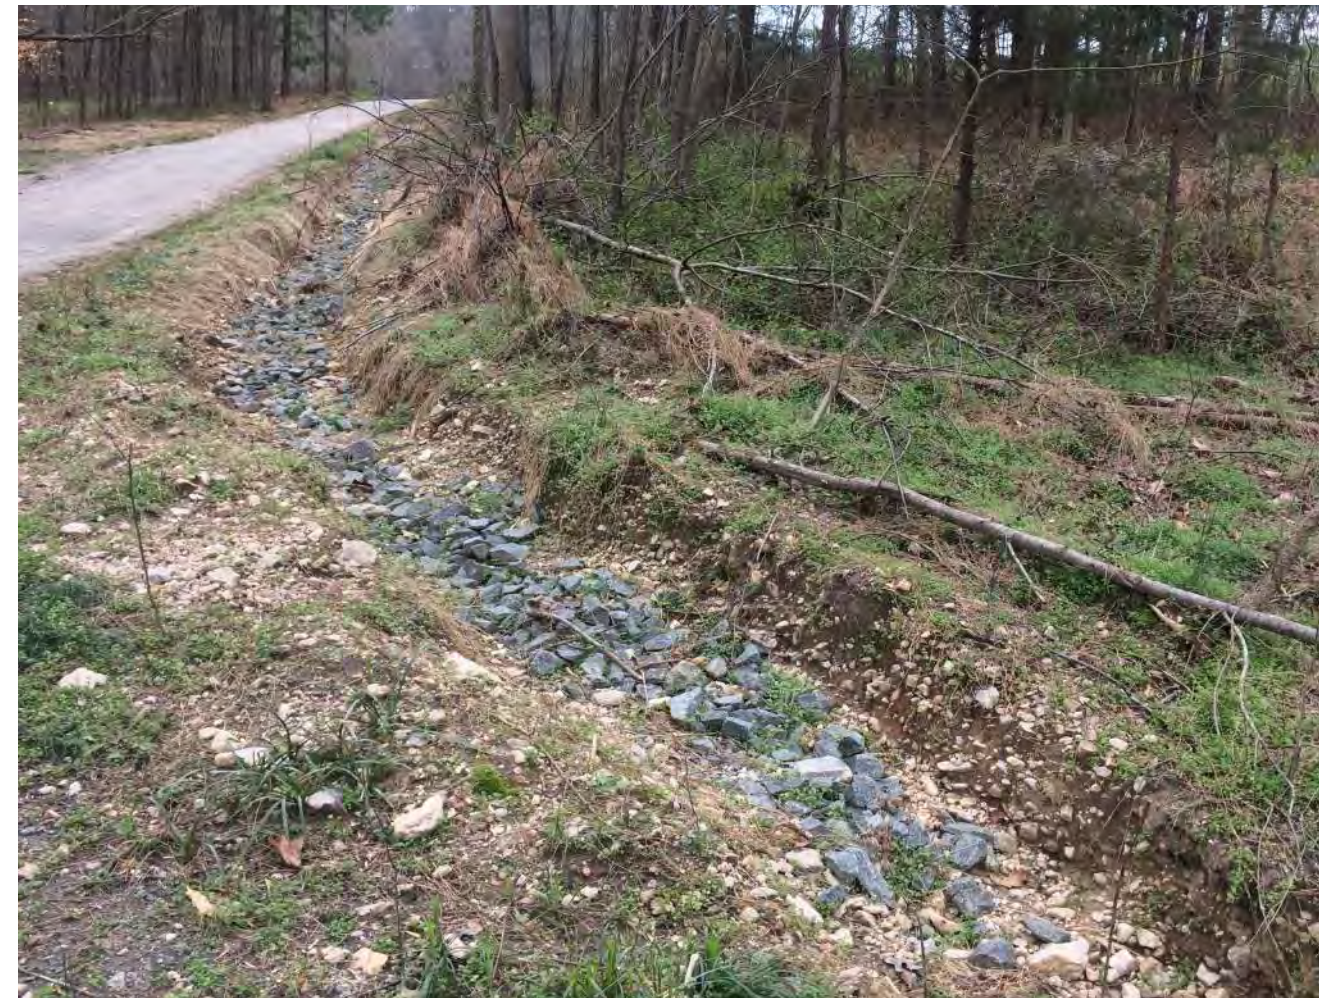
Erosion caused by concentrated runoff from Lower Meadow; Photo: Andropogon

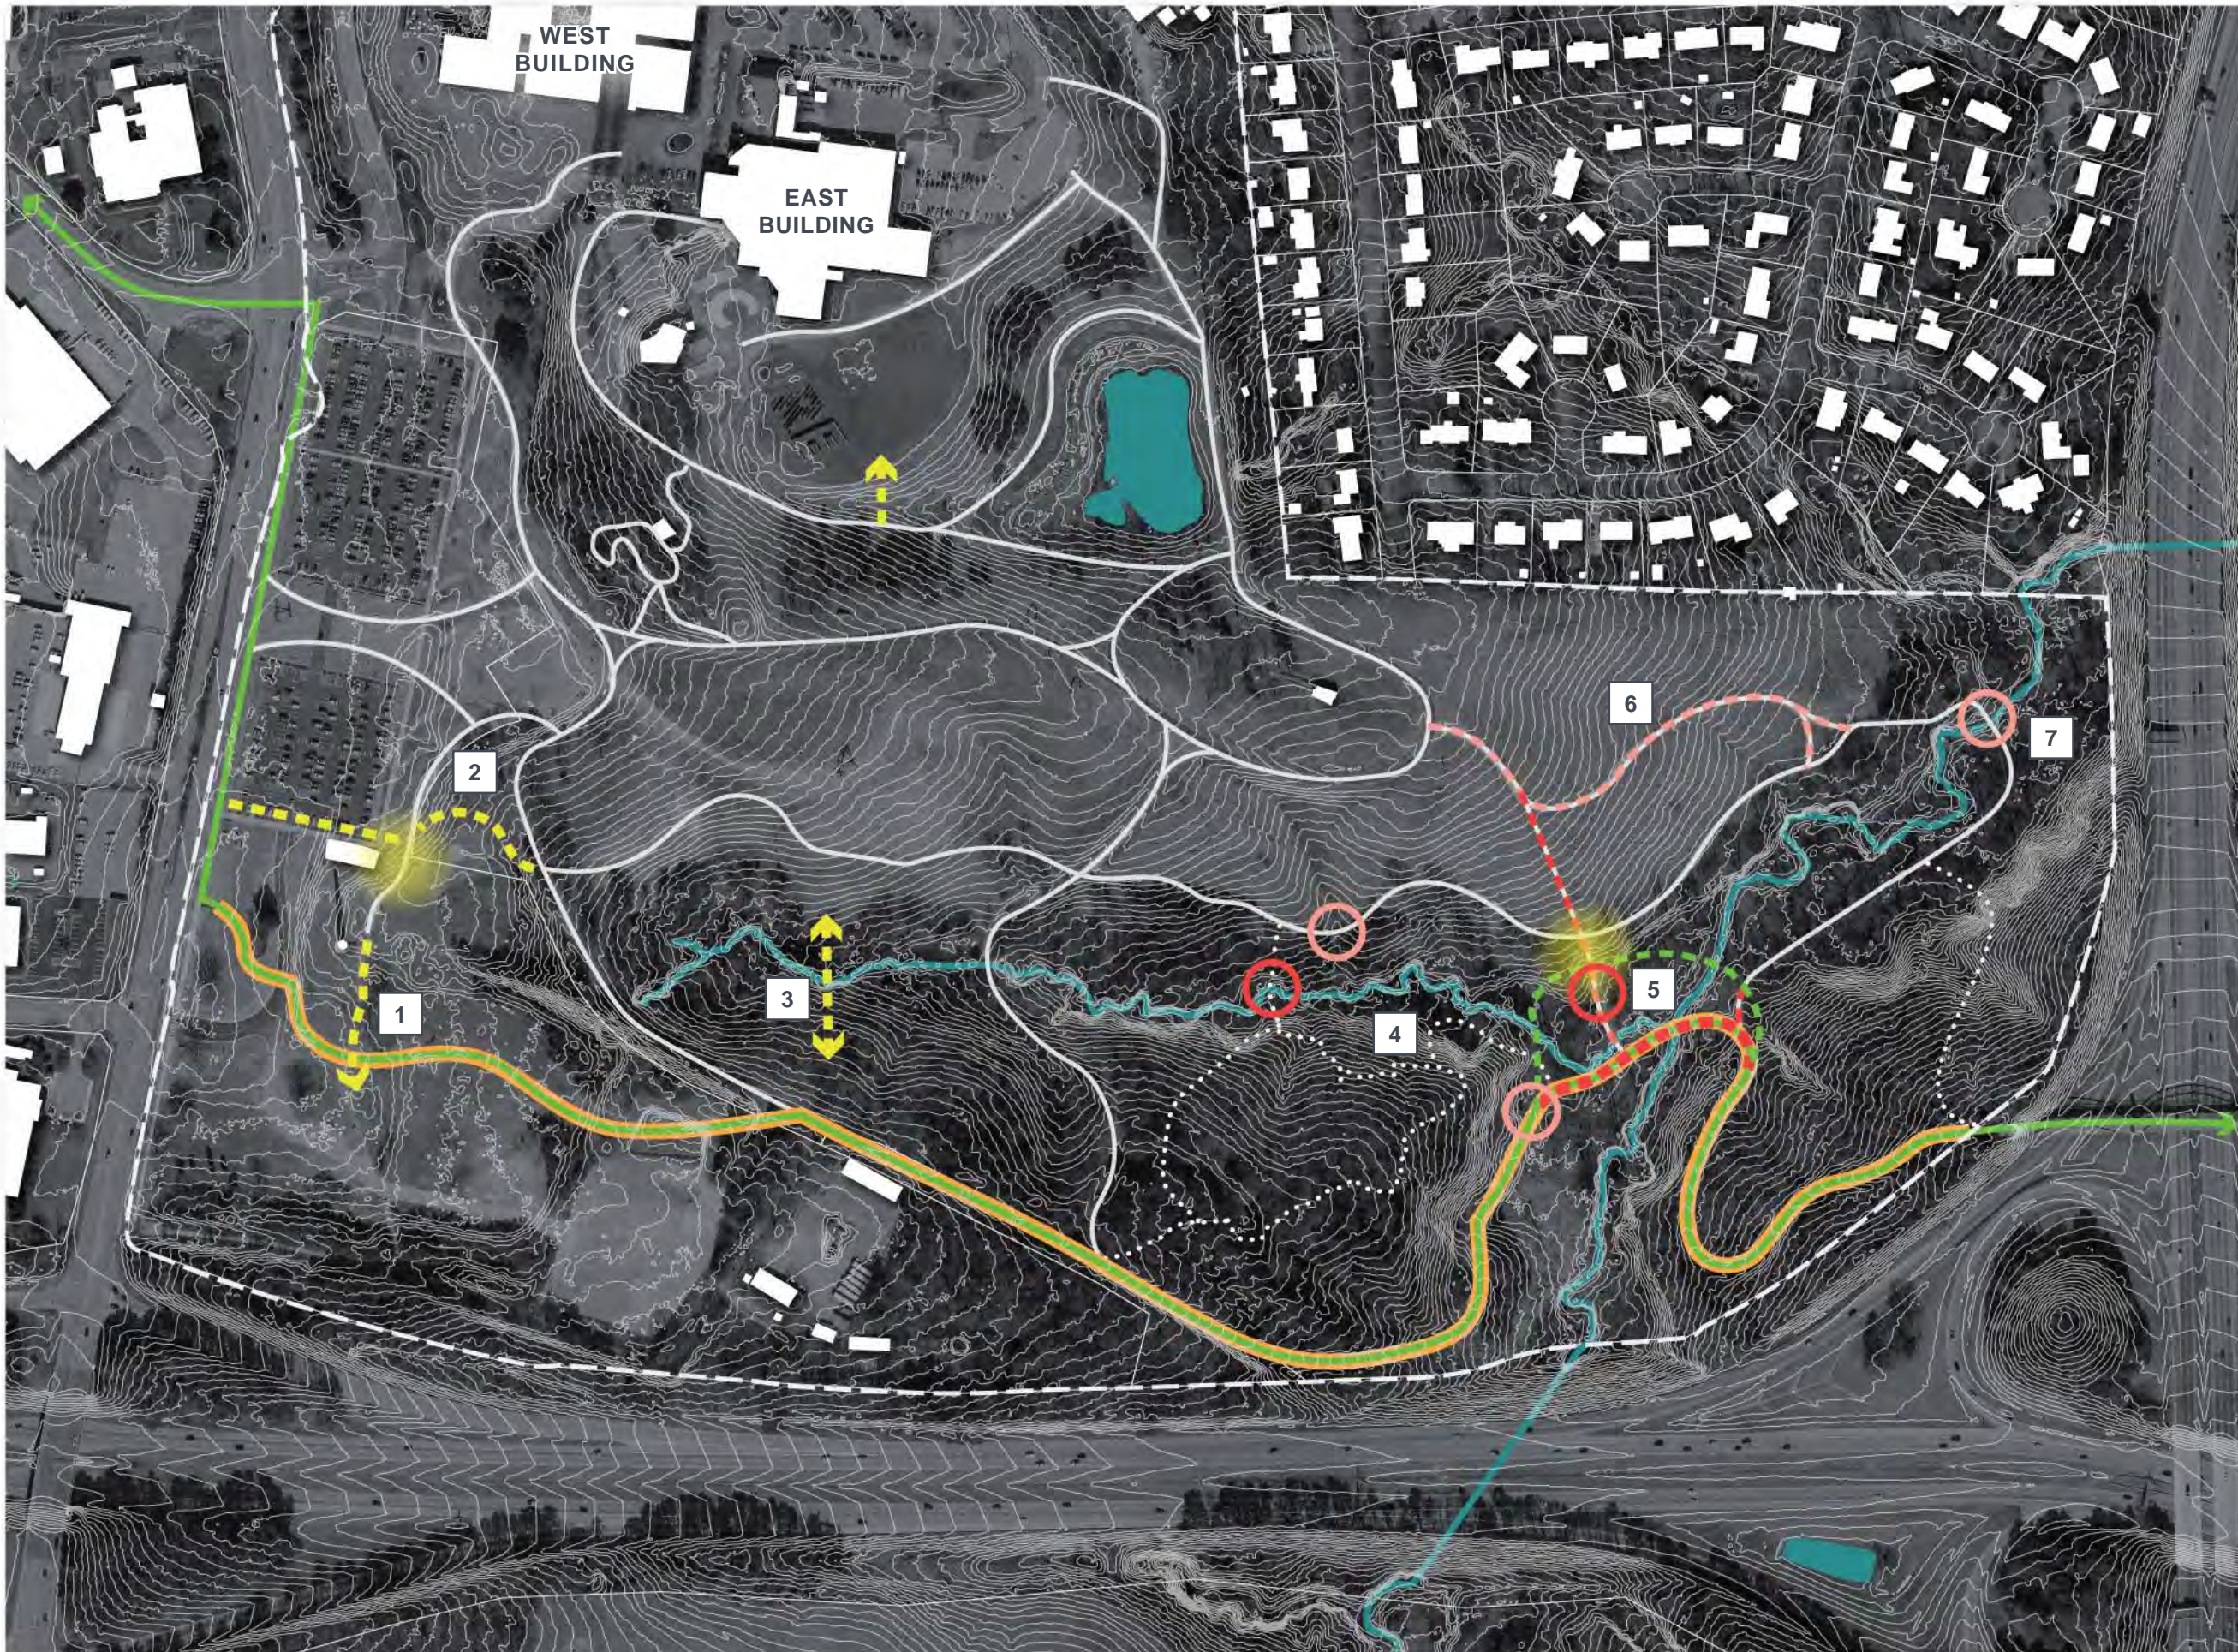
**CIRCULATION:
TRAILS + CROSSINGS**

- 1 Connect Welcome Center, Stack, Ellipse, Greenway
- 2 Connect Welcome Center, Upper Meadow, Greenway
- 3 Connect South Woods to Upper Meadow
- 4 Stabilize Tertiary Path and Crossing
- 5 Improved Greenway/Meadow Path Connection, Gateway
- 6 Remove, Realign Ridgeline Path
- 7 Improve Crossing, Safety, and Increase Vegetative Buffer

- Gateway to Preserve
- Damaged/Unusable Crossing
- Inadequate Crossing
- Proposed Trail Connection
- Trail to Be Realigned
- Trail to Be Removed
- Existing Forest Path
- Existing Trail
- Proposed Greenway
- Existing Greenway, Increased Width Needed
- Existing Greenway
- Existing Blue Loop

- Places where trail alignments need to be reconfigured to improve safety, protect infrastructure investments, and improve water quality (note 6, right);
- Places where trail alignments could be slightly adjusted to ease steep slopes and provide an easier walking experience (throughout the Park);
- Places where small paths and creek crossings could provide additional access to the water, especially for children (note 4, right); and
- Places where trail alignments need to be completely redesigned in order to provide a more interesting and enjoyable visitor experience (note 7, right).

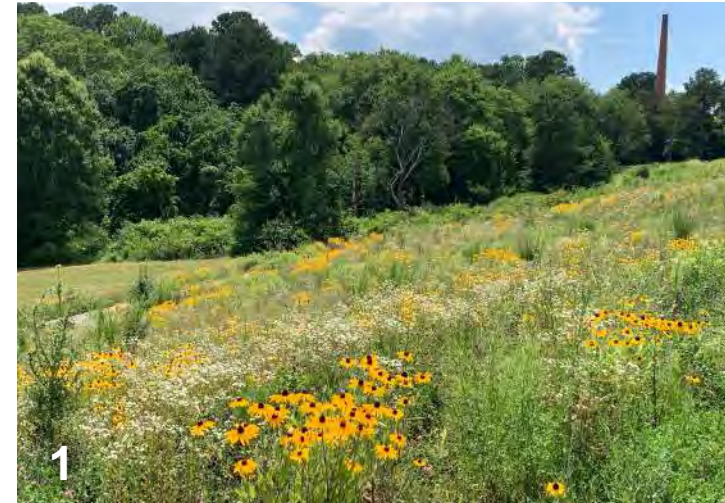
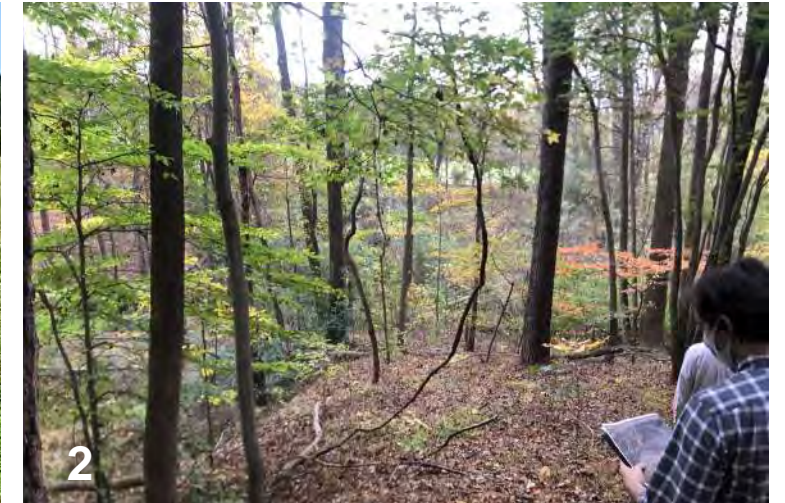
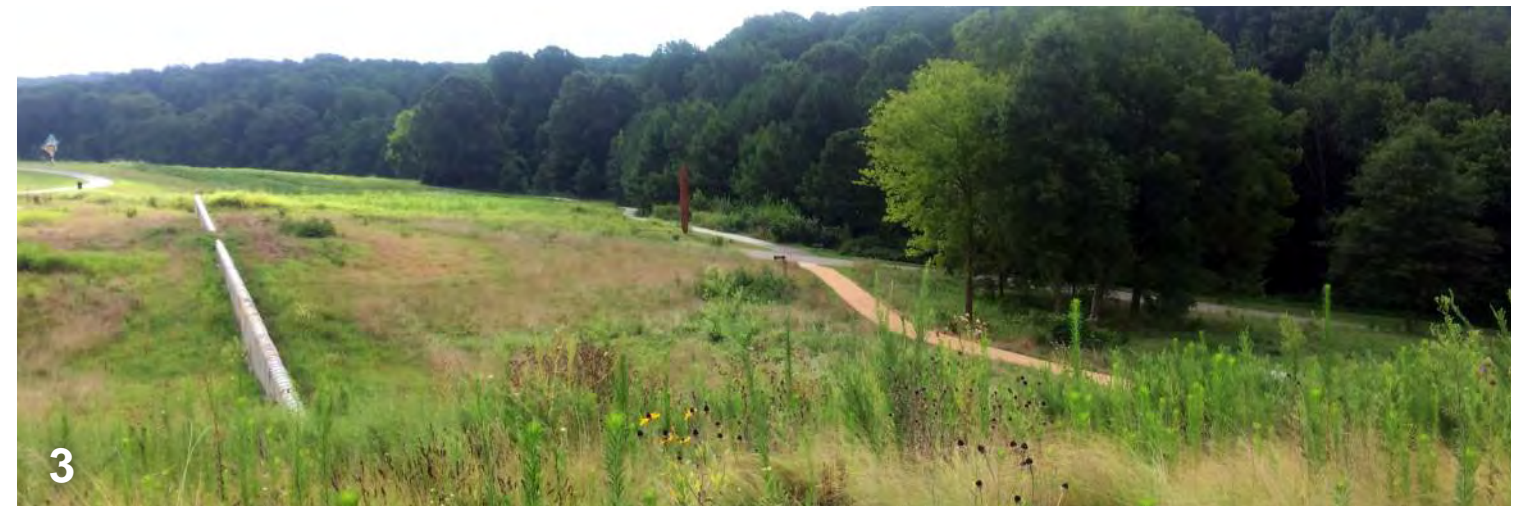
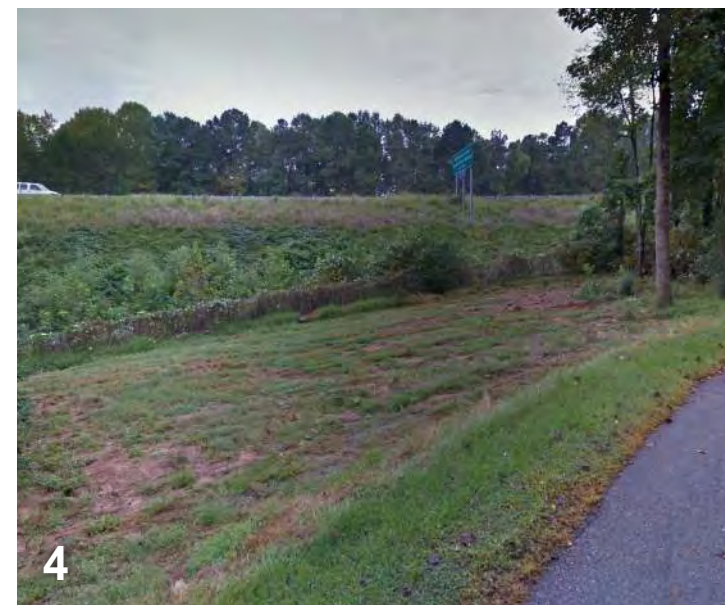
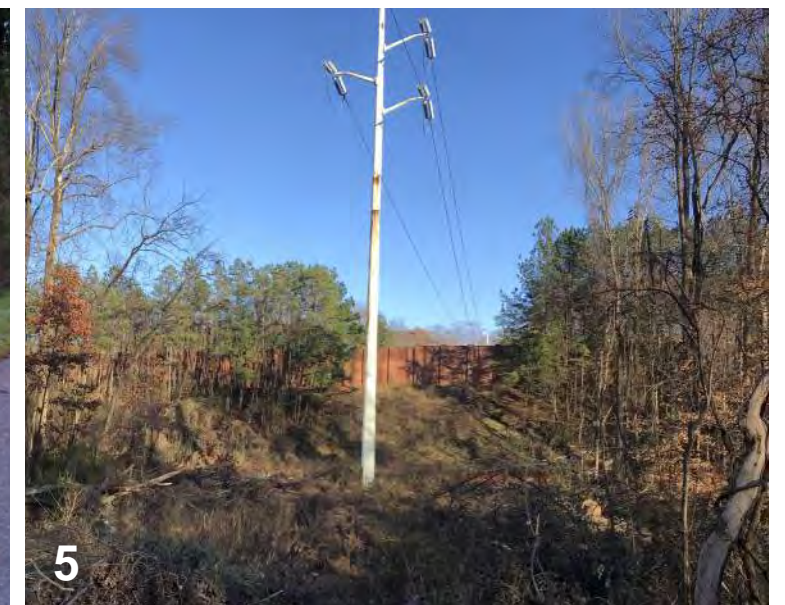
- Employ the concept of “hide and reveal” within the landscape. (Photo 1, right)
- Create contrasts among simple and complex textures, colors, and light. (Photo 1, right)
- Create opportunities to view the streams from above. (Photo 2, right)
- Highlight the structure of the landscape. (Photo 3, right)
- Create opportunities to see wildlife, especially along the riparian corridors.
- Reduce visibility of the impacts from DOT construction. (Photos 4 and 5, right)

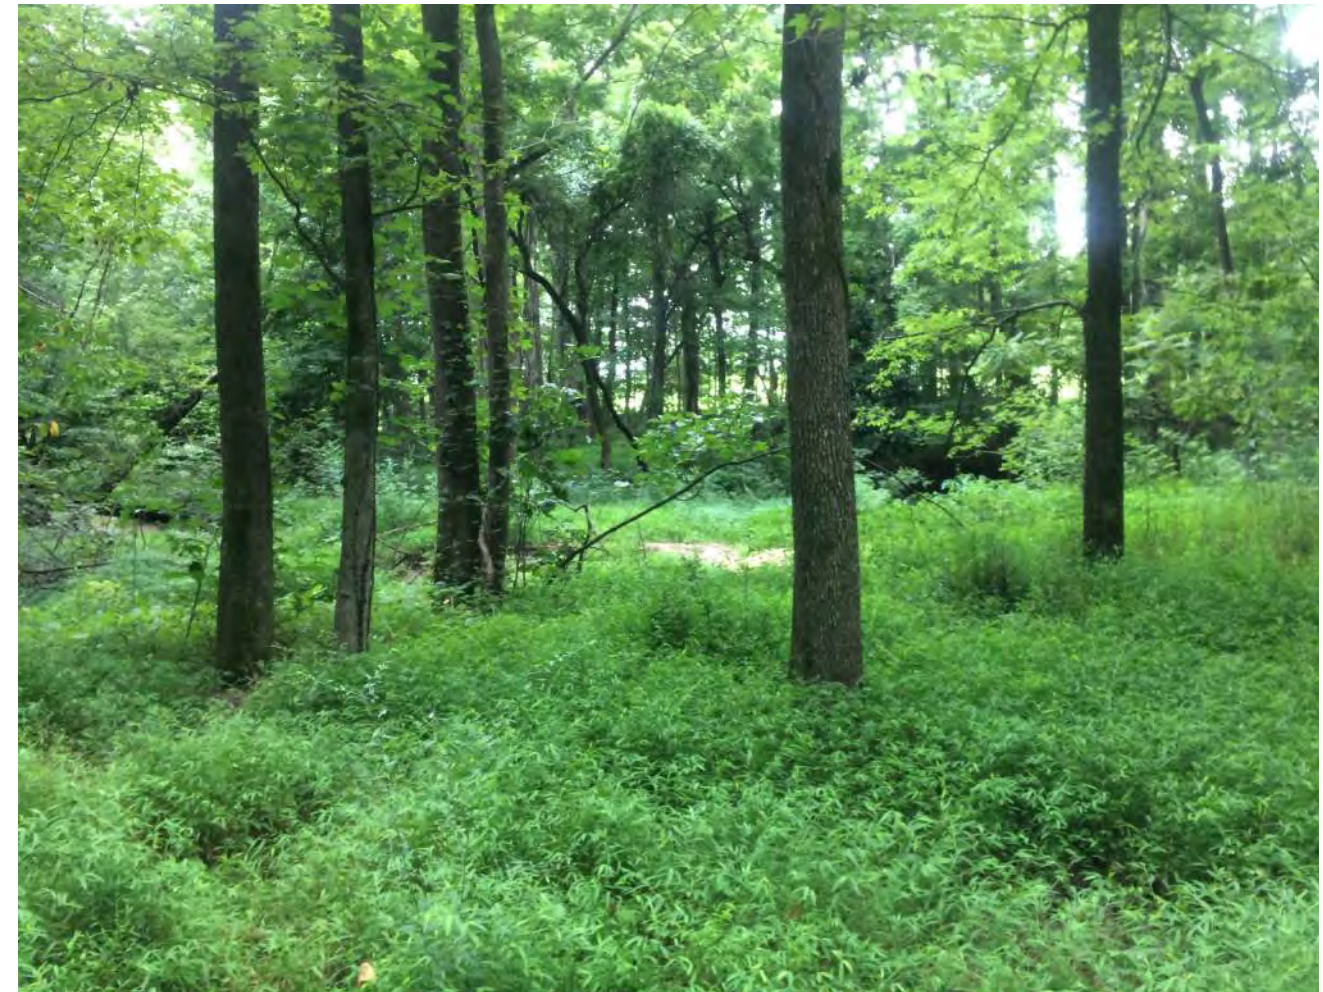
Invasive Japanese stiltgrass (Microstegium vimineum) in understory; Photo: Andropogon

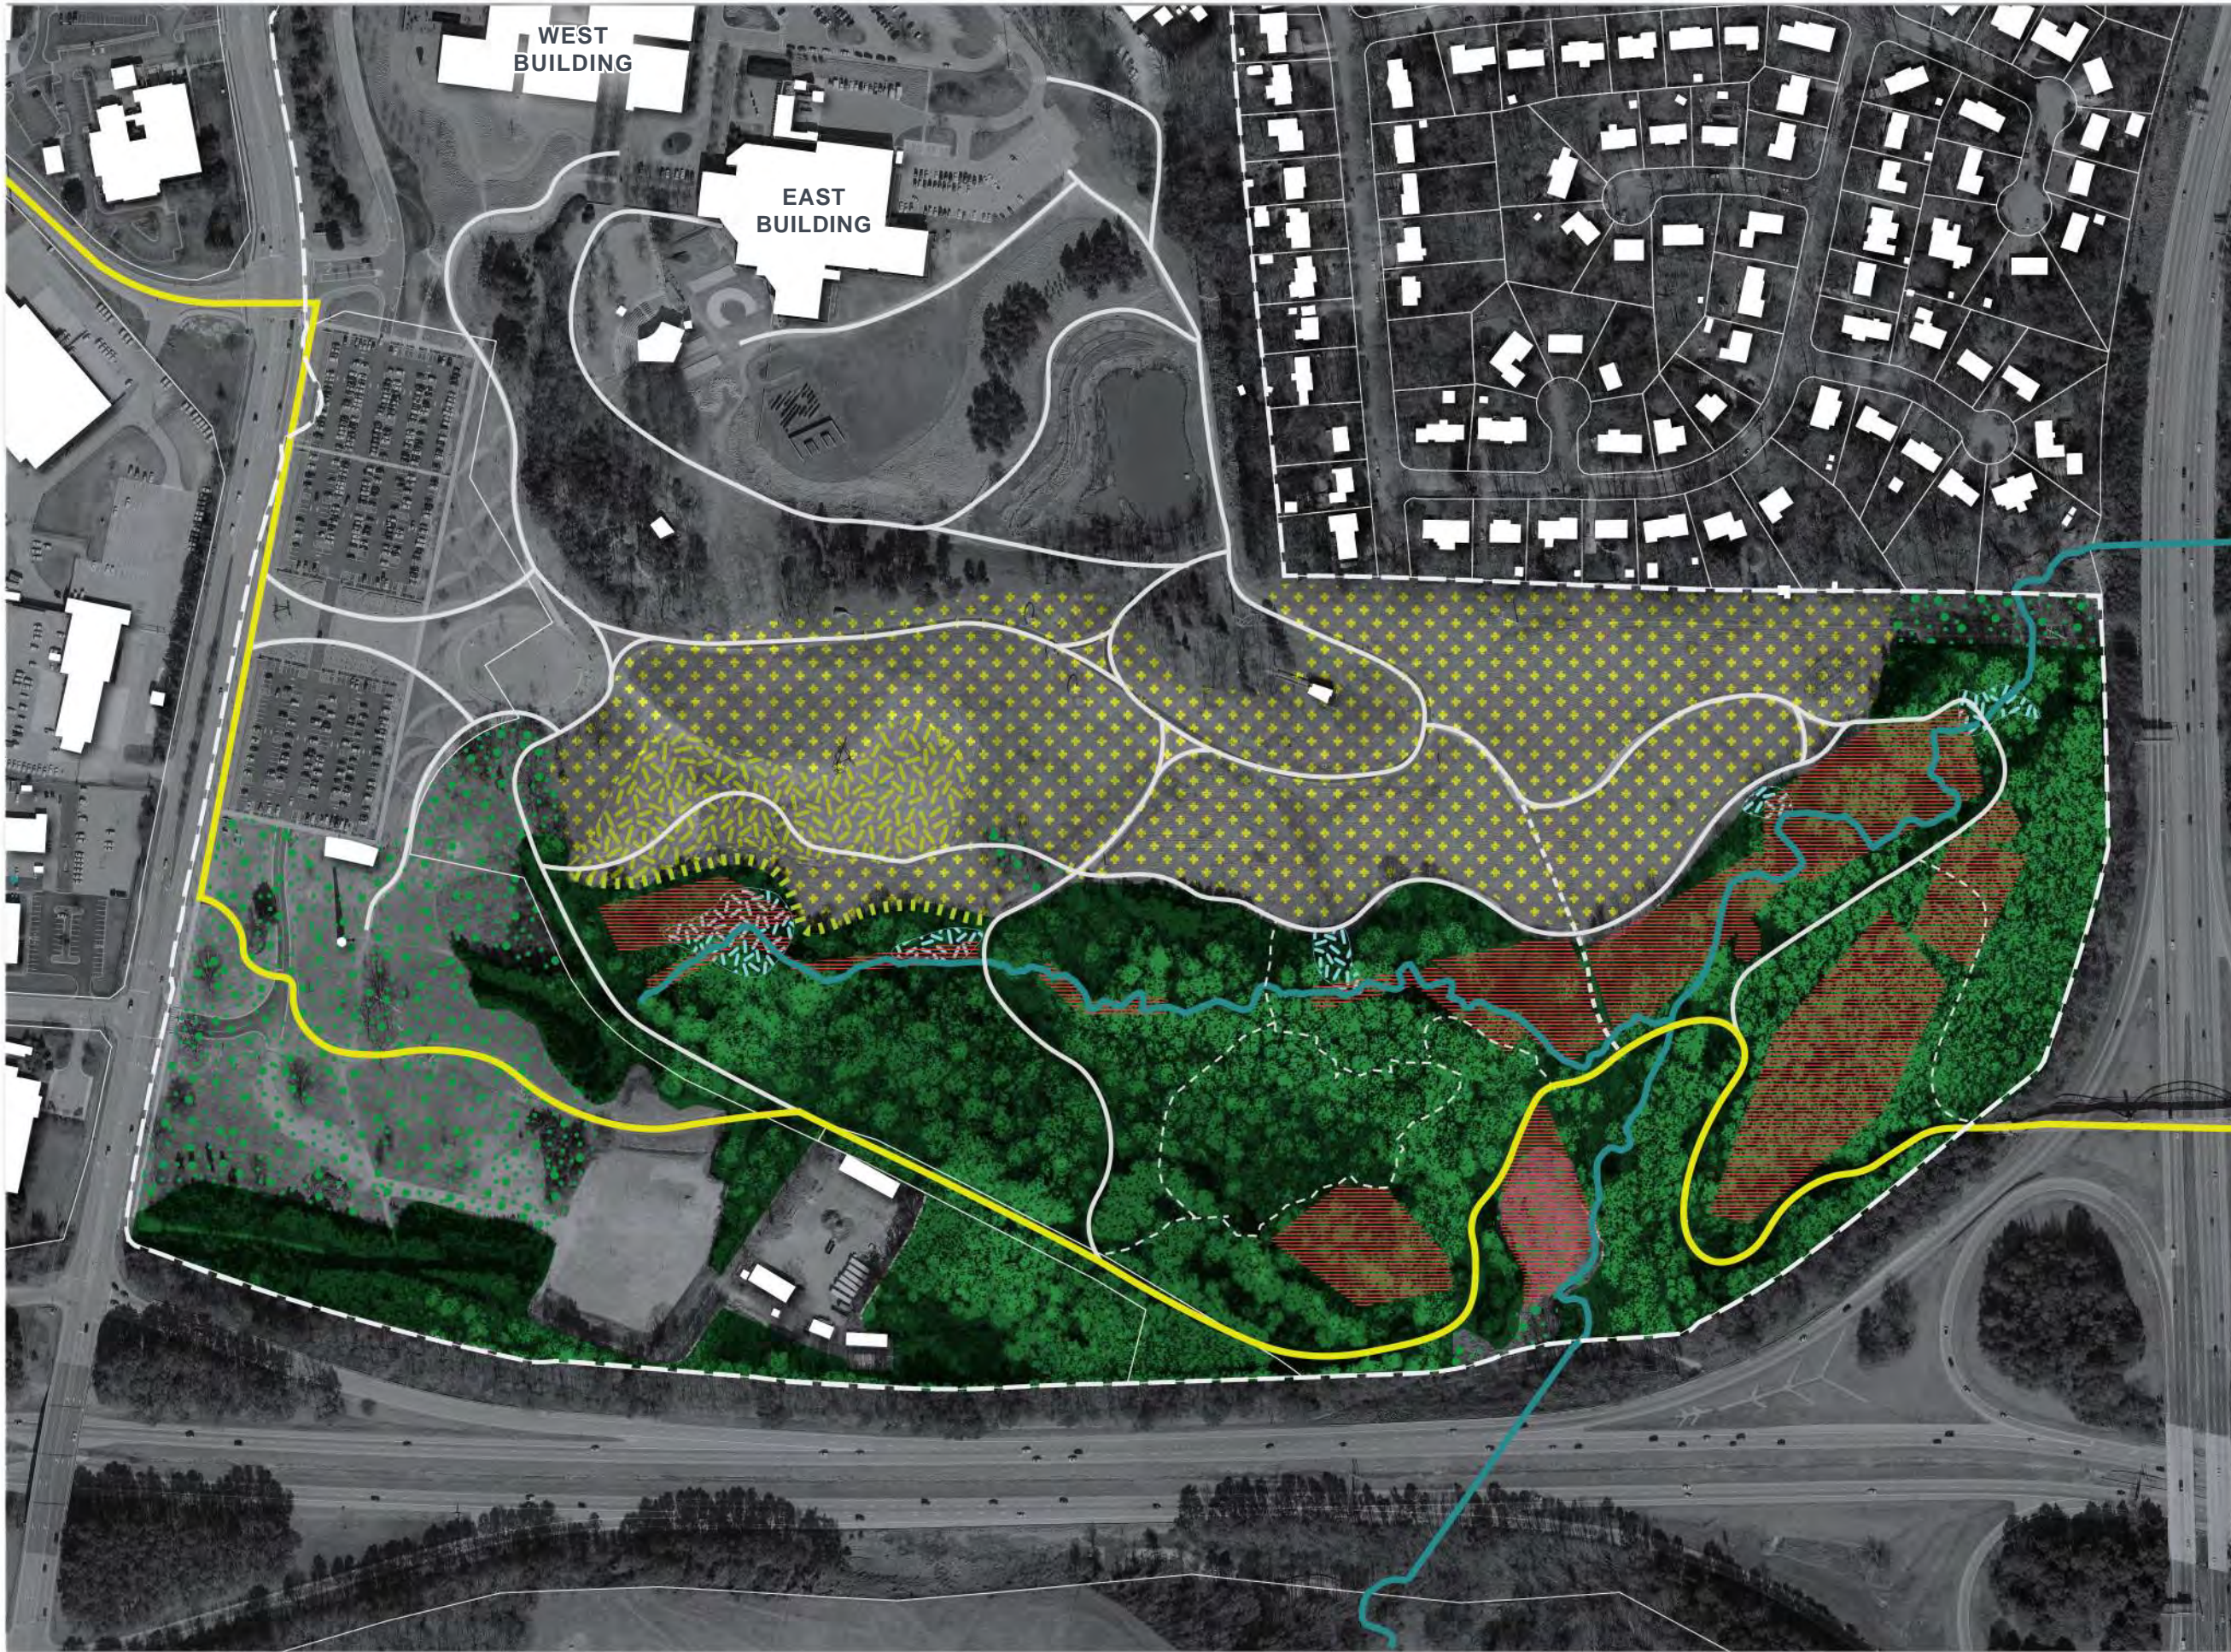
SPATIAL ECOLOGY

As shown in the data collected by the NCMA on the map to the right, many of the worst invasive plant infestations coincide with the worst areas of erosion in the stream corridor. Soil disturbance along the stream banks during large storm events allows for invasive species to take root and spread, particularly in areas where the tree canopy has been lost. This is especially apparent in the lower sections of the unnamed tributary and House Creek.

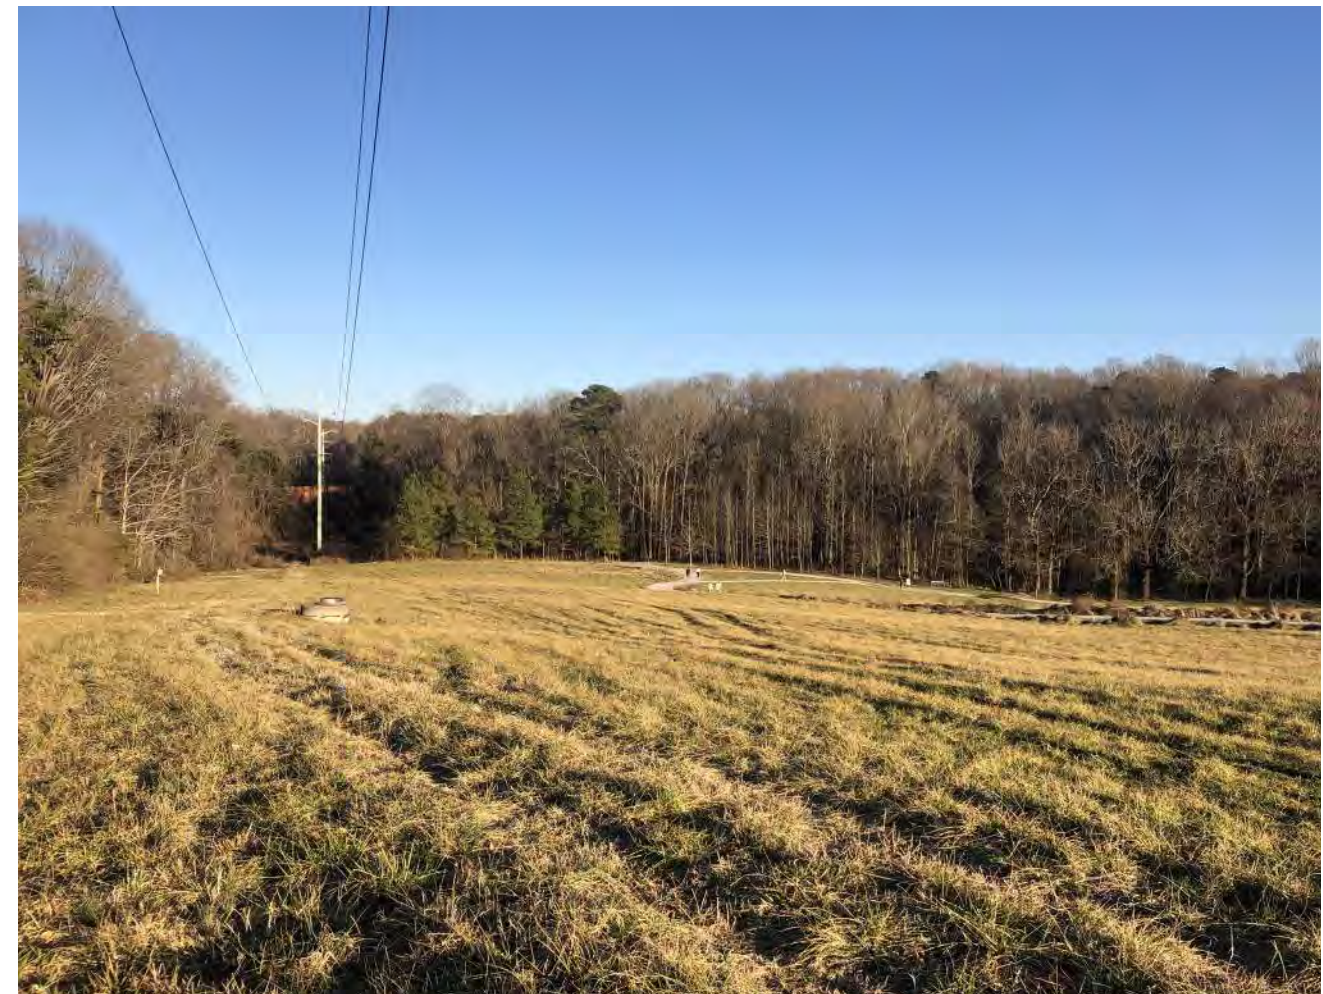
Existing power lines through Lower Meadow, looking toward I-440; Photo: Andropogon

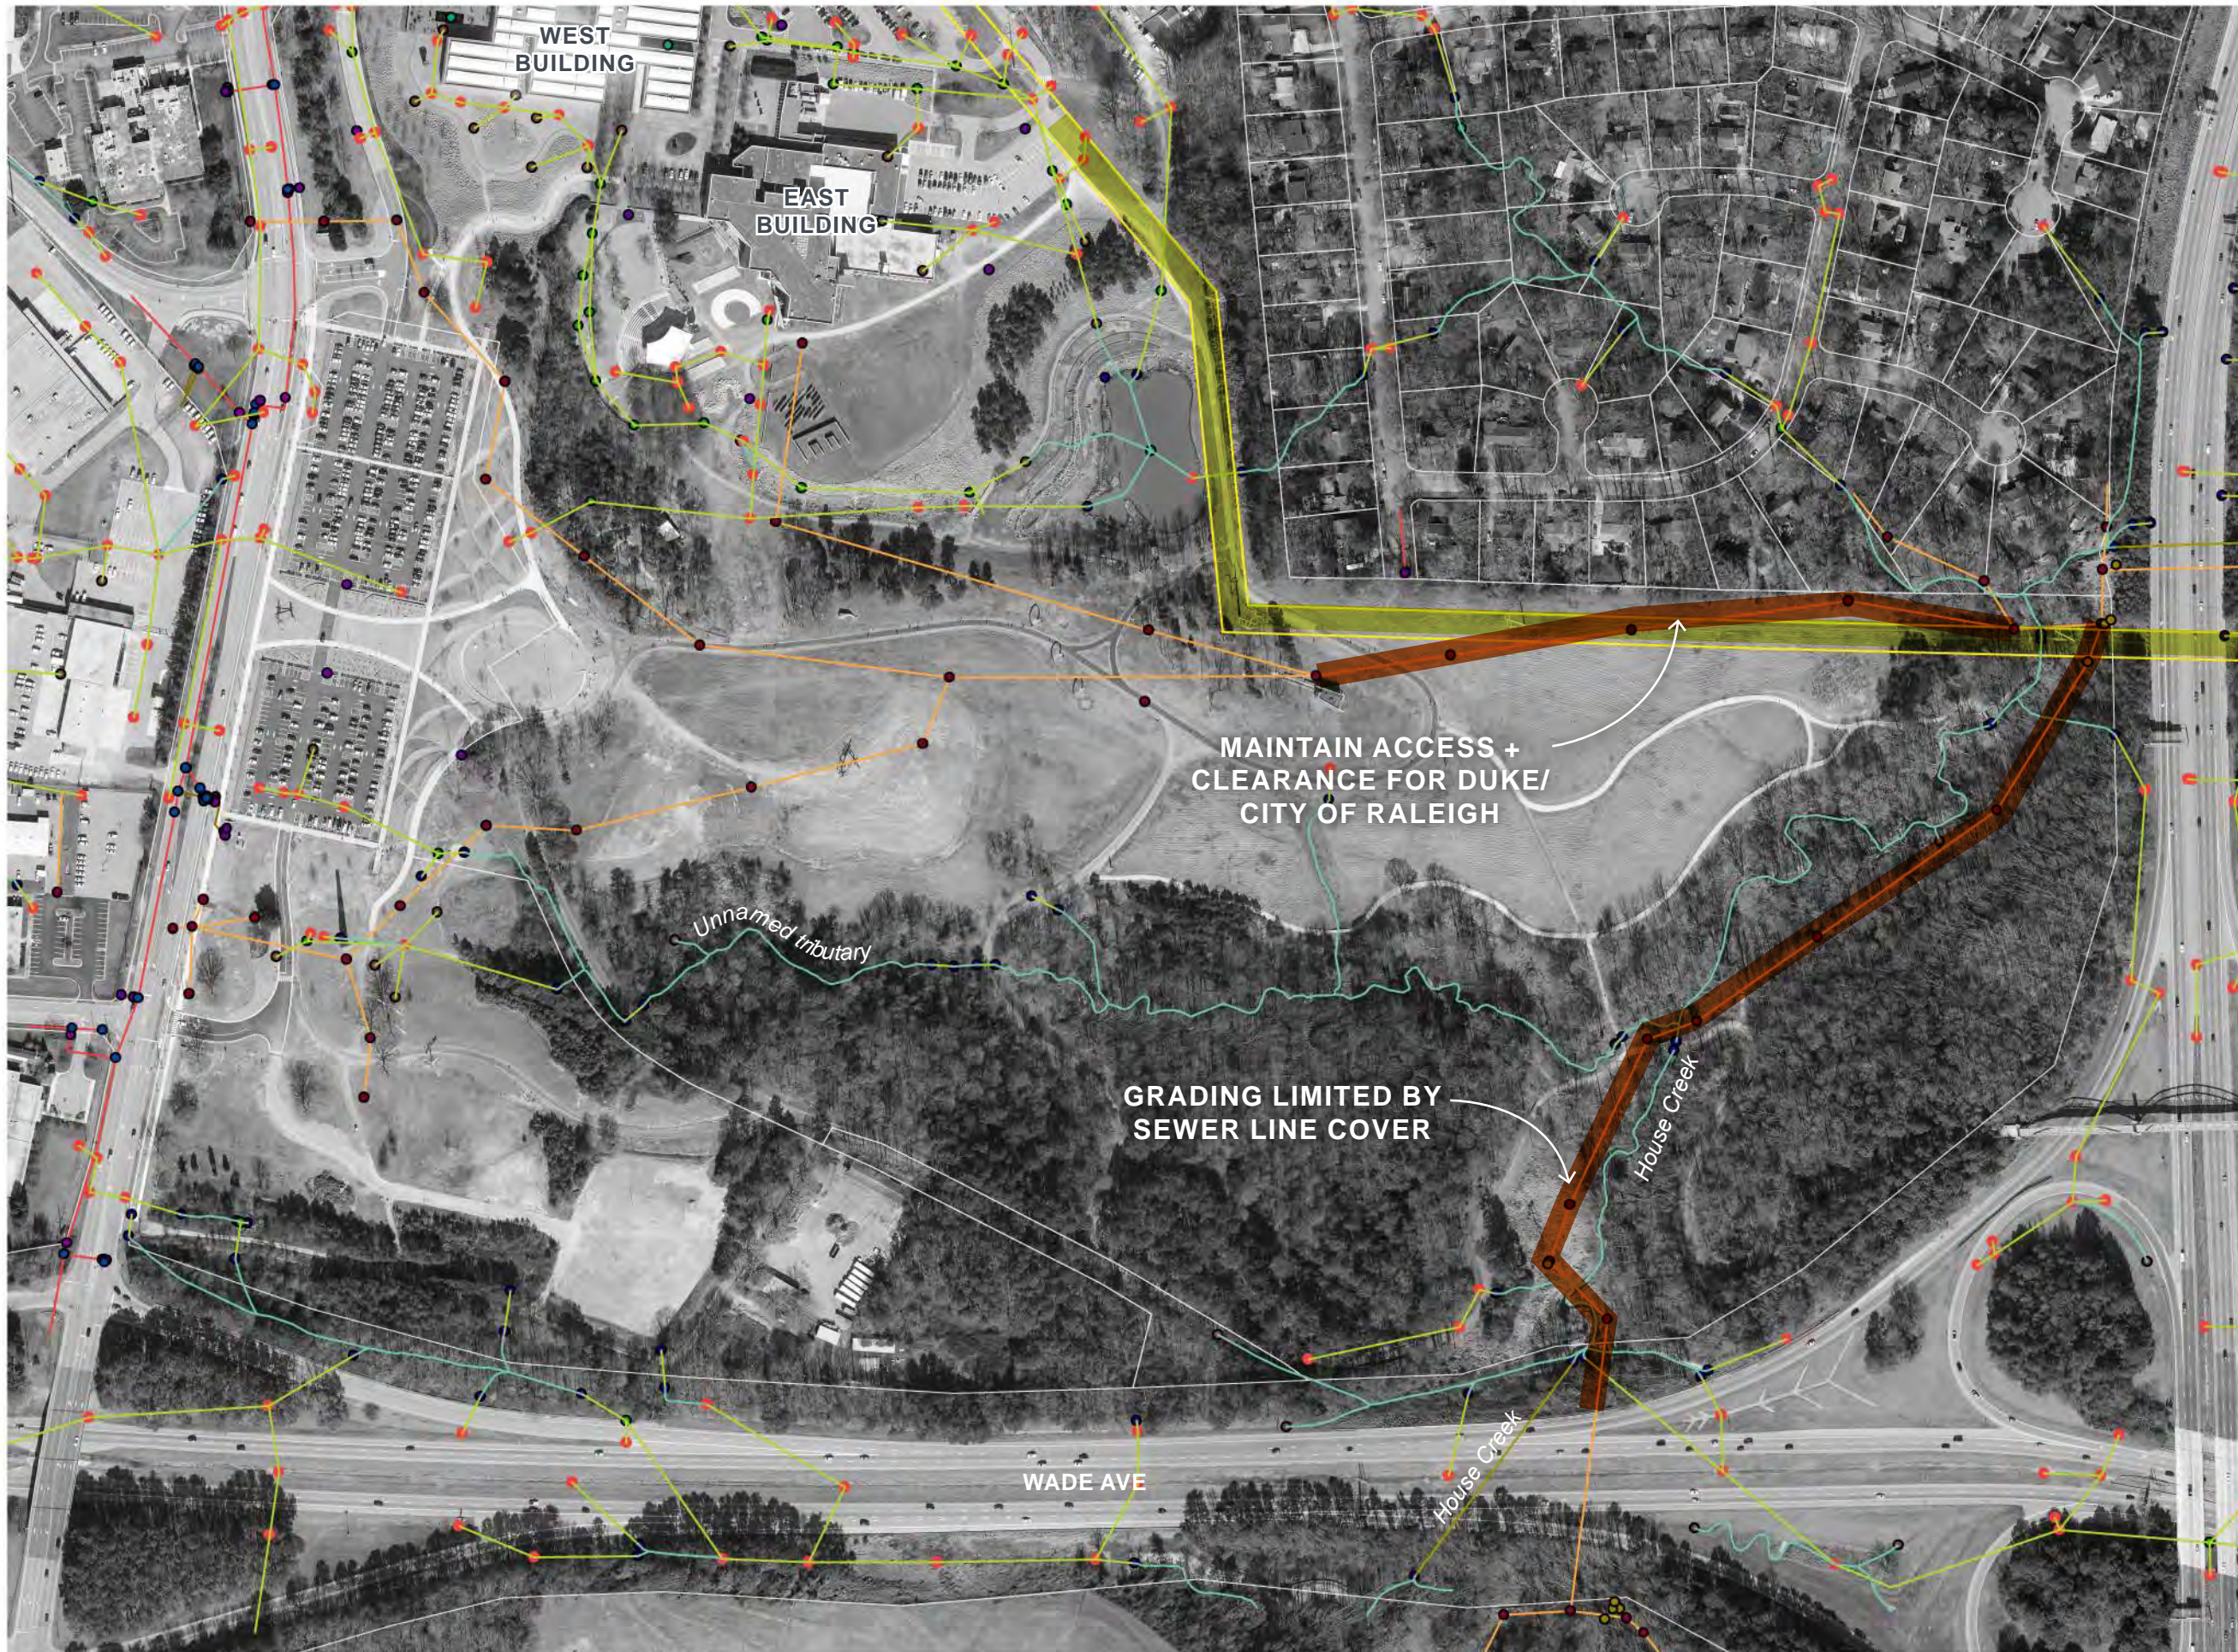
MAINTAIN ACCESS +
CLEARANCE FOR DUKE/
CITY OF RALEIGH

GRADING LIMITED BY
SEWER LINE COVER

City maintenance vehicles must be able to access the entirety of the sewer line, which means woody vegetation is removed by the City on a regular basis.

As the Museum makes improvements to the floodplain area where House Creek enters the property from Wade Avenue, restrictions on the amount of cover over the sewer line may limit the amount of grading feasible in this area.

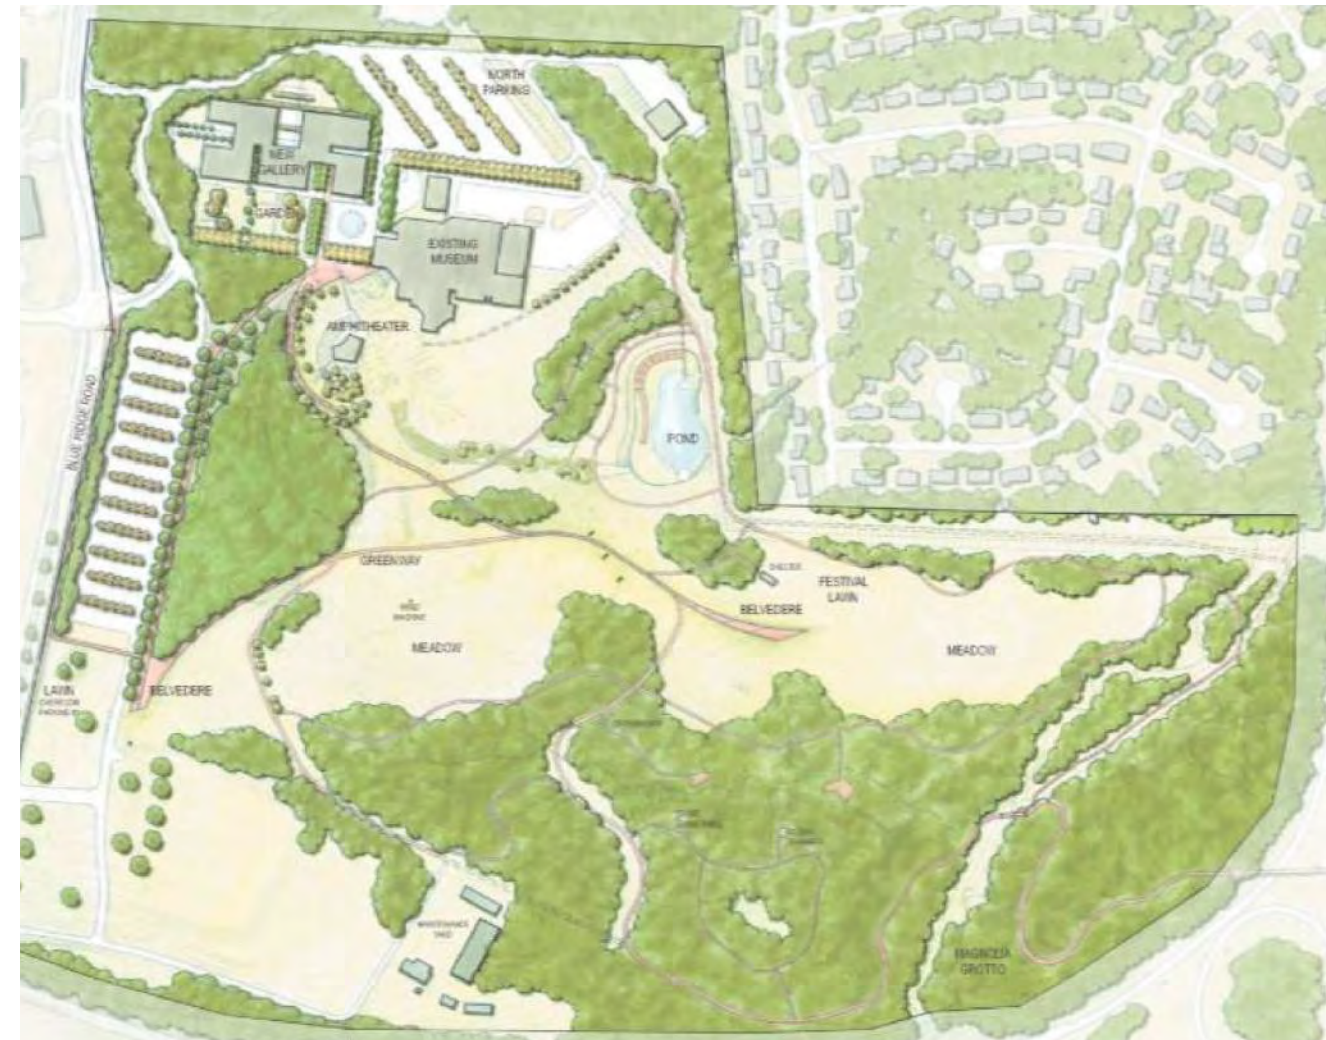
2007 Park Master Plan, Lappas + Havener (NCMA)
