North Carolina Museum of Art

MUSEUM PARK VISION PLAN

Prepared by Andropogon Associates, Ltd.
with contributions from Biohabitats, Inc., and WK Dickson
December 2021

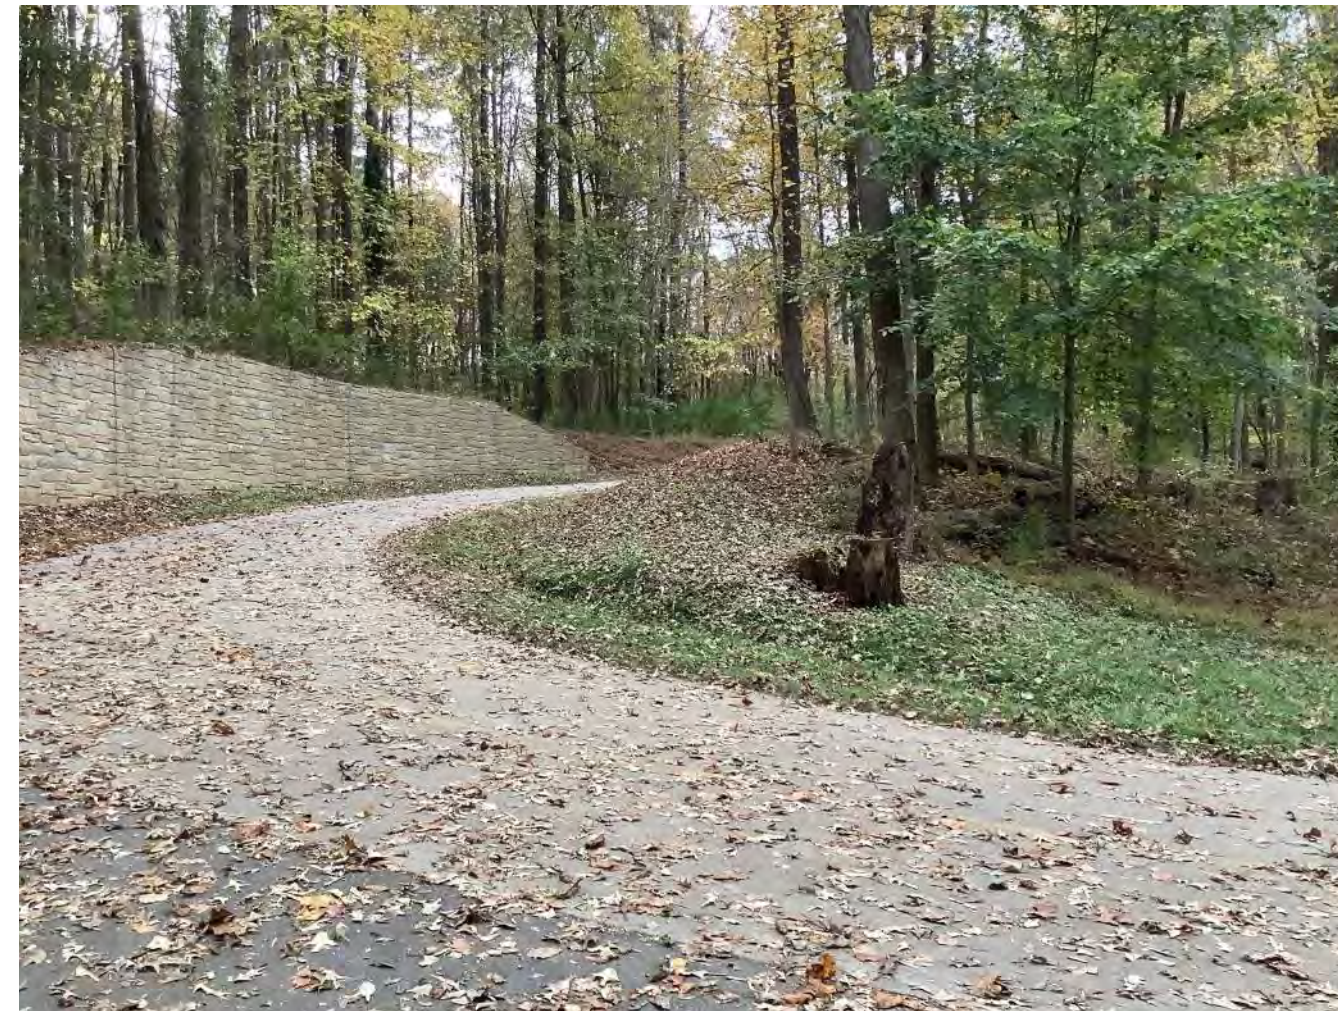
*Greenway slope and curve not in compliance with AASHTO standards;
Photo: Andropogon*

The American Association of State Highway and Transportation Officials (AASHTO) has developed trail design recommendations for shared-use paths, which although non-binding, are recommended in order to ensure cyclist and pedestrian safety in the Park. The existing grade of the greenway trail as it approaches the confluence area from the west is 8 percent in some areas. According to AASHTO, the grade of a multiuse path designed for 25 mph max speed should be no higher than five percent. Additionally, AASHTO standards recommend a minimum radius of 166 feet for curves on paths with a design speed of 25 mph and grades of six percent or more.⁴ The existing curve radius in this area is 53 feet.

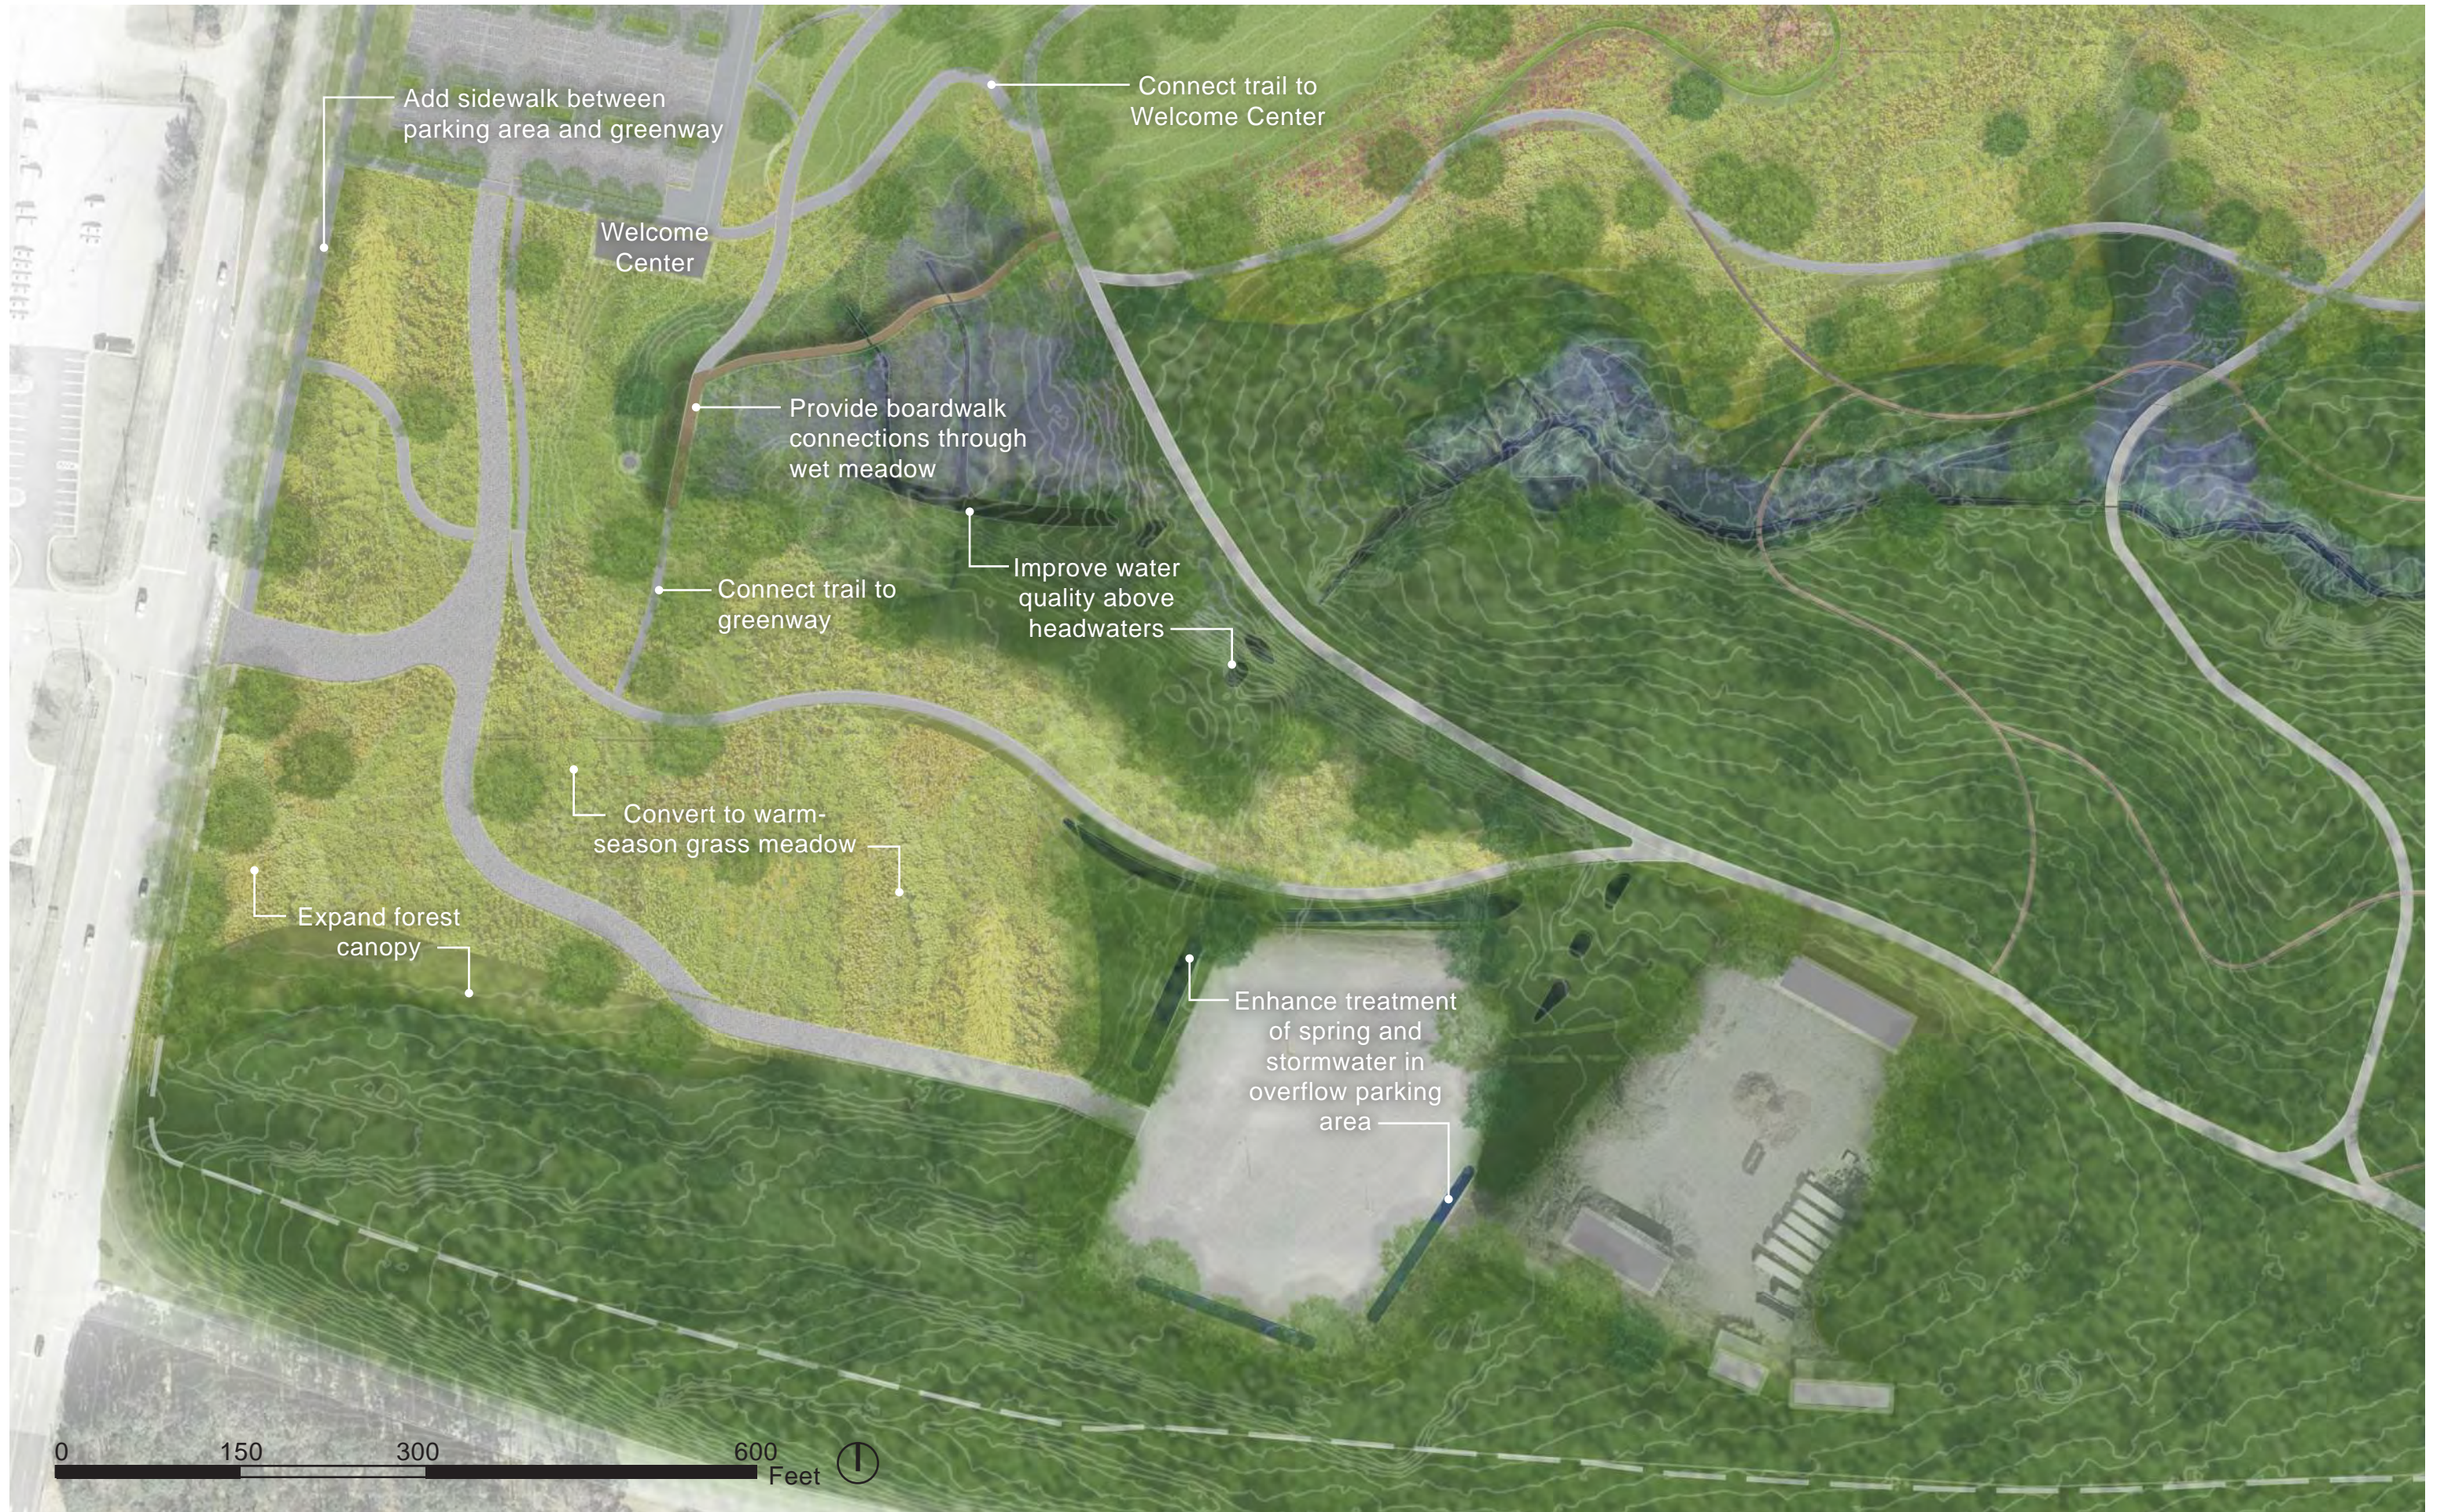
Add sidewalk between parking area and greenway

Connect trail to Welcome Center

A wet meadow will help treat runoff from the main parking area to the north of the Welcome Center, preventing it from channelizing along the trail. Additional stormwater treatment in the areas surrounding the overflow gravel parking lot will help capture and filter water before it flows over the greenway trail, where it currently creates a hazard for cyclists. Water quality improvements in the area near the southwest section of the Blue Loop, above the current headwaters, will help slow runoff and stabilize slopes as the water enters the unnamed tributary channel.

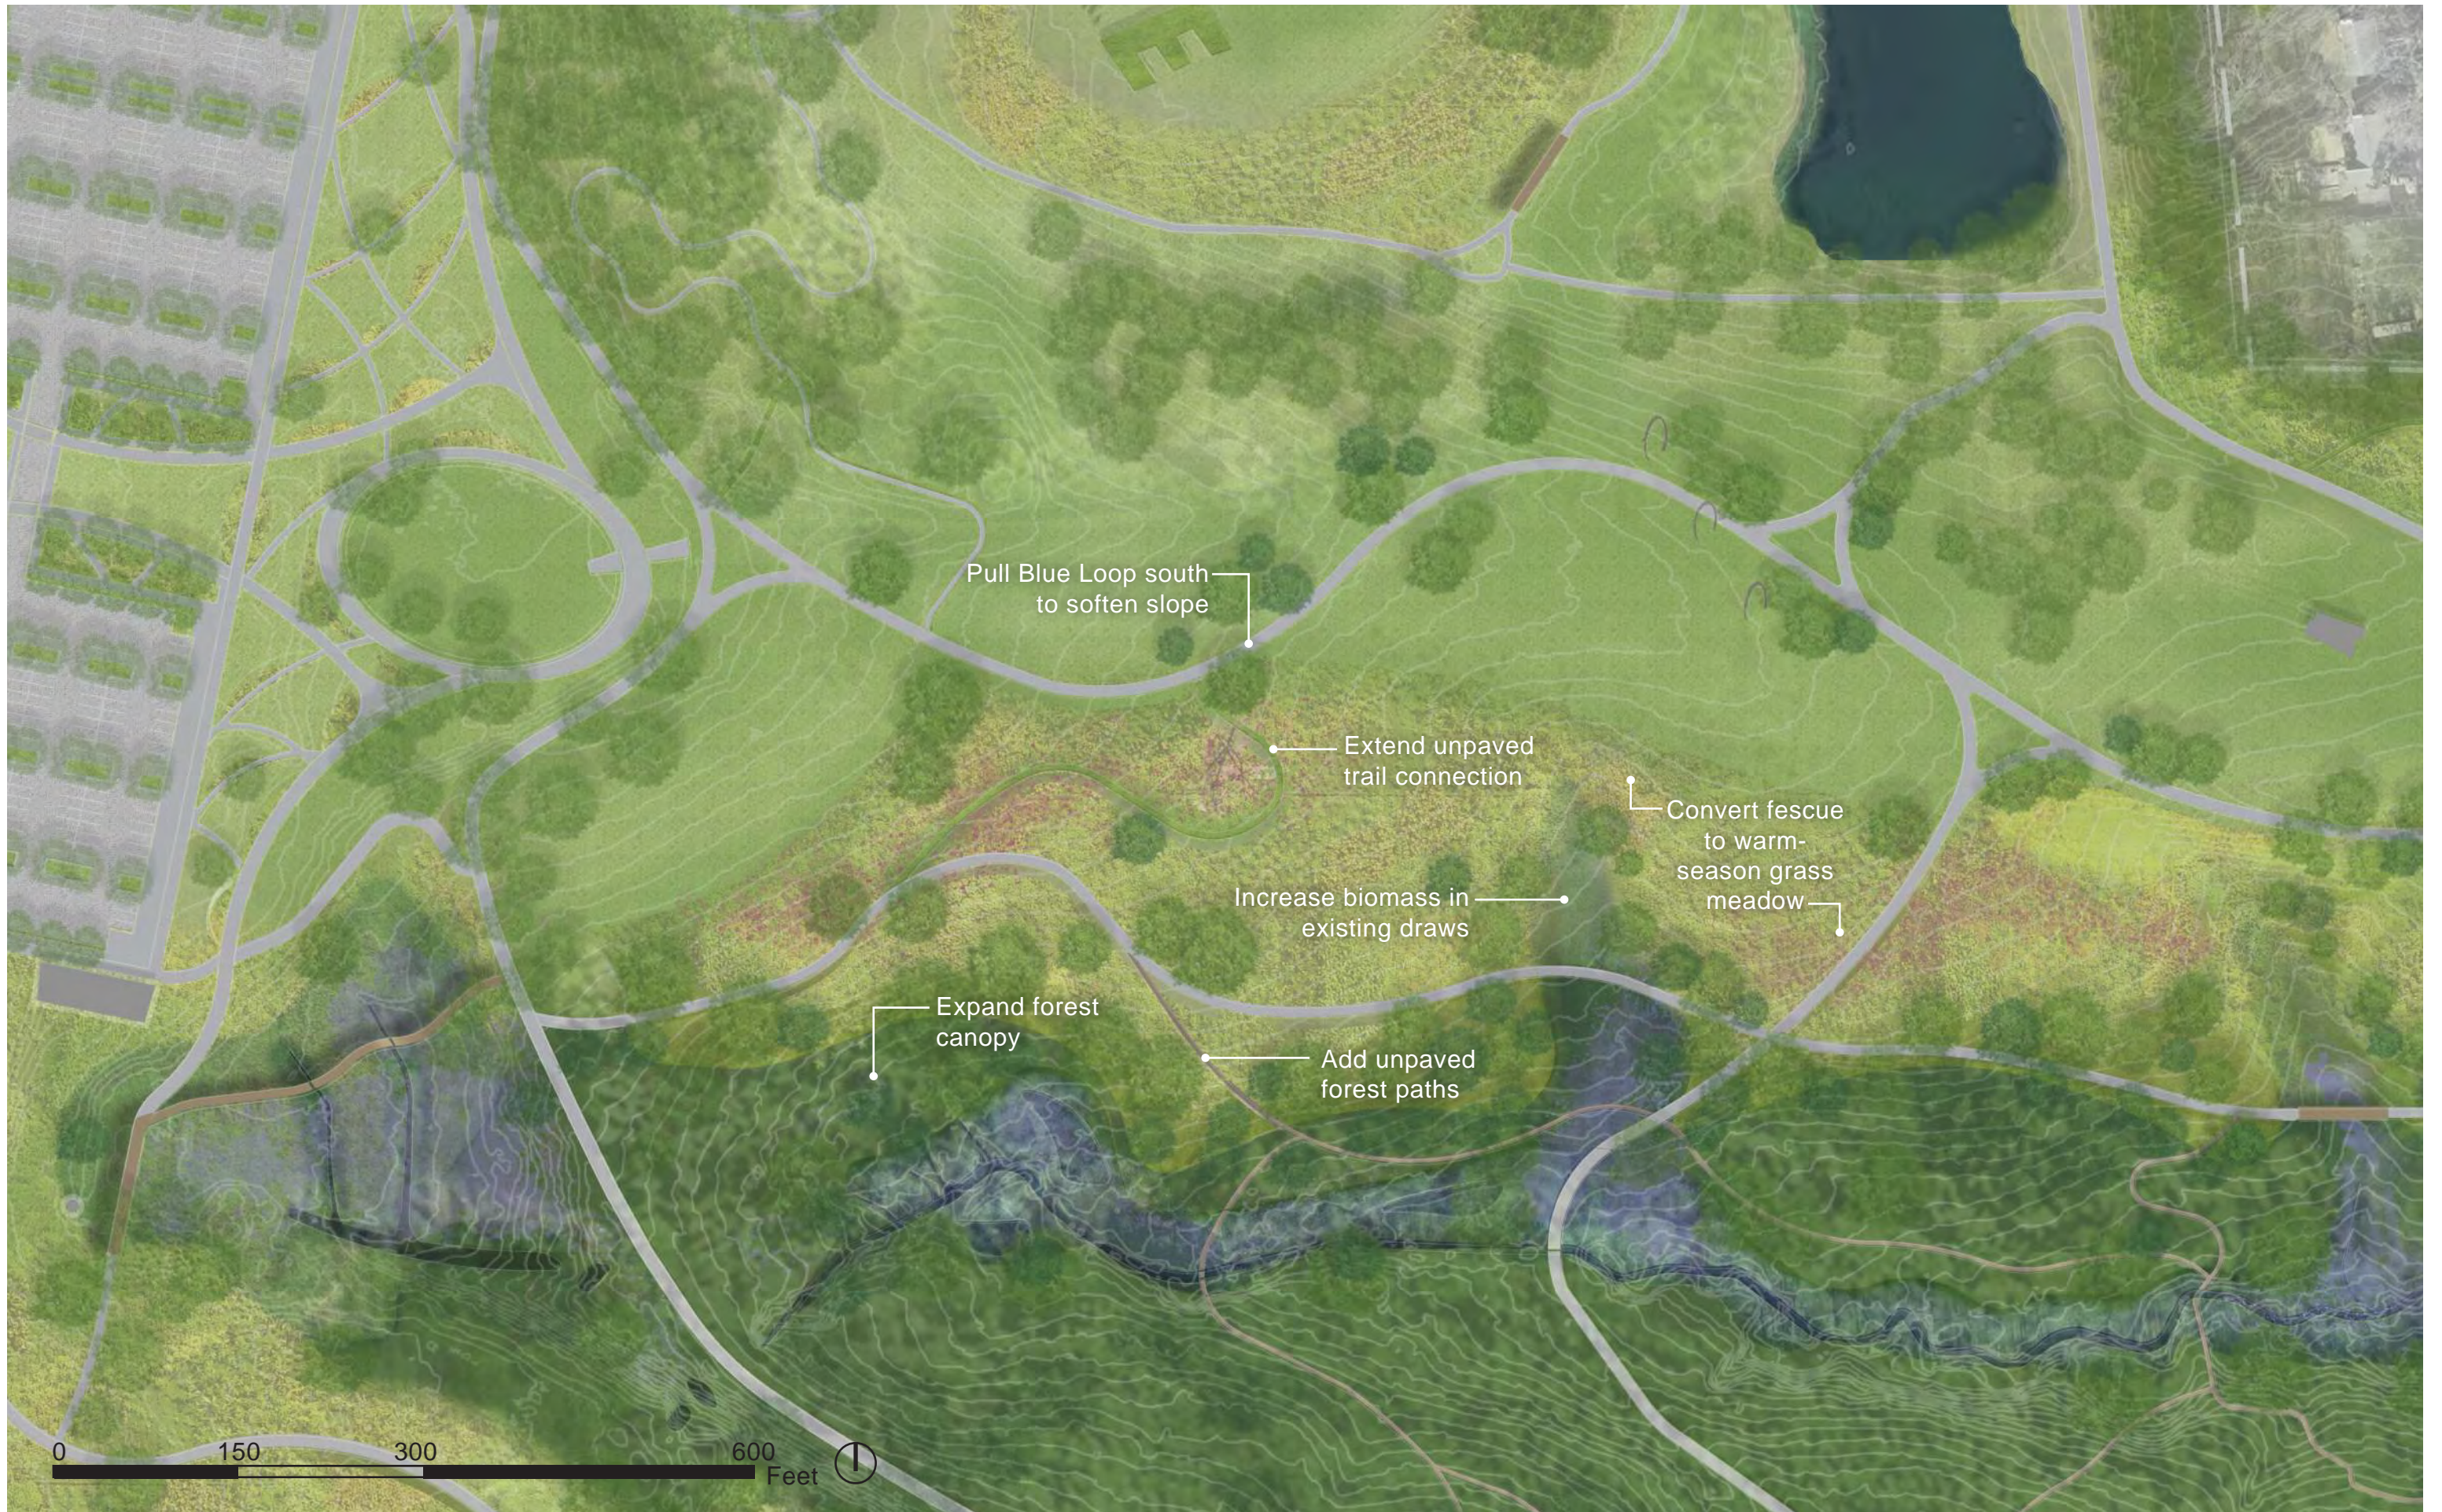
Pull Blue Loop south to soften slope

Extend unpaved trail connection

The Blue Loop trail is shifted off of the ridge line near the Ellipse to ease the grade as the trail dips east into the Park. It will return to its current alignment prior to

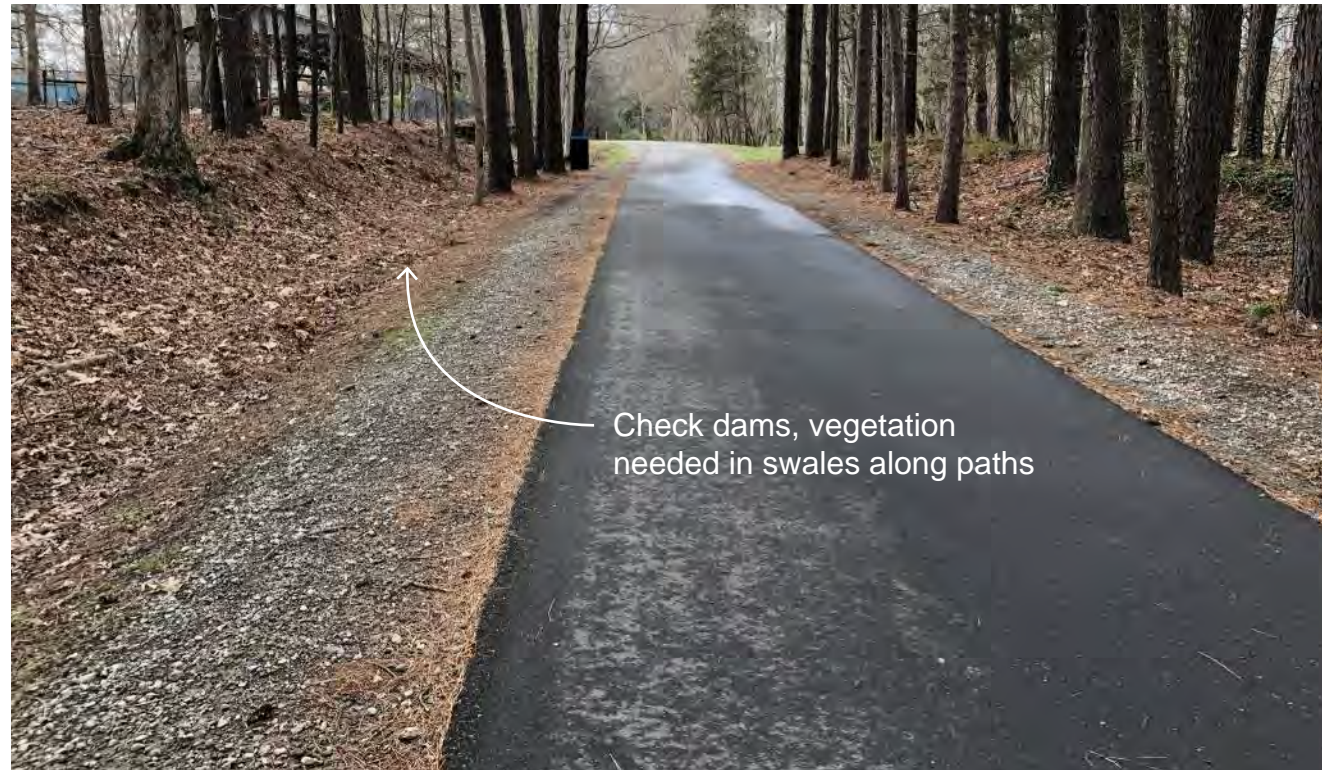
Existing swale along path; Photo: Andropogon

Stone check dams and dense perennial plantings should be added to the existing swales along pathways throughout the Park. This is especially important in areas with steep slopes that drain directly into the streams. The check dams will slow runoff and allow sediment and pollutants to filter down through the soil before reaching the stream corridors. Plantings that can withstand extremes of wet and dry conditions will be best suited for these areas, and the added biomass will slow runoff while also capturing carbon. Flowering plant species will provide visual interest for trail users and sustenance for pollinators.

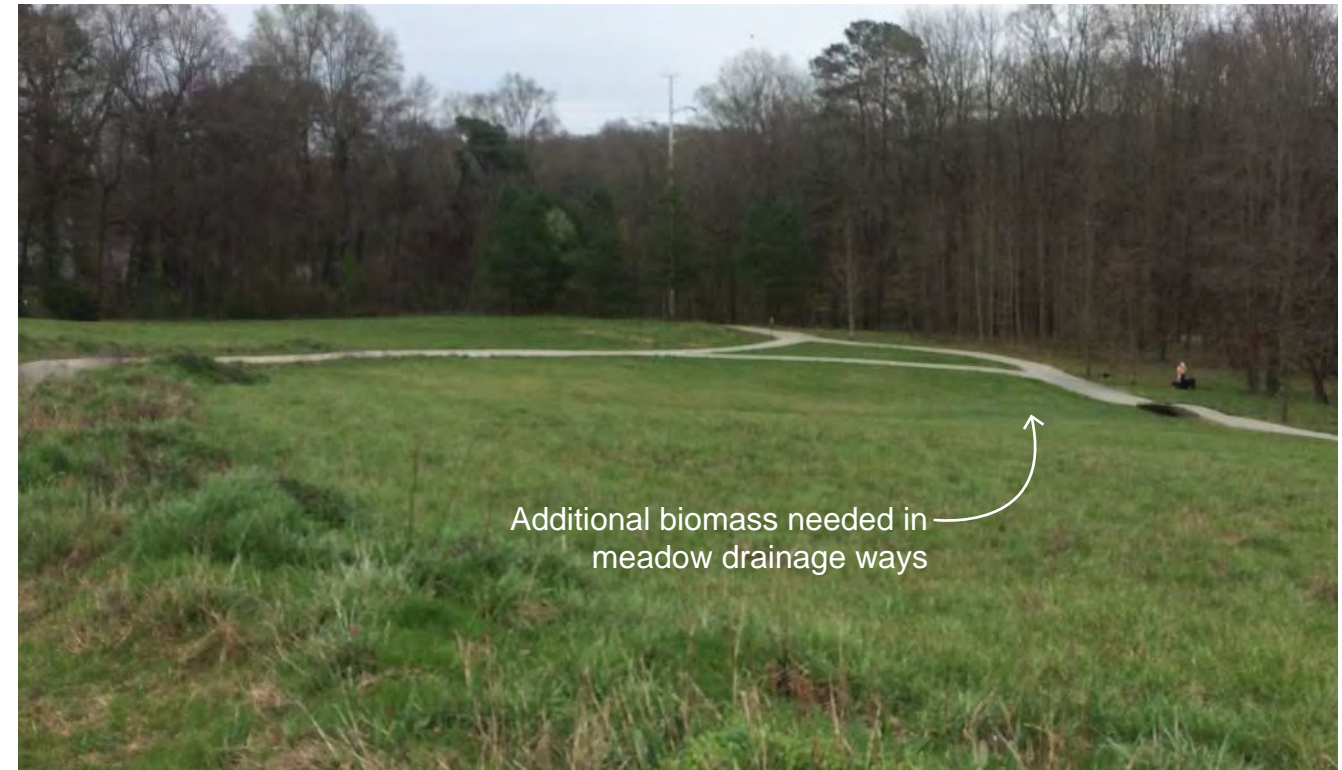
Existing draw in fescue meadow; Photo: Andropogon

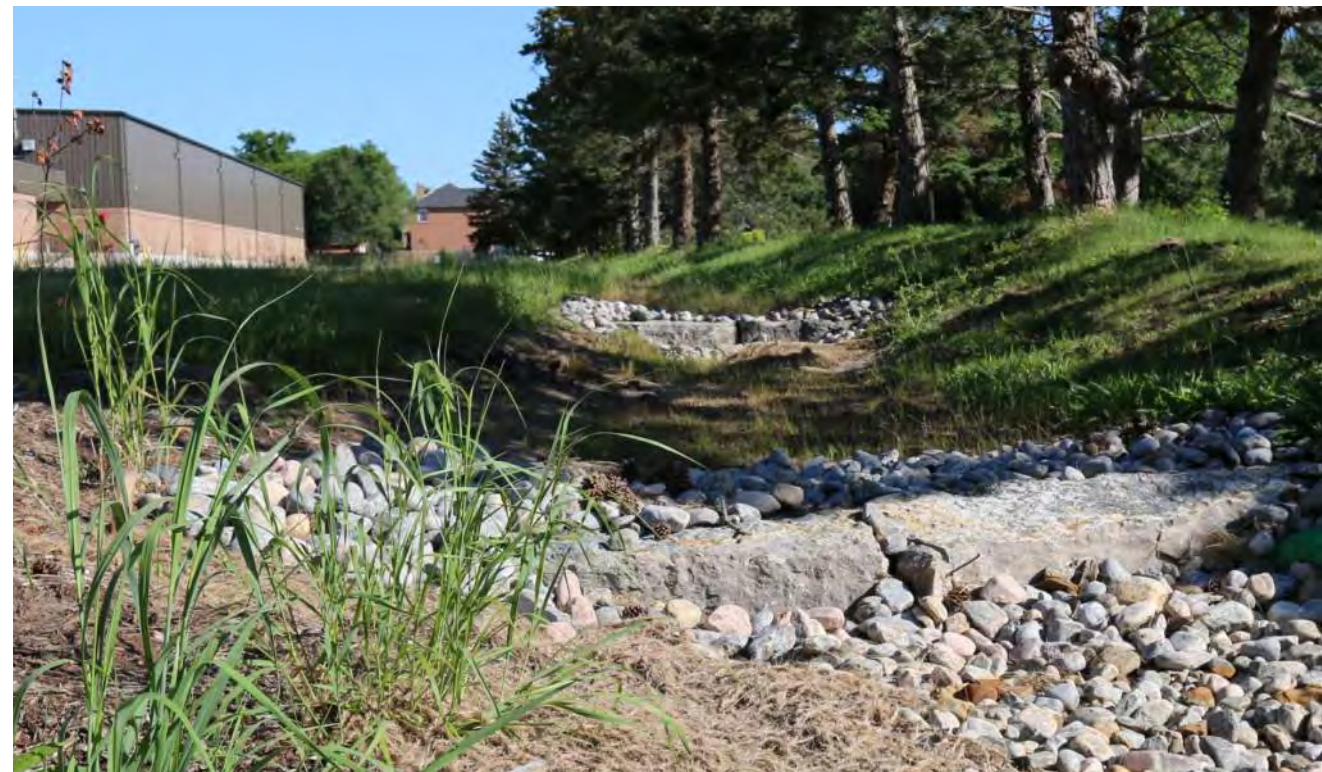
Example of proposed enhancements to swales along paths; Photo: Sustainable Technologies Evaluation Program's LID SWM Planning and Design Guide

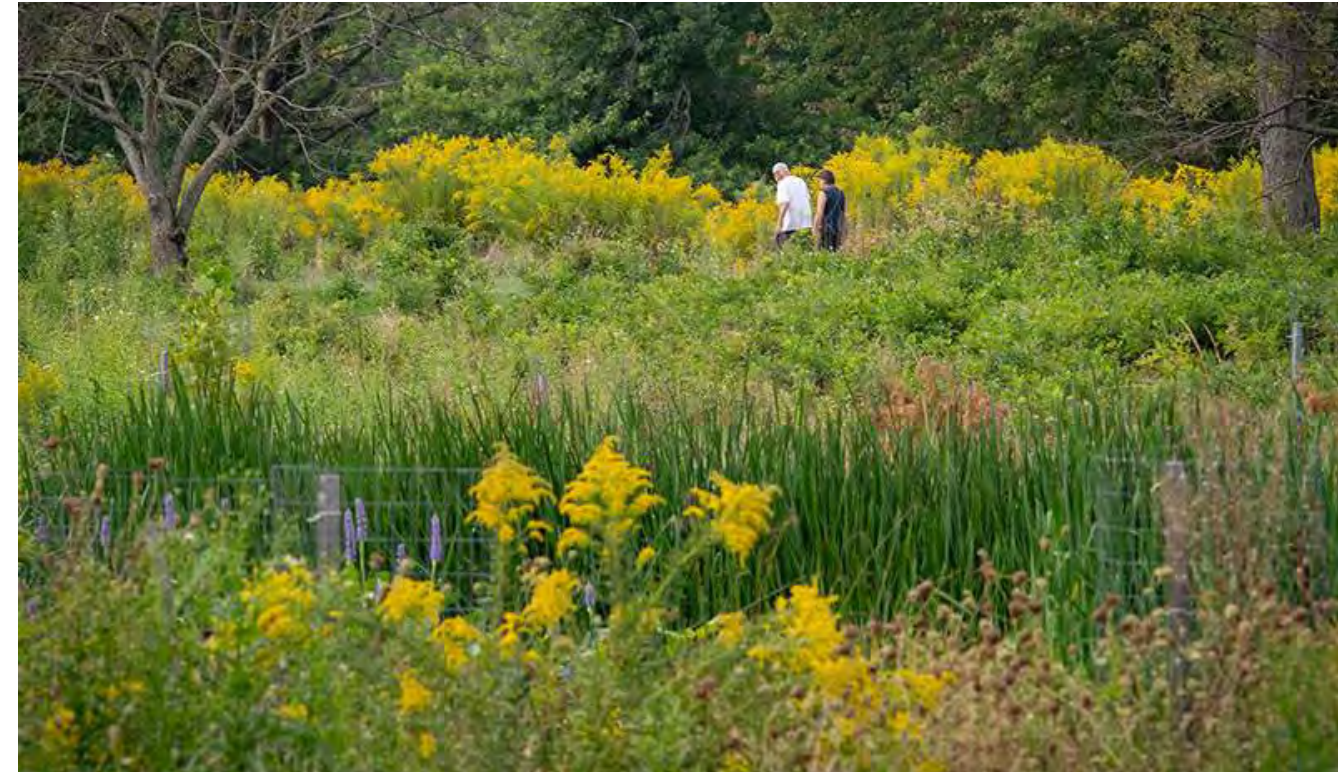
Example of proposed enhancements to draws in meadow ecosystem; Photo: Kyle Lanzer

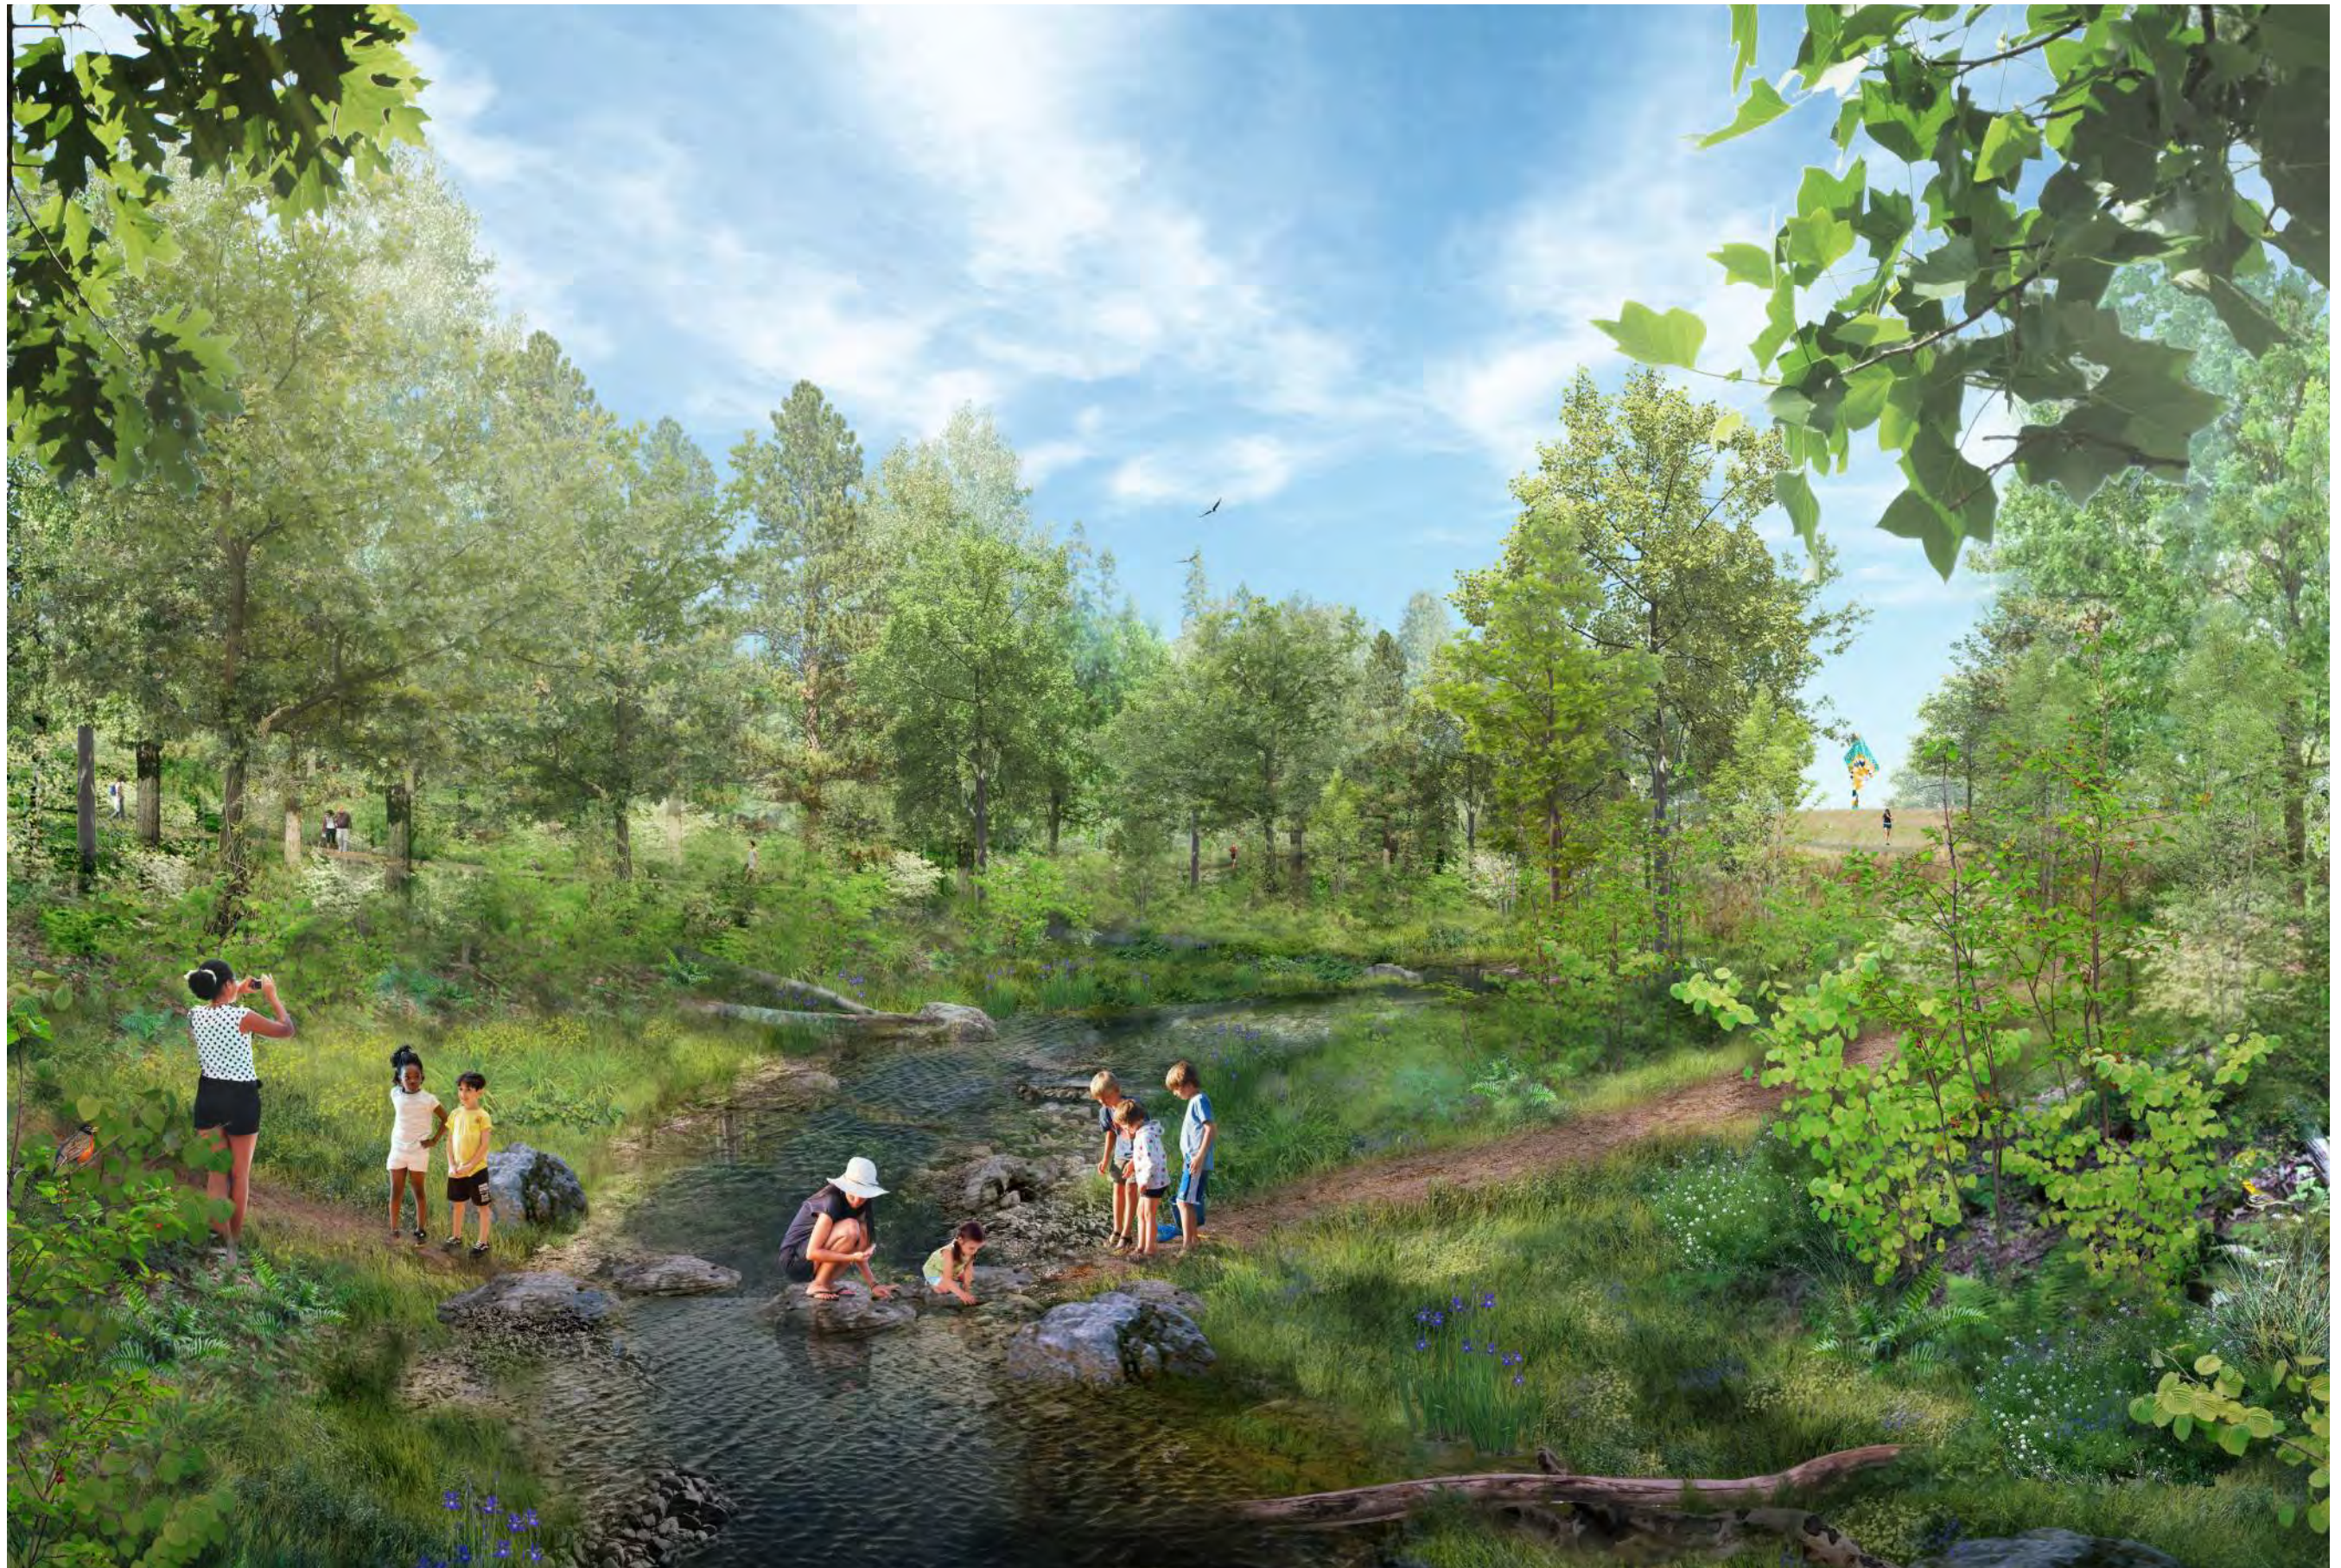
Stepstone crossing at unnamed tributary

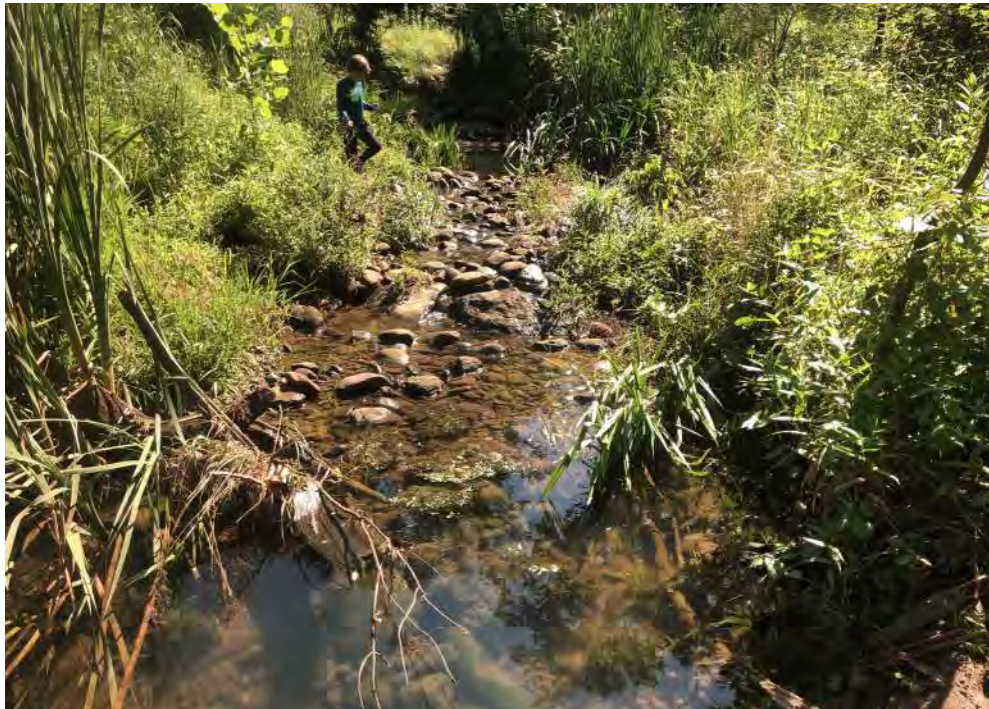
Tributary riffle structure

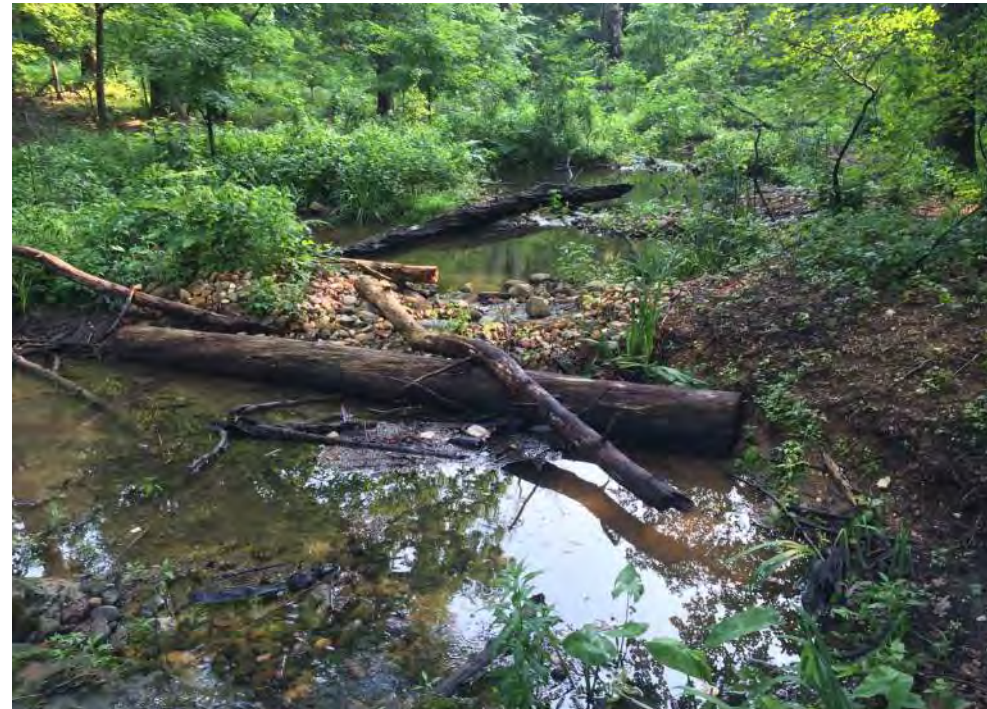
Tree and woody debris incorporated into stream and riparian wetlands

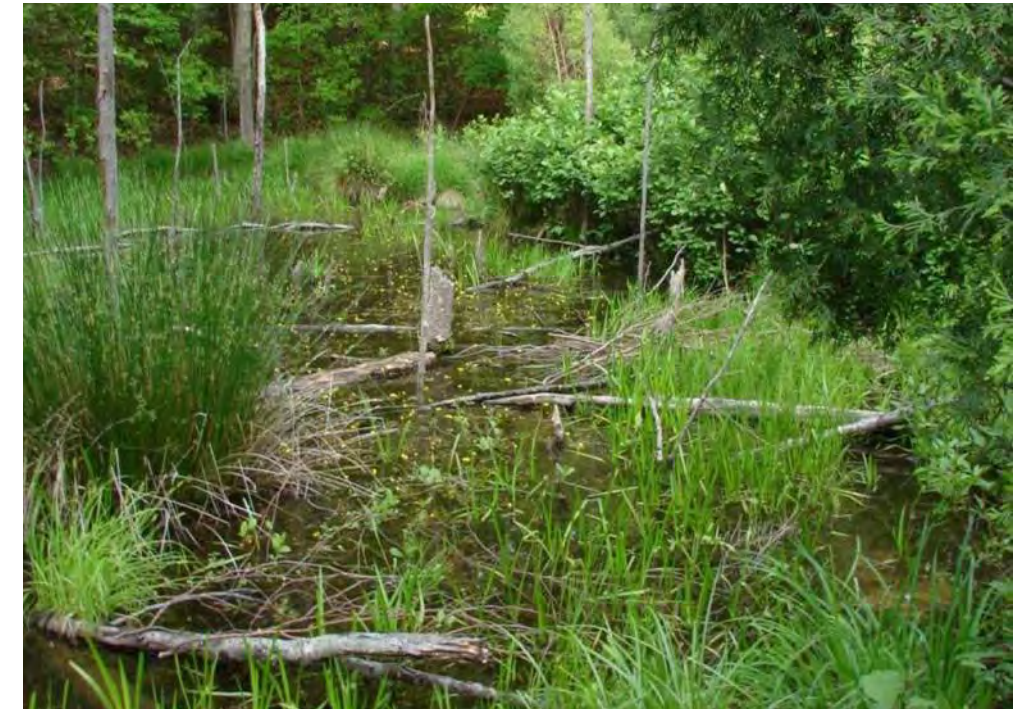
Floodplain depression wetlands

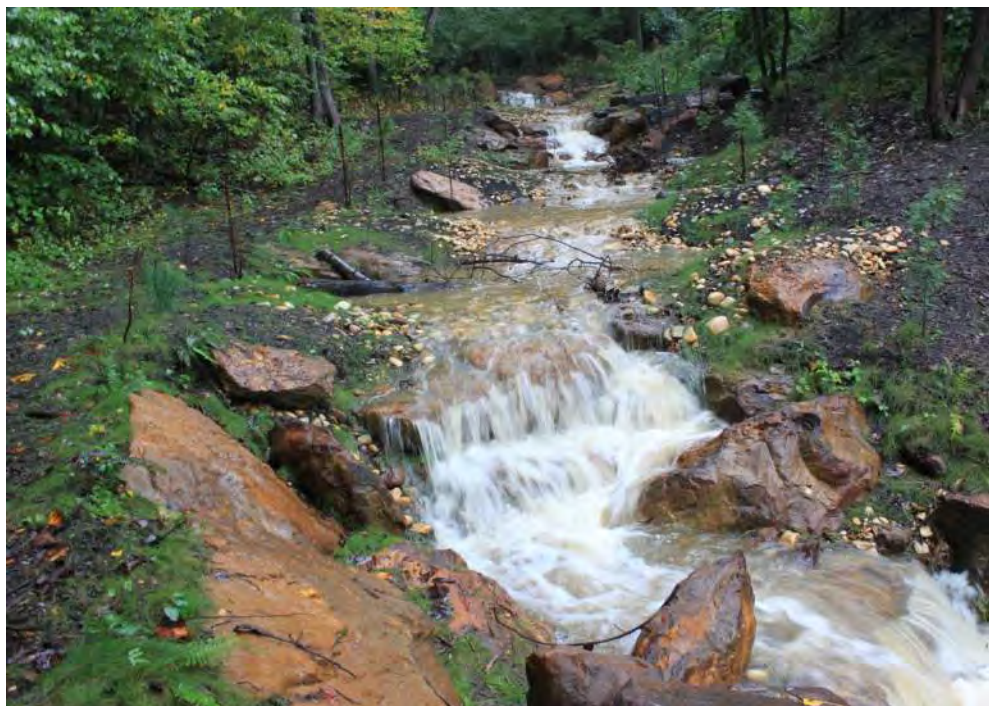
Cascade drop structure

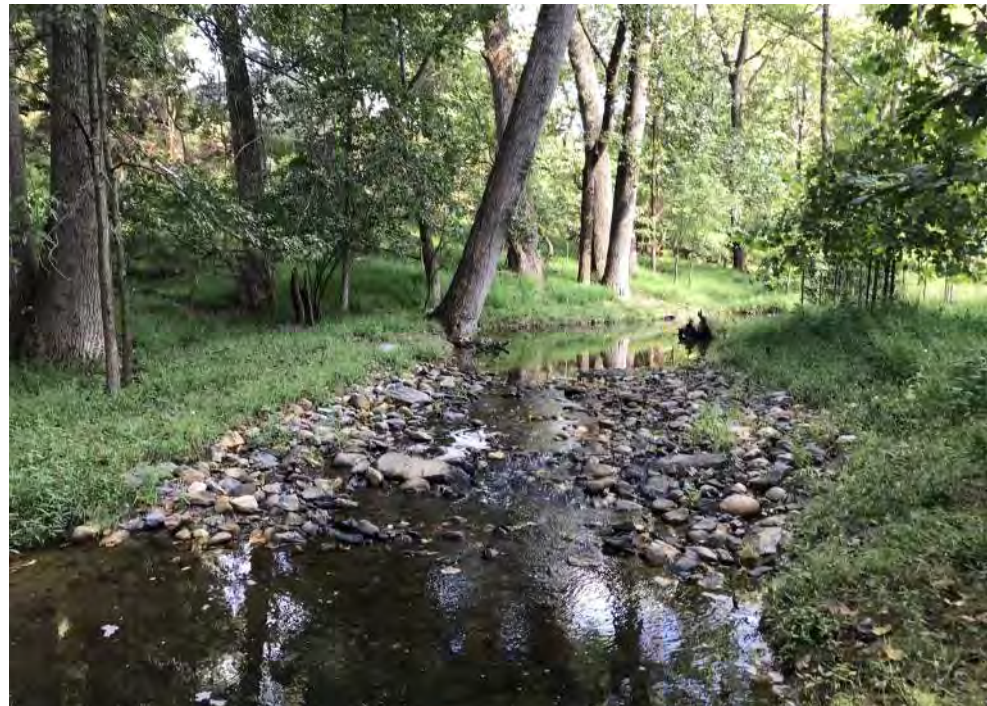
House Creek riffle structure

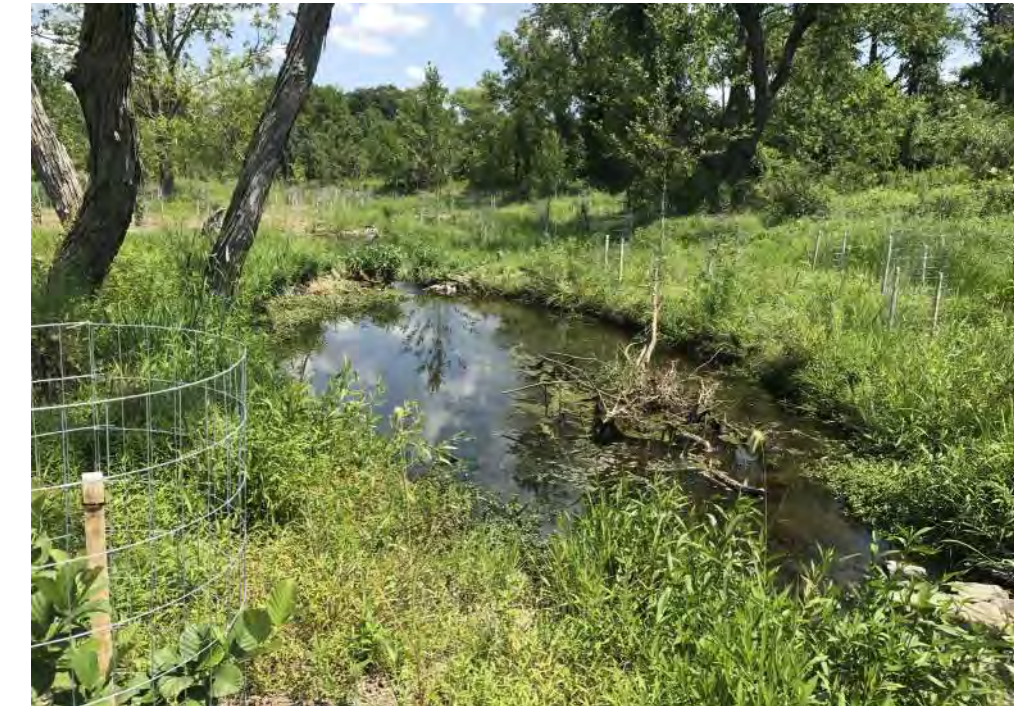
Floodplain bench with adjacent wetland

Precedent imagery from previous stream restoration efforts: Biohabitats

The most relied-upon restoration channel structure used in the conceptual design is the cobble riffle structure, which stabilizes the channel elevation, preventing future erosion and incision. Pools are created in between the riffle structures, and the combination of the two provides improved aquatic habitat diversity for aquatic insects (macroinvertebrates) and fish species. An at-grade boulder structure is located at the downstream extent of restoration on House Creek, preventing scouring and erosion from proceeding upstream, and protecting

the restoration structures. Numerous floodplain depressions will be created in the House Creek floodplain to diversify aquatic and terrestrial habitat. Wood from trees harvested during the construction process will be reused on the site to create habitat such as standing snags for birds and floodplain logs for terrestrial wildlife habitat in the floodplain. The photos on the facing page illustrate the use of these features in previous stream restoration projects of similar scale and character.

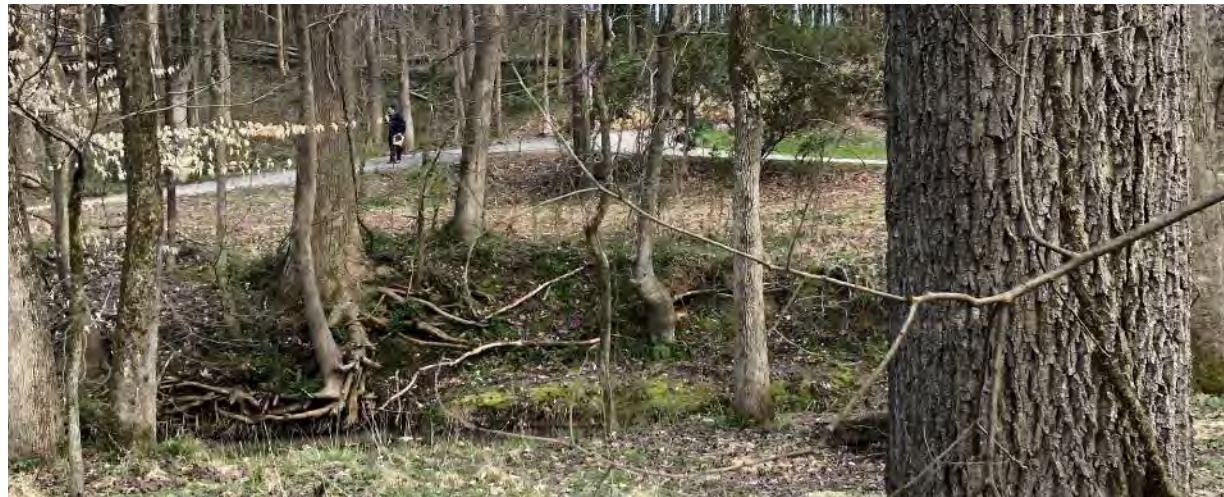
Existing oak trees near confluence, damaged by erosion

As part of the process of adjusting grades in the stream corridors to lift the channel closer to its floodplain elevation, some existing trees along the stream will be impacted. However, the substantial tree loss that is currently happening along the banks of the unnamed tributary and House Creek will continue to worsen if restoration does not occur. An increase in volume and speed of water during storm events in both streams is causing the roots of trees along the channel to become exposed, and eventually the trees become so unstable that they fall. Not only does this contribute to erosion and poor water quality, but it poses a safety risk for trail users near the damaged trees. Evidence of this condition, both in terms of fallen trees and trees with heavily damaged root systems, can be seen throughout the stream corridors in the preserve.
