North Carolina Museum of Art

MUSEUM PARK VISION PLAN

Prepared by Andropogon Associates, Ltd.
with contributions from Biohabitats, Inc., and WK Dickson
December 2021

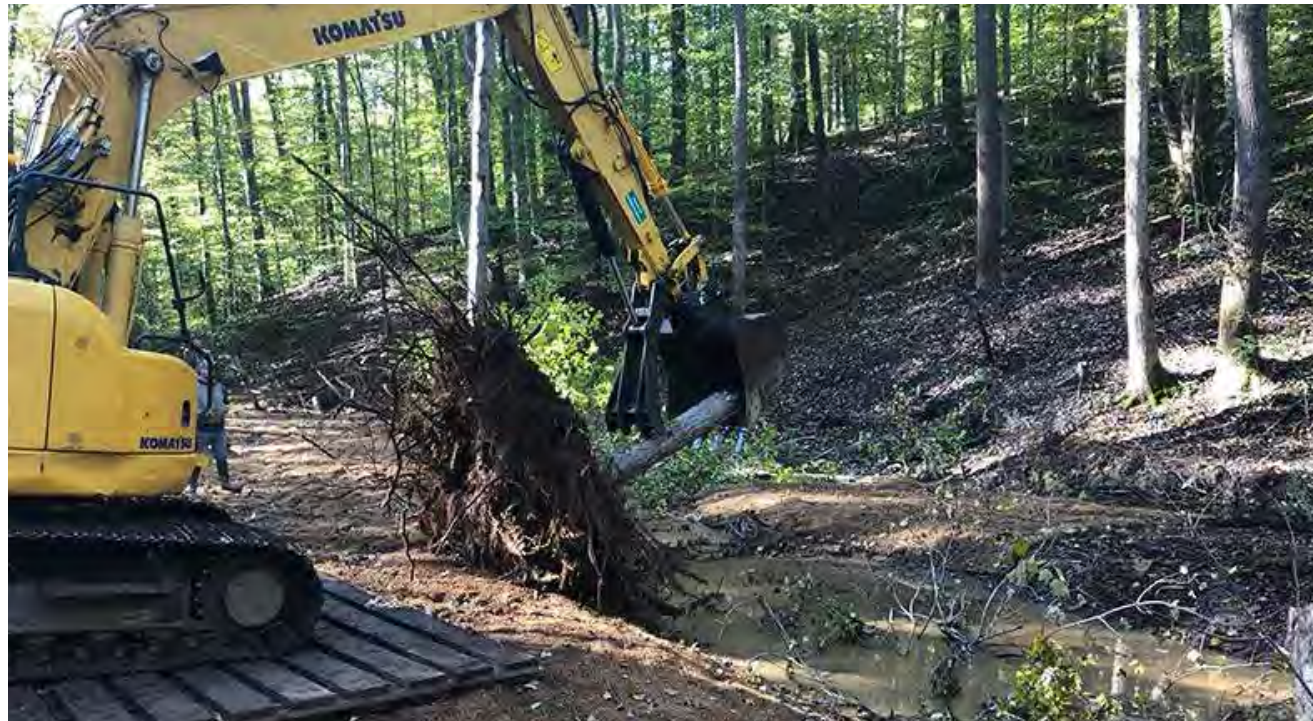
Construction: placement of a root wad to raise the stream invert level

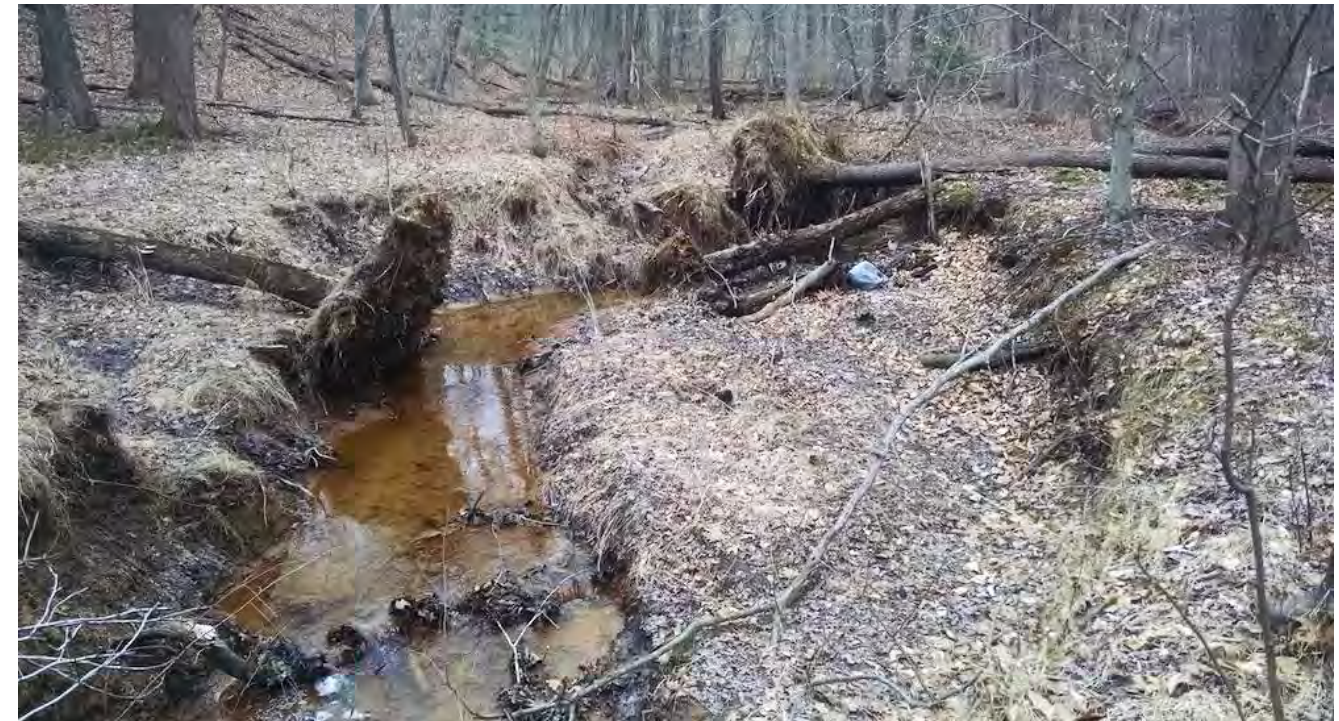
Prerestoration: substantial tree loss along stream due to erosion

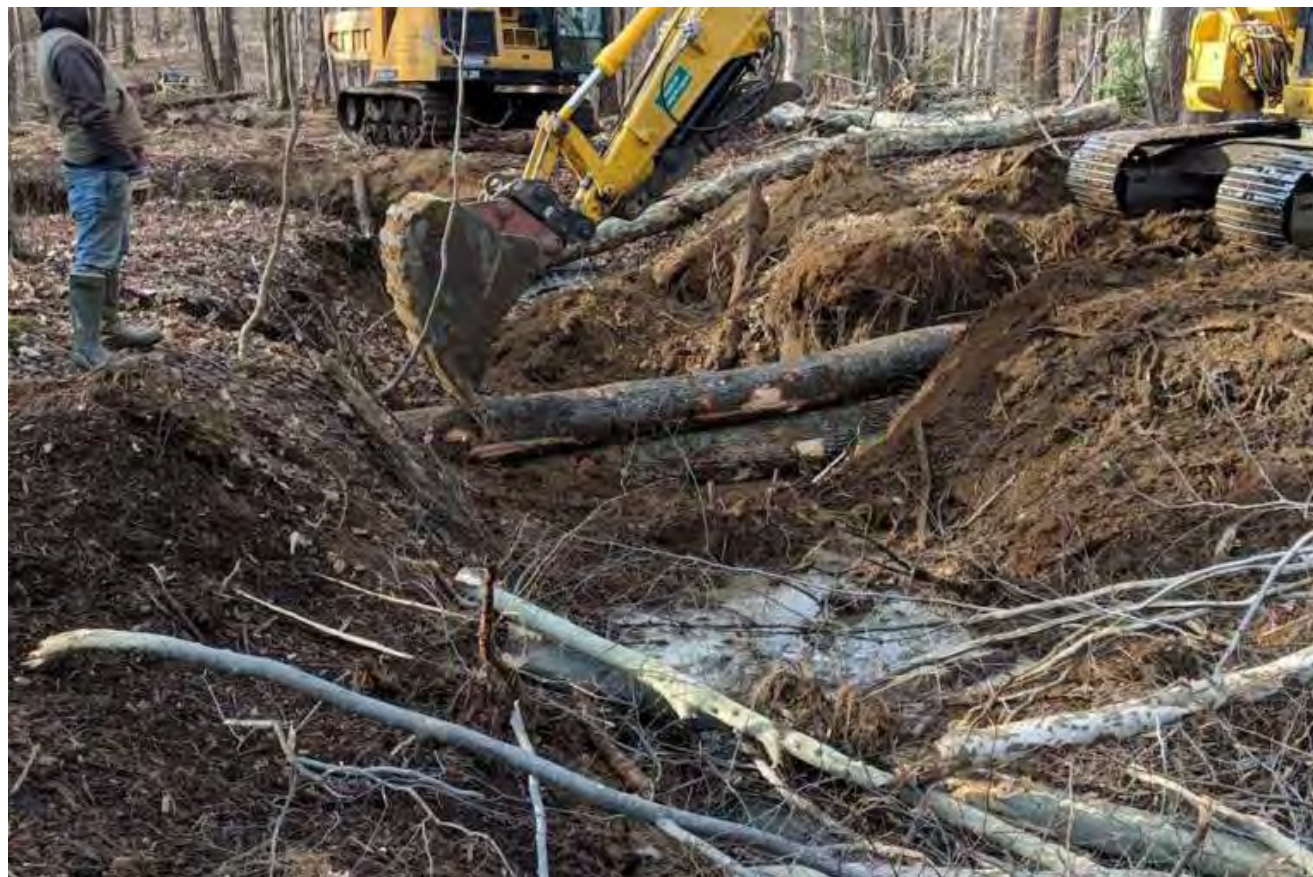
Construction: installation of log check dams

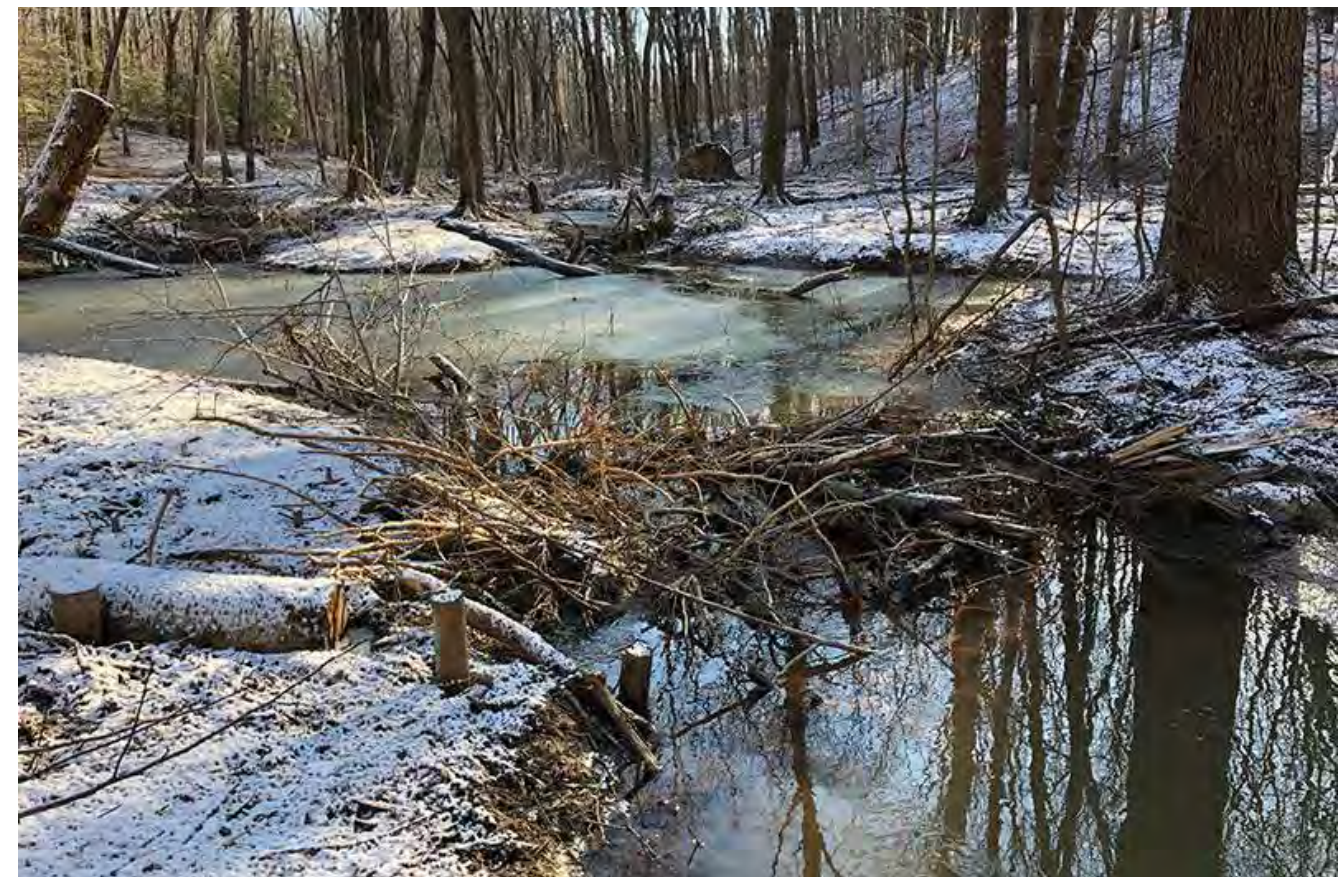
Postrestoration: woody debris and log jams constructed from wood harvested on site

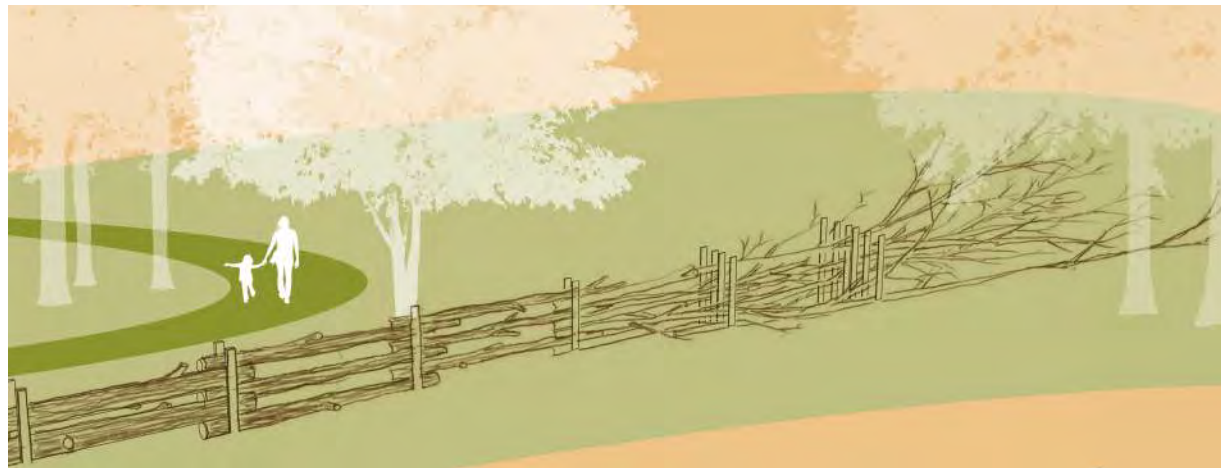
Living fence constructed from reclaimed wood, Avalon Nature Preserve (Andropogon)

Wood harvested on site could also be used to construct movable or permanent fences, which can aid in keeping trail users out of sensitive or hazardous areas. These fences could replace the existing orange construction fencing currently used in the lower preserve, creating a more visually appealing and sustainable way to control foot and bike traffic.

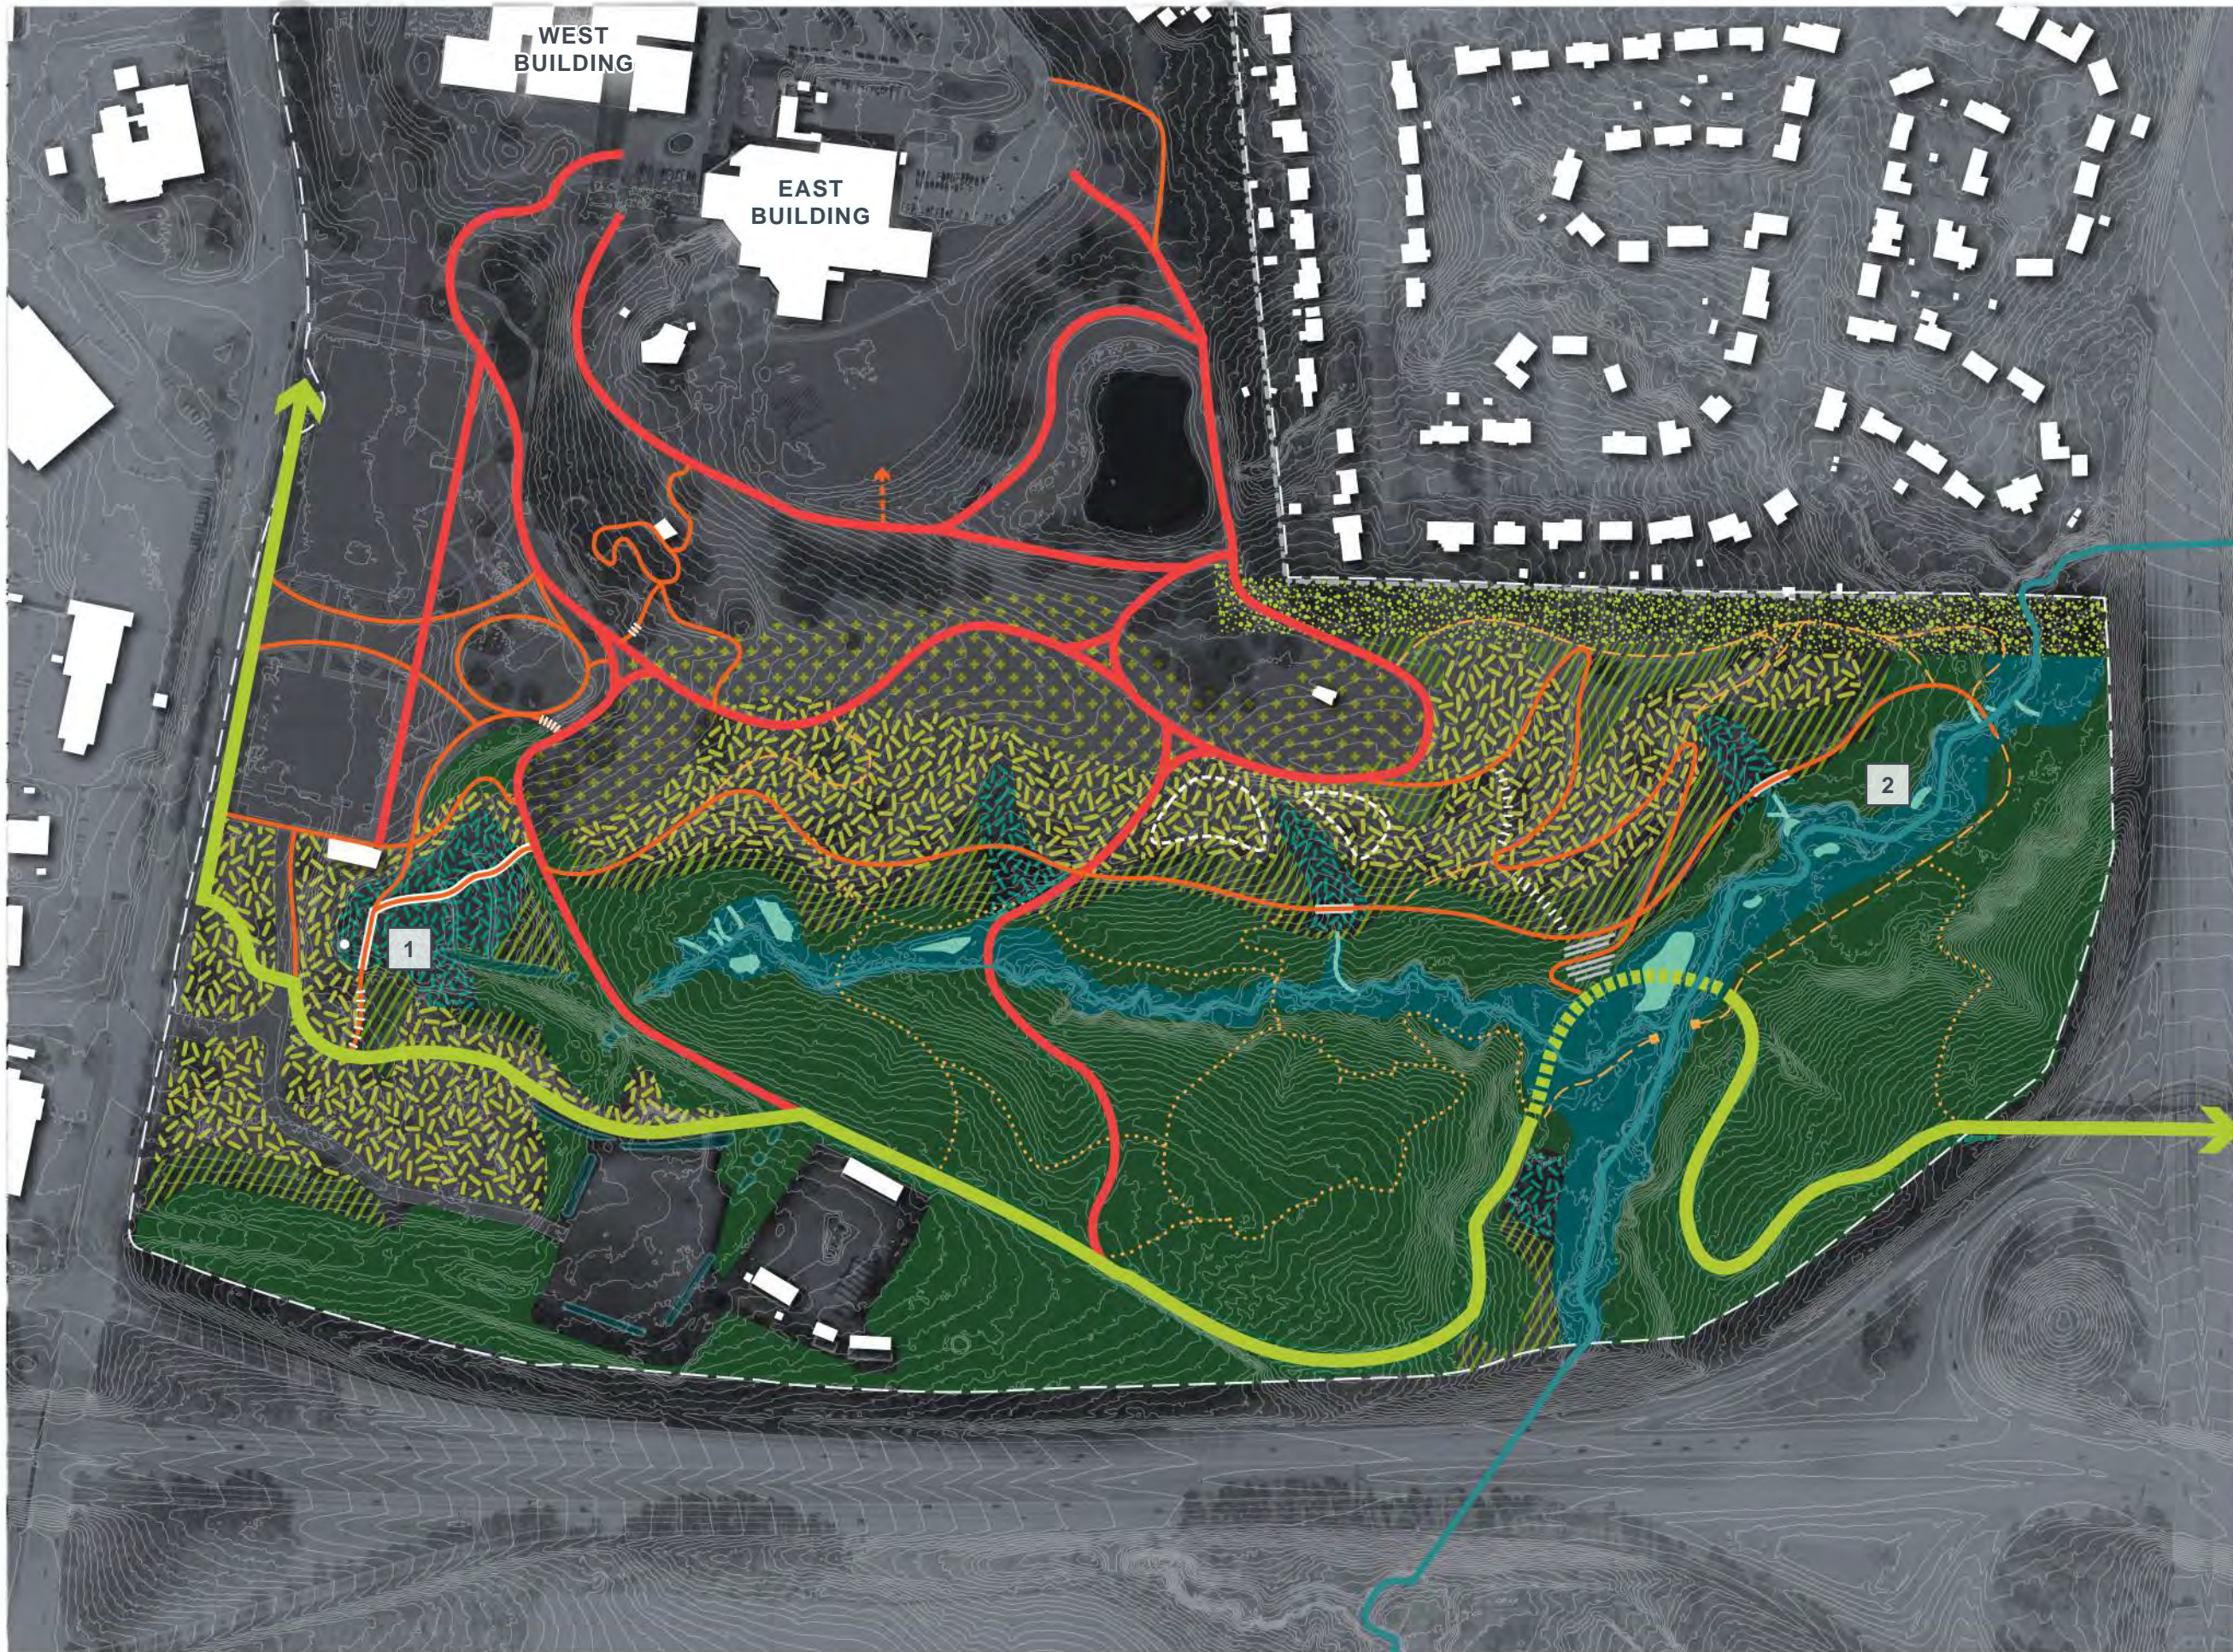
PLANT COMMUNITIES

- 1 Proposed Bald Cypress Grove
- 2 Protect/Expand Existing Walnut Grove
- Horticultural Exhibition Space
- Turf
- Arrested Succession Zone
- Wet Meadow
- Mesic Warm-Season Grass Meadow
- Mesic Mixed-Hardwood Forest (Proposed)
- Mesic Mixed-Hardwood Forest (Existing)
- Piedmont Alluvial/Headwater Stream Forest
- Wetland
- Stormwater Detention

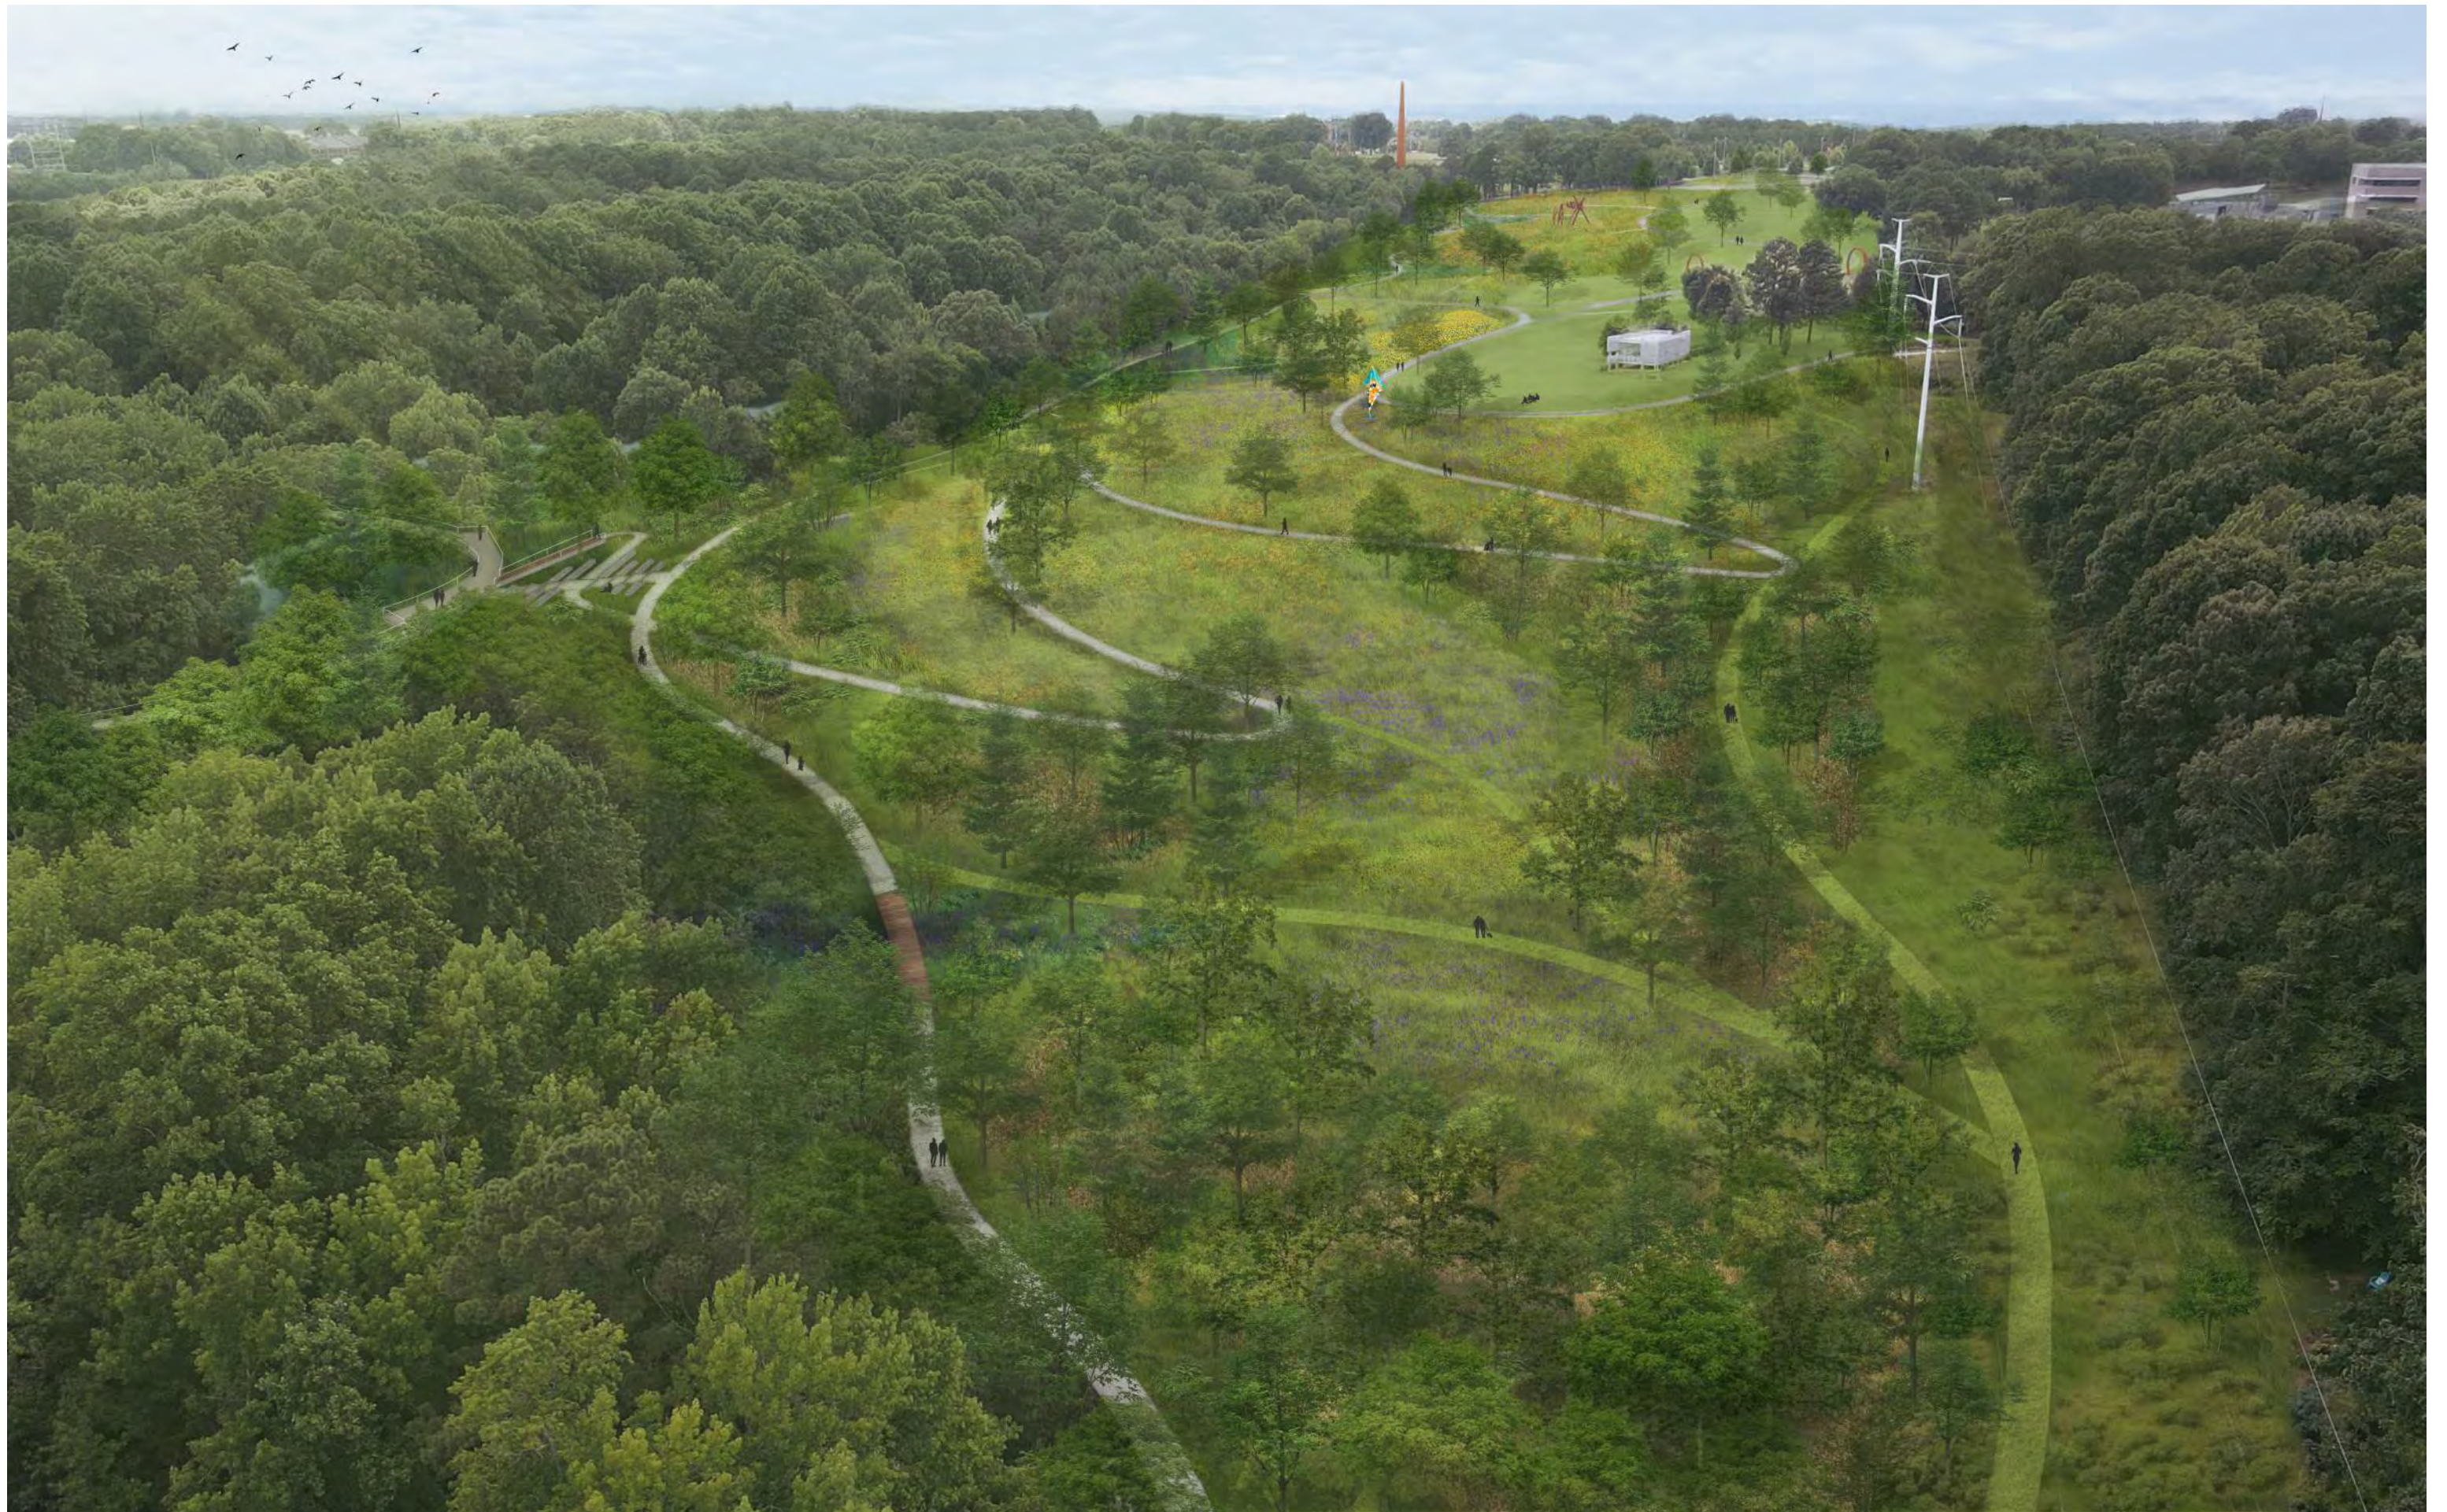
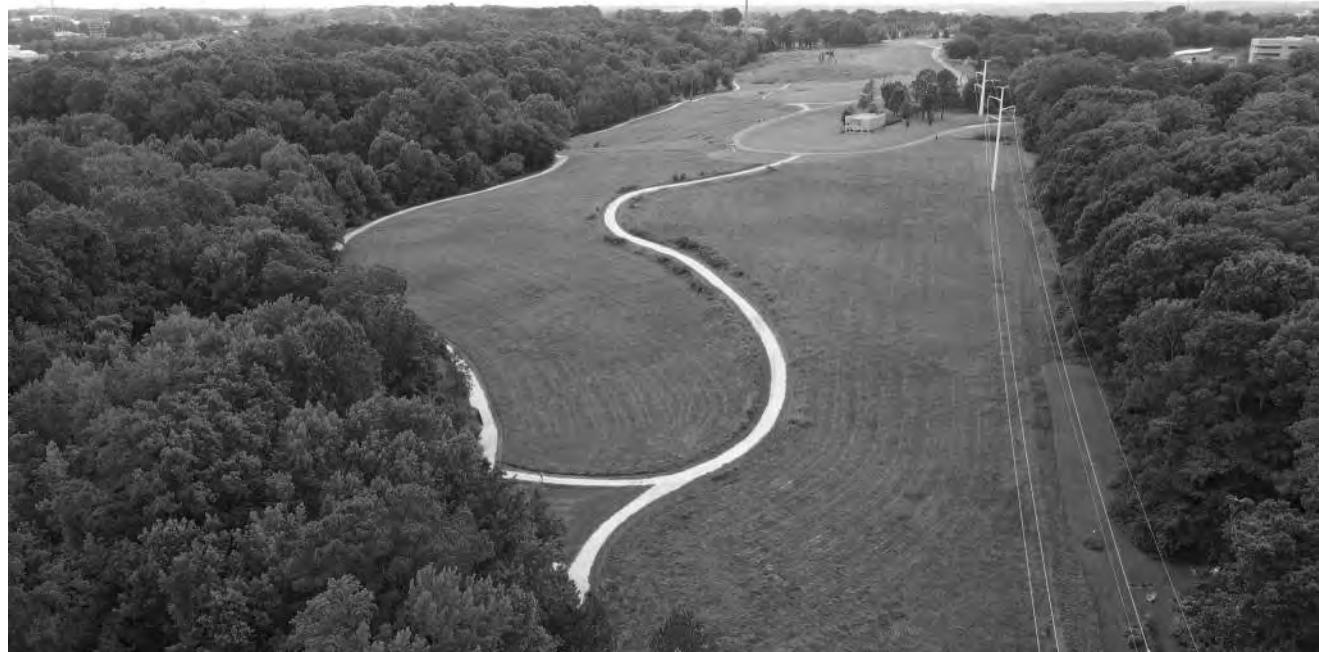
TRANSFORMING THE LOWER PRESERVE

*Lower preserve proposed trails and plant communities (facing page) and existing (above);
Photo: Luke Mehaffe*

Strategic improvements to the lower preserve will engage this area as a critical experiential component of the NCMA visitor experience. The existing fescue meadow will be transformed into a rich, diverse palette of native warm-season grasses dotted with groves of trees and seating where walkers can rest and socialize in the shade, while maintaining long views to the riparian corridor below.

Trail realignments will ease steep slopes and provide visual interest through a rhythm of hide and reveal as visitors move through the landscape.

The new gateway connection to the greenway and confluence area will link the Lower Meadow with the riparian corridor and woods, drawing cyclists and walkers from the greenway trail into the core of the preserve and up to the main Museum buildings.

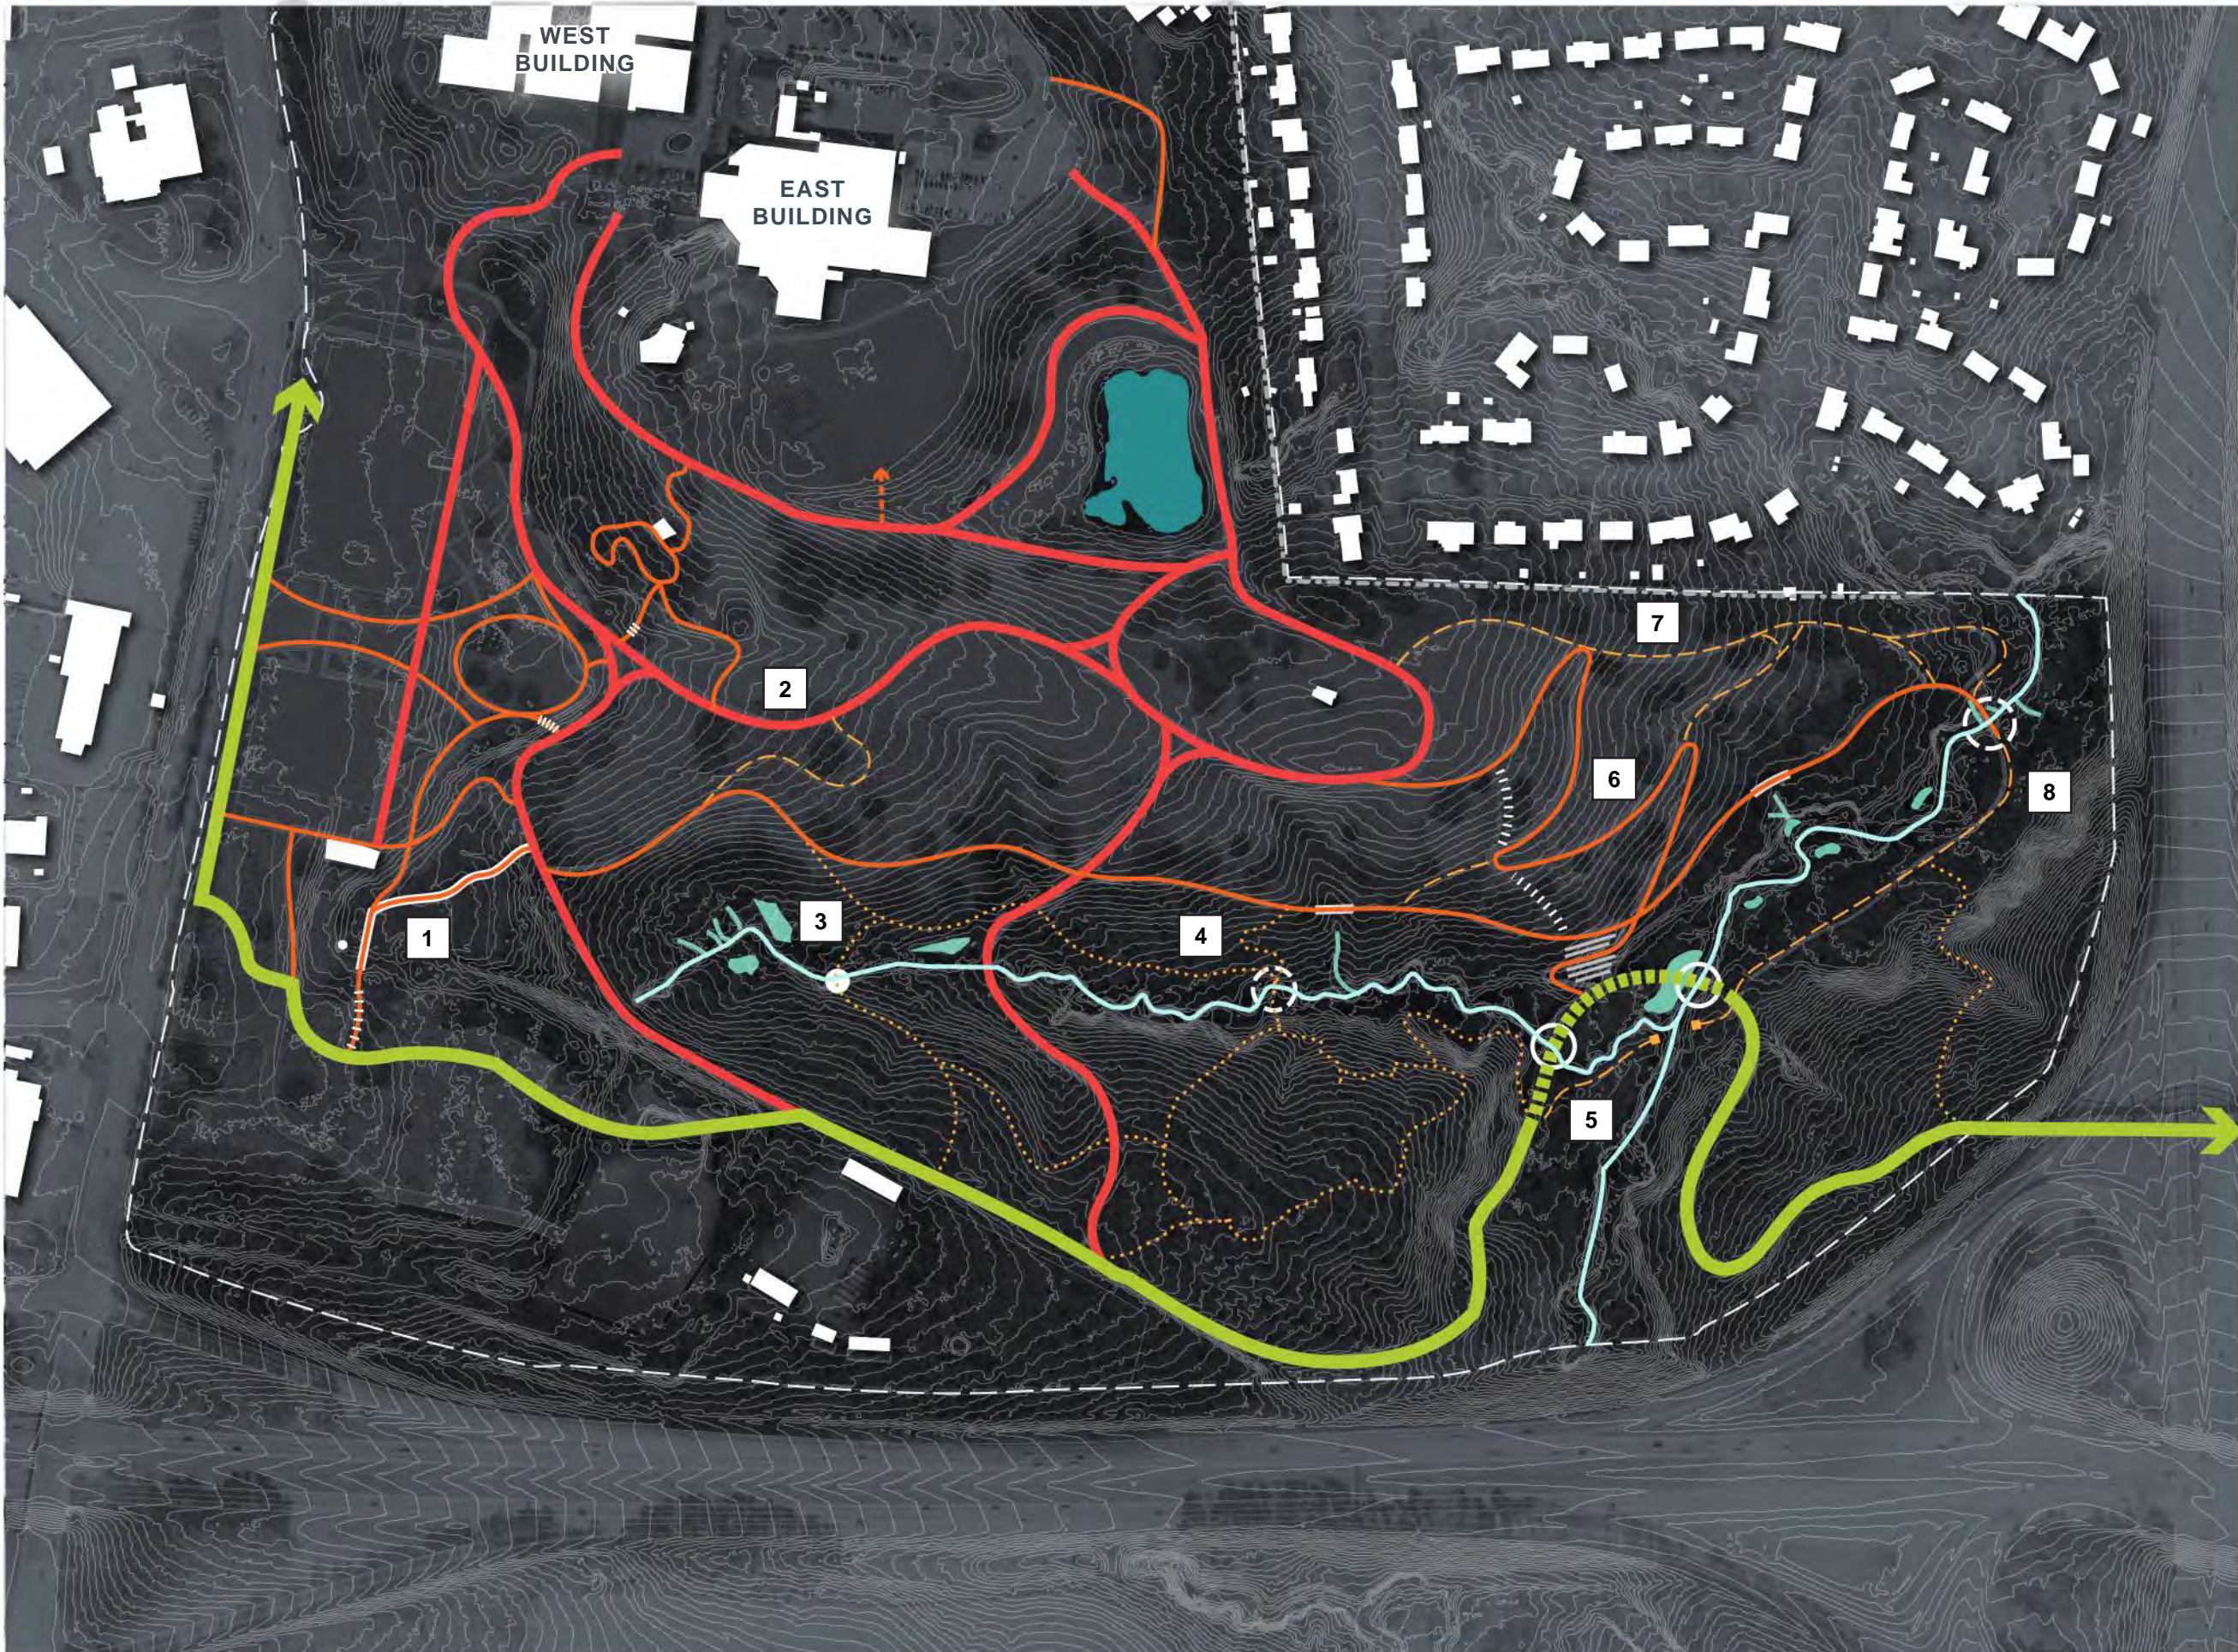
**CIRCULATION:
TRAILS + CROSSINGS**

Additional updates along the Blue Loop should be integrated to connect to the new Welcome Center, as well as connections from the Welcome Center to the smokestack and greenway (note 1, right). Some of these new connections will traverse sensitive areas at the headwaters of the unnamed tributary, where a wet meadow condition is planned. Boardwalks and steps will be

The existing unpaved trail that follows the sewer easement along the south side

of House Creek will maintain its current alignment (note 8, right). However, the bridge crossing at the lowest reach of House Creek will be upgraded so that it spans the entire floodplain, improving water quality and increasing the longevity of the structure.

- 1 Add Trail Connections through Wet Meadow
- 2 Shift Blue Loop Trail Down from Former Ridgeline Location
- 3 Add and Upgrade Woodland Trails, Stream Crossing
- 4 Add and Upgrade Woodland Trails, Stream Crossing
- 5 Realign Greenway Trail at Confluence Area
- 6 Realign Trail at Lower Meadow Hillside Area
- 7 Create Mowed Paths through Arrested Succession Zone
- 8 Maintain Trail Above Sewer Line; Improve Bridge Crossing

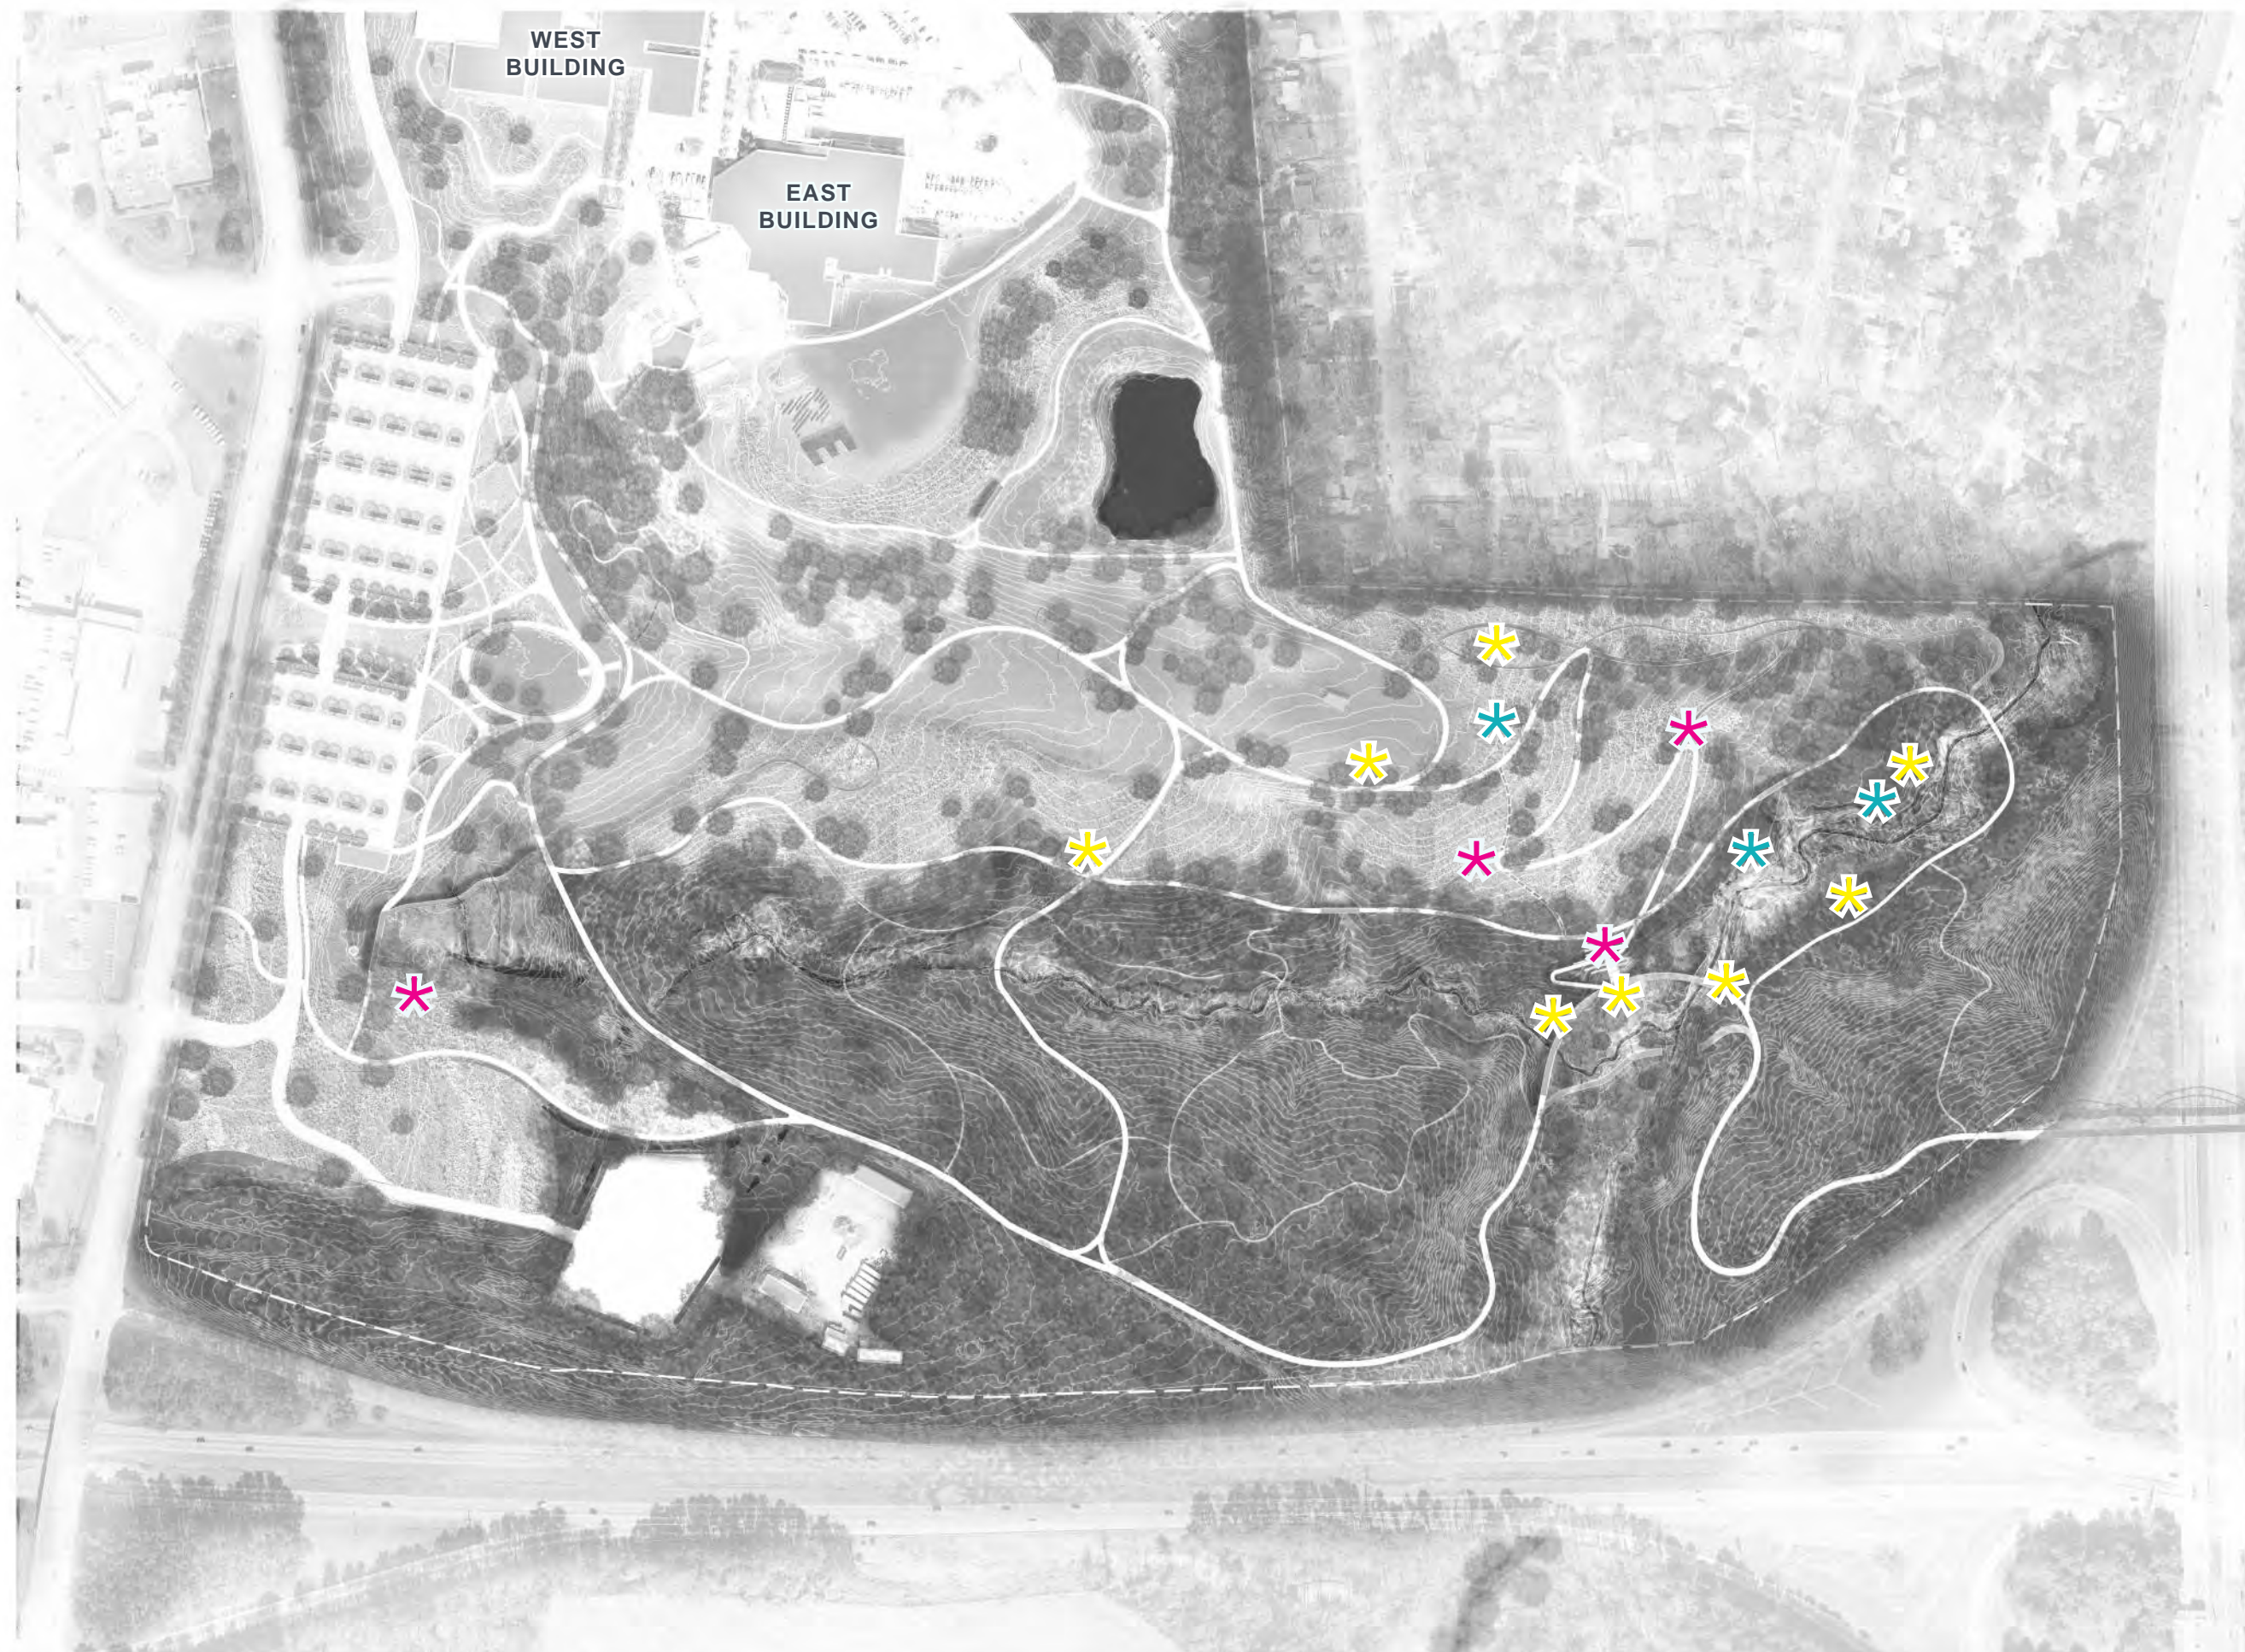
ACCESSIBILITY IMPROVEMENTS

In many locations a slight realignment is enough to bring a path's slope below five percent. Several locations along the southern portion of the Lower Meadow trail can be modified to reduce steep slopes, and in some areas also provide a more direct route or clearer sight lines. In other locations a larger intervention is required. Where the Lower Meadow trail splits off from the Blue Loop just below Lowe's Park Pavilion, the existing path cuts straight down the hillside at a roughly seven-percent slope. The Vision Plan replaces this steep path with a series of gently sloped switchbacks, providing easy access to the confluence area, where the elevated greenway offers an immersive experience in nature.

Along certain areas of the greenway and in the stream corridor, achieving a five percent slope for all trails may not be practical. Where existing slopes exceed five percent and trail realignment would cause significant disturbance in forested areas, there may be other opportunities to improve visibility and safety in spite of the slope, such as improved sightlines, signage, or trail width.

The trail alignments proposed in the Vision Plan are based on slope information gathered from available GIS data and surveys of discreet areas in the preserve. As proposed improvements are designed in more detail and implemented, trail alignments may require adjustment to reconcile existing conditions with desired slopes.
