North Carolina Museum of Art

MUSEUM PARK VISION PLAN

Prepared by Andropogon Associates, Ltd.
with contributions from Biohabitats, Inc., and WK Dickson
December 2021

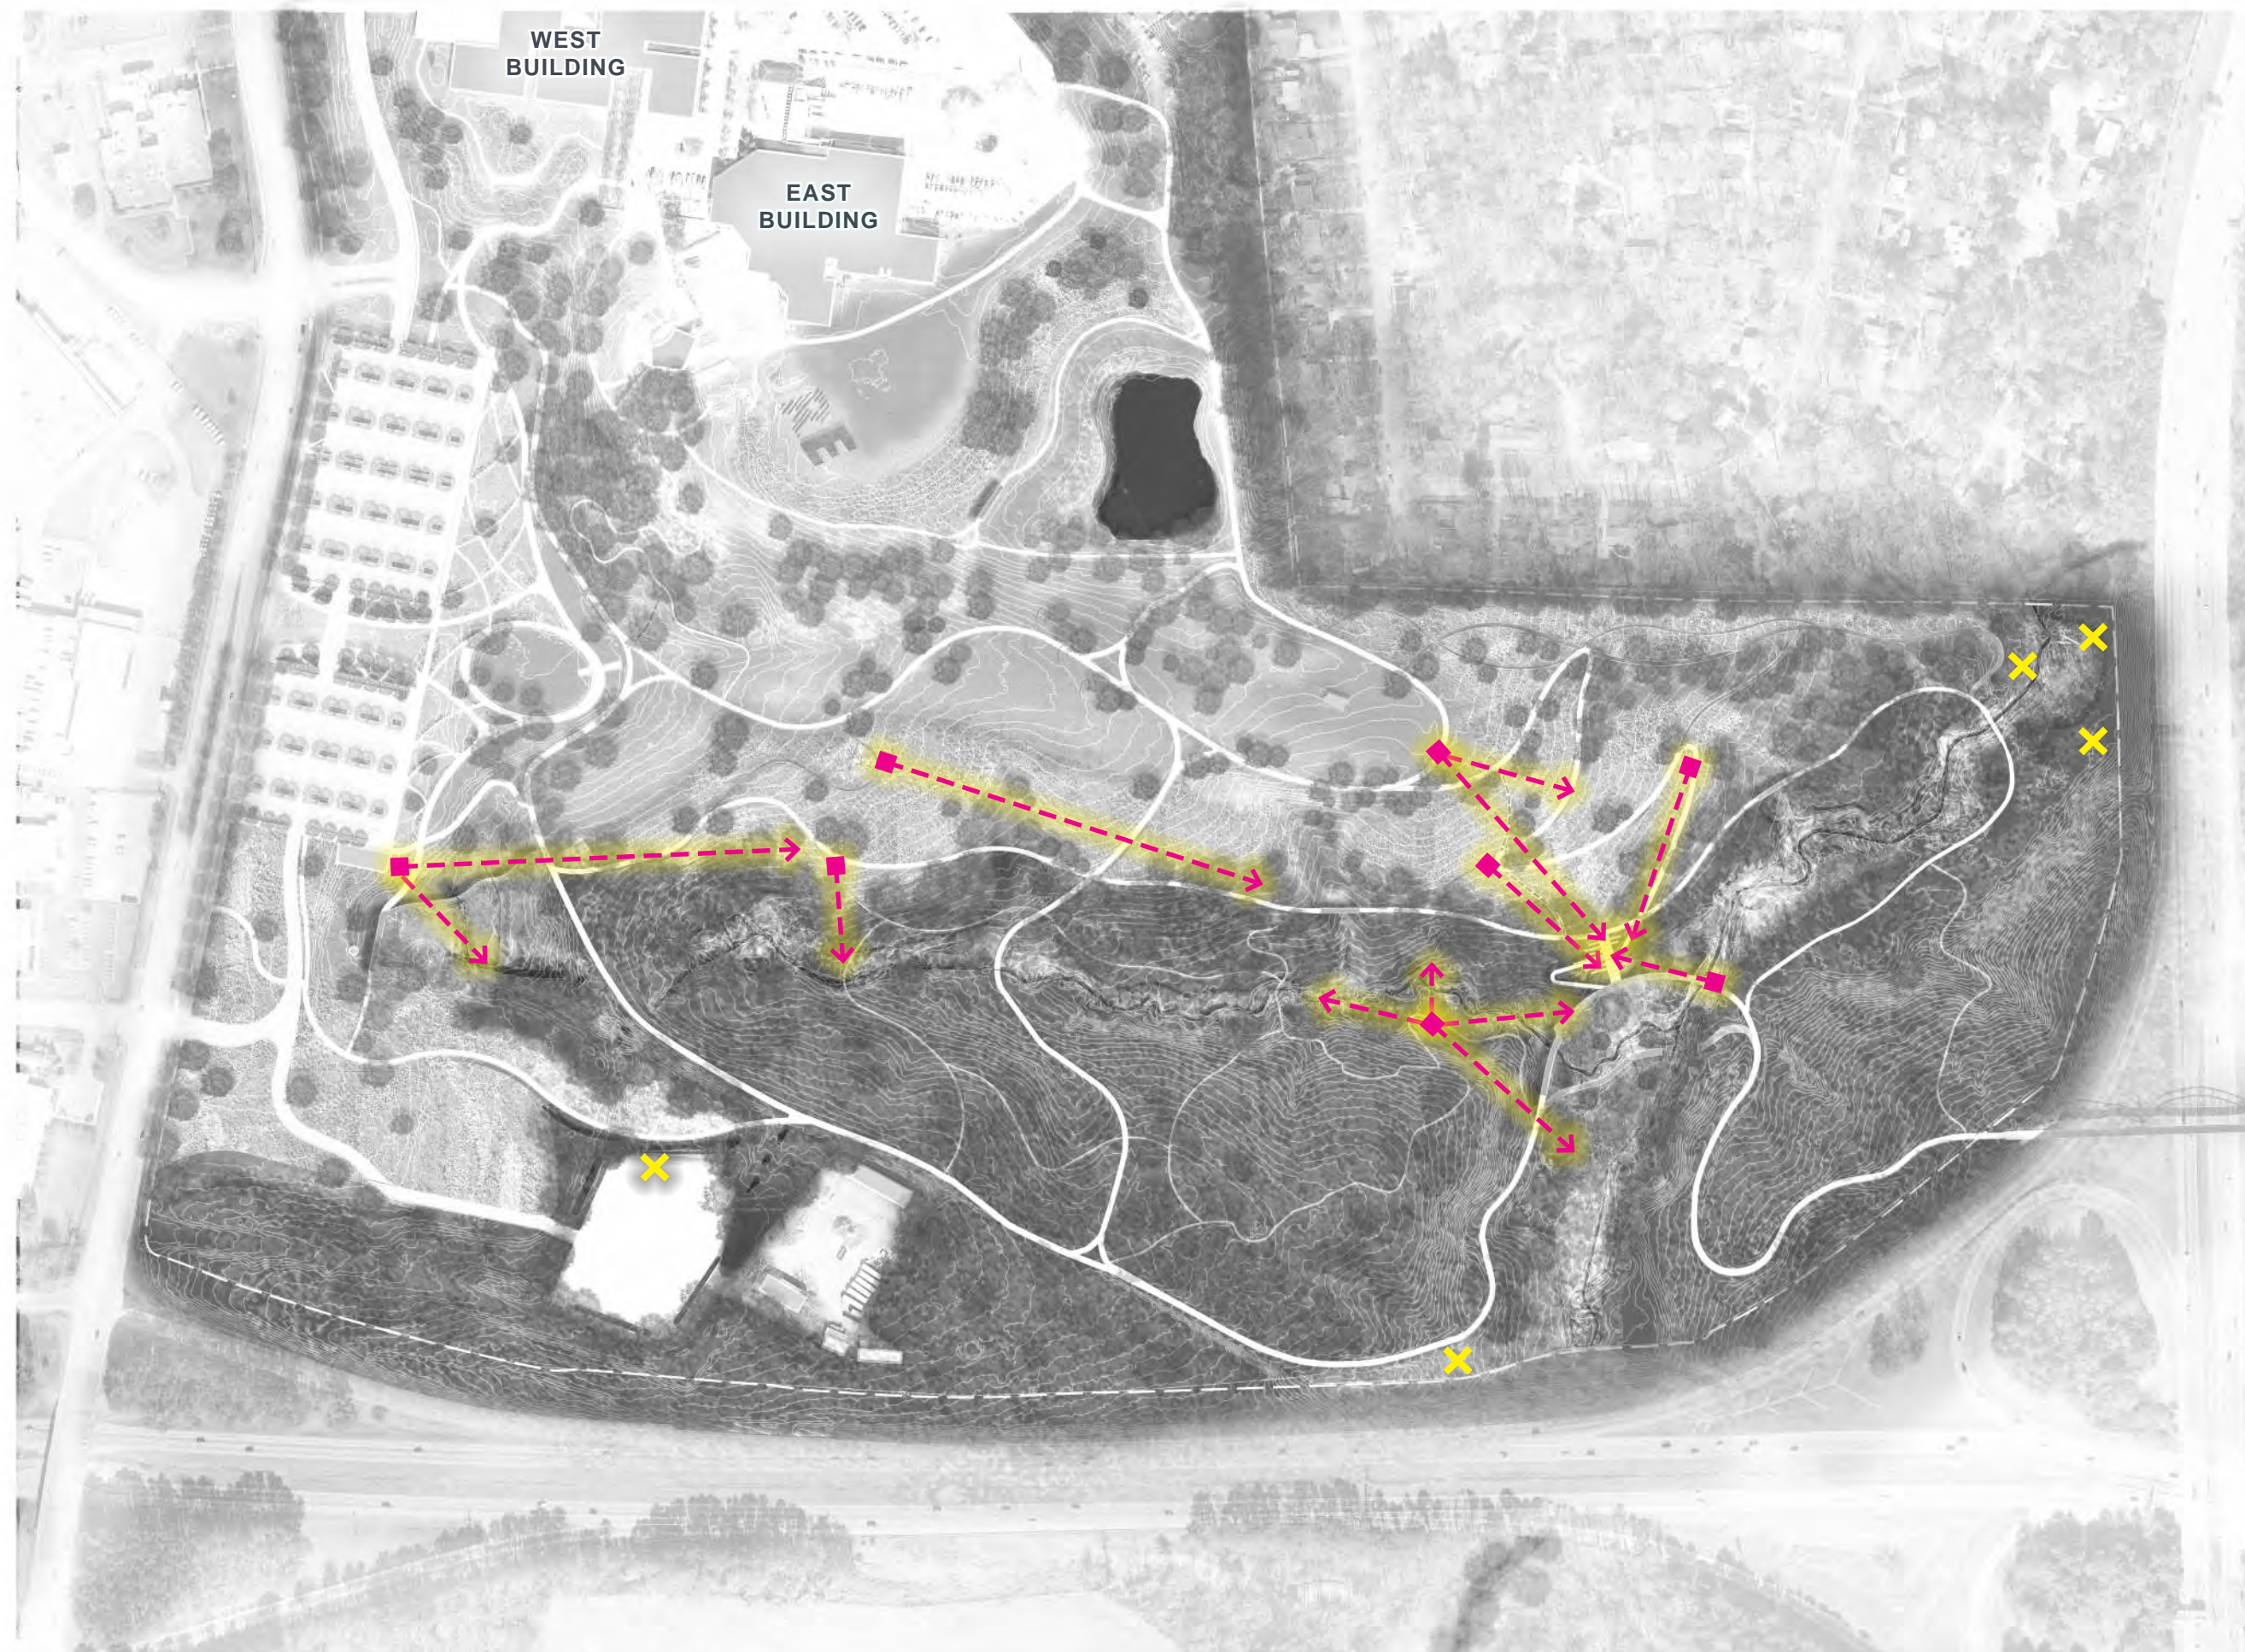
Adequate, appropriately designed access for security and maintenance operations is essential for the Museum Park to provide the best visitor experience possible. In the Vision Plan, proposed security and maintenance routes were considered both as improvements to the existing conditions and for the integration of security and maintenance in the Park landscape as it evolves over time.

Addressing security and maintenance access at the stream crossings was identified as a high priority for the preserve, as crossings have deteriorated or been damaged by hurricanes in several locations. Some crossings do not provide the needed width or loading capacity for security vehicles, and some do not span the entire floodplain, causing erosion and structural damage during large storm events.

Along the Duke Energy easement, mowed paths will double as walking paths and maintenance access. While the Museum should be prepared for some regular vegetation removal by Duke Energy, the design for this location provides access and vegetation heights that comply with regulations, and large-scale removal should be minimized. While this approach deviates from a typical maintenance access path under overhead power lines, the hope is that with communication between the NCMA and Duke Energy, this more diverse planted edge can provide a better experience for Museum visitors while maintaining the necessary level of access for the utility company.

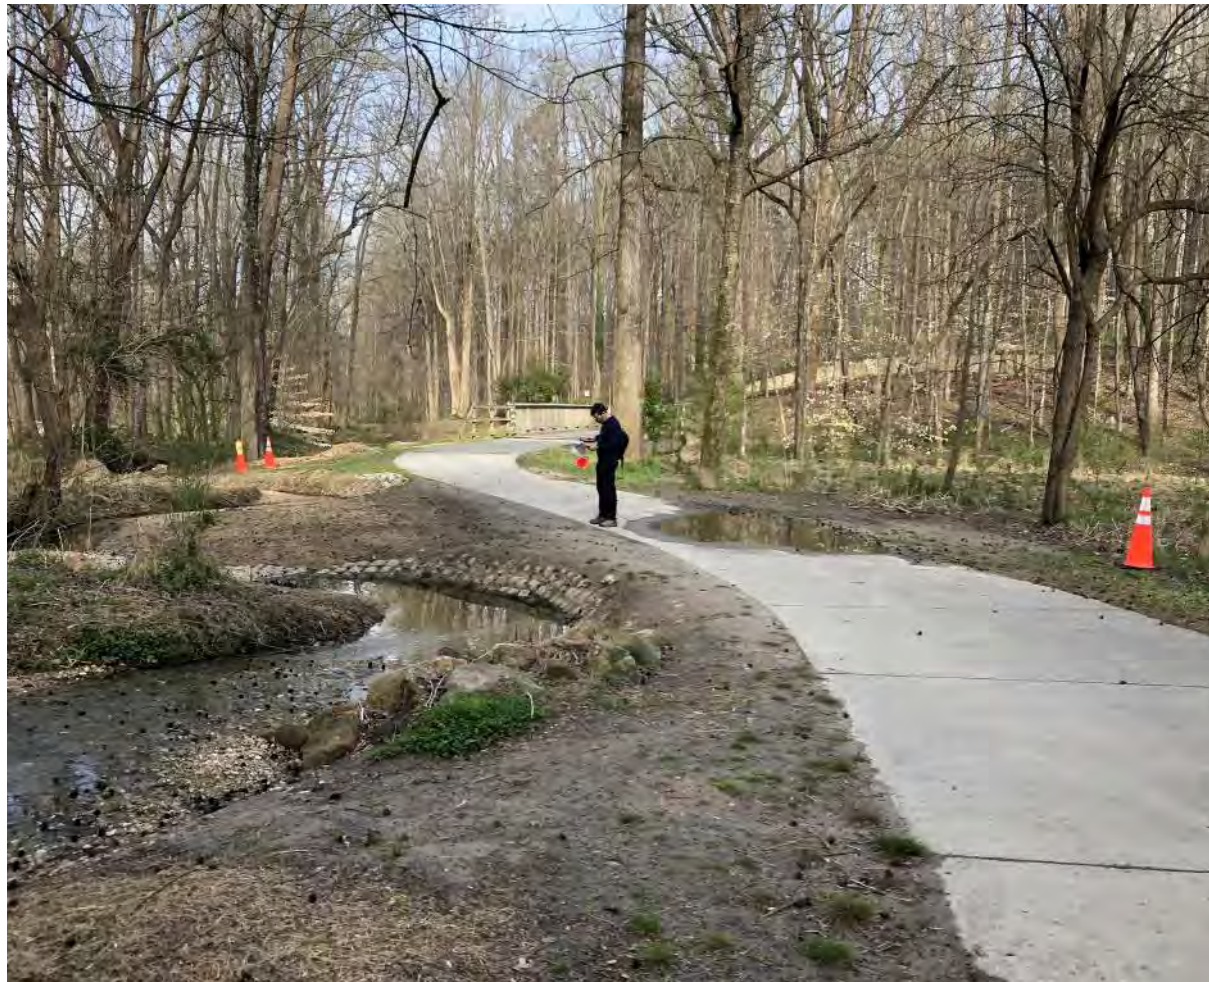
Unnamed tributary eroding banks and overtopping greenway to reach natural floodplain; Photo: Andropogon

The existing at-grade greenway trail acts as a barrier to water movement in the confluence area, preventing the unnamed tributary and House Creek from accessing the floodplain during large rain events. Evidence of this is clearly visible along the greenway, where eroded banks must be stabilized with concrete, and water collects on the trail.

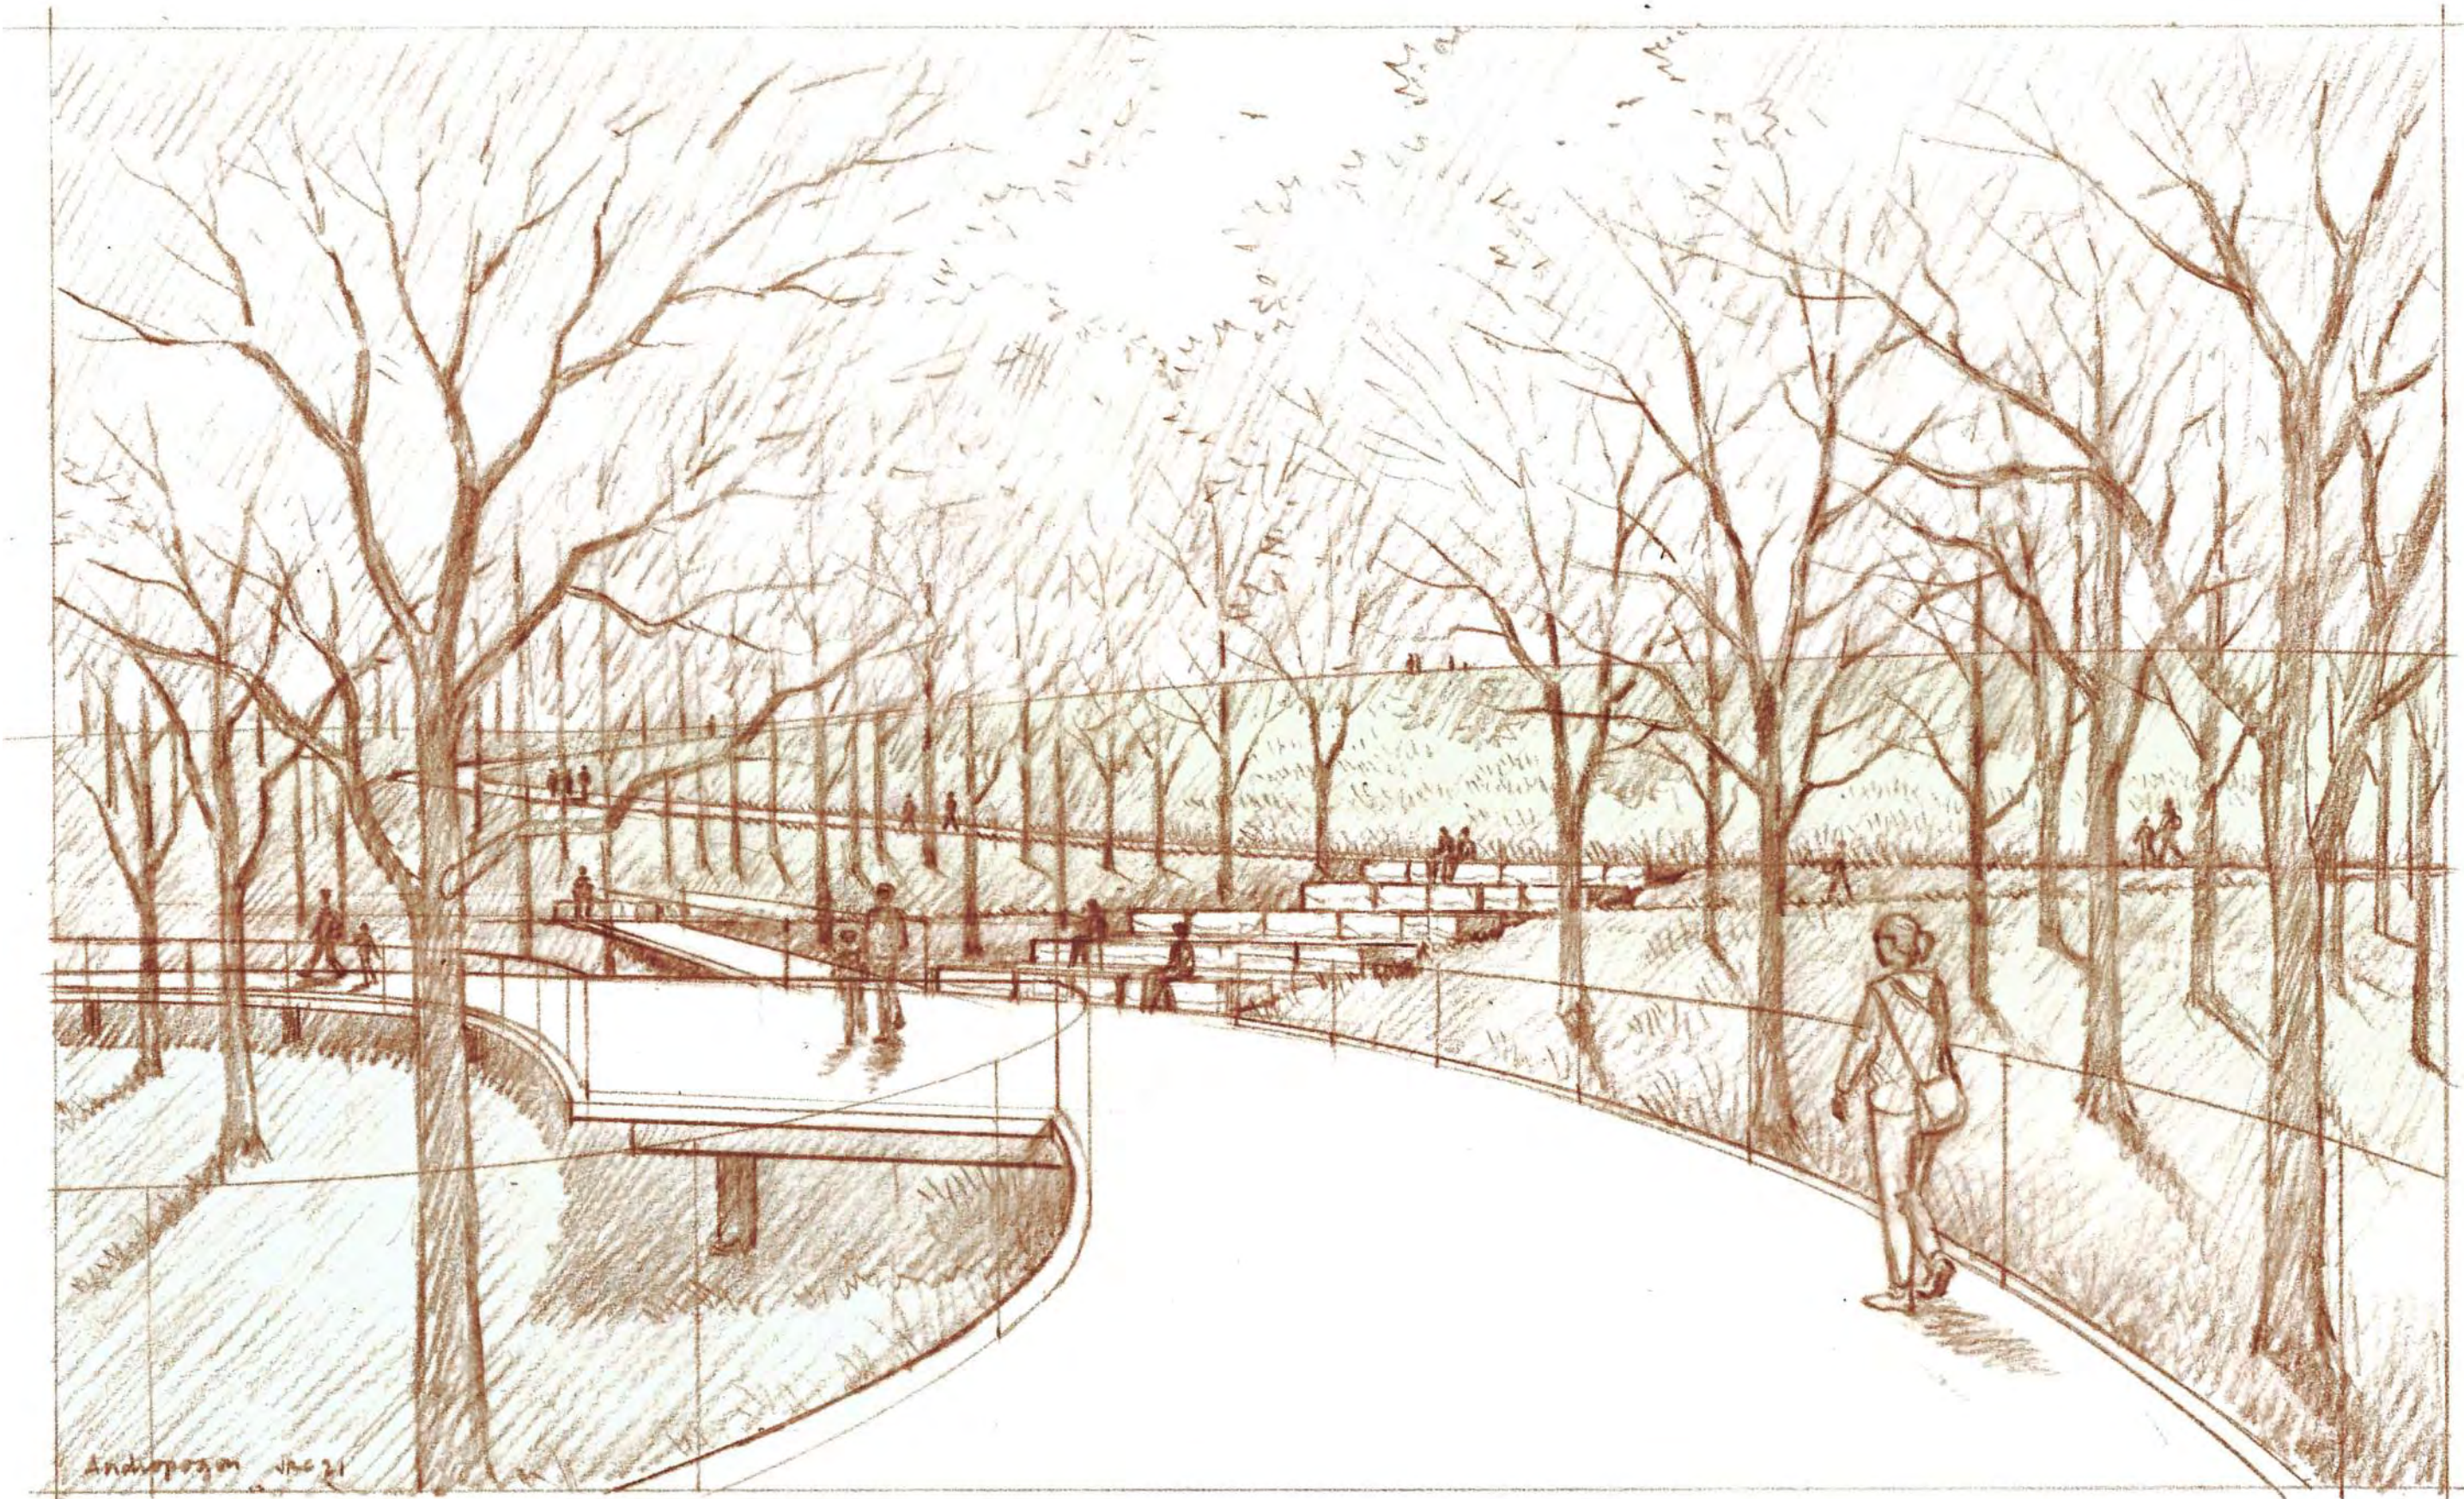
As bikers and walkers navigate the sweeping curve of the path, their view frame will change, creating a rich and varied but cohesive trail experience as they move through this new feature of the preserve.

Eye-level view of elevated greenway trail at confluence area, looking west from House Creek bridge

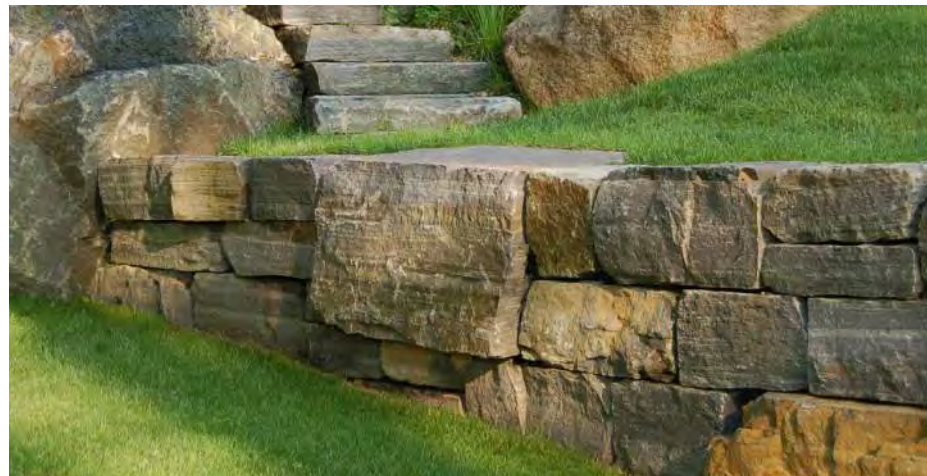
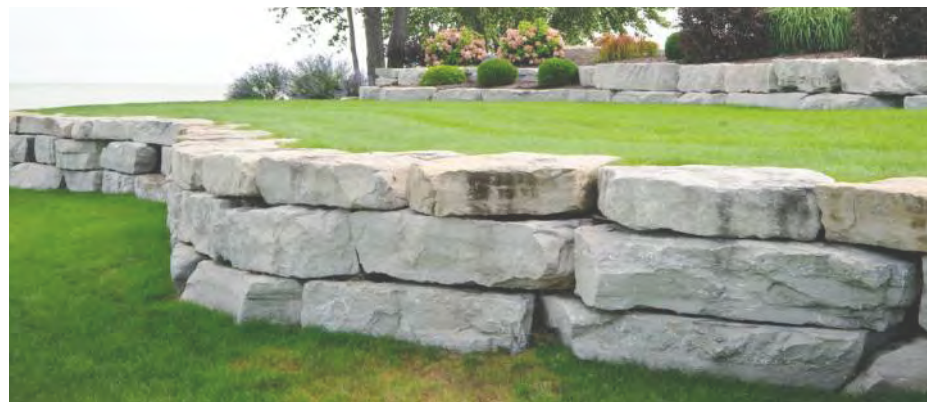
Examples of terraced rough-cut stone retaining walls; Photos: Andropogon (top) and Esch Landscaping (bottom)

Terraced stone seating and steps to the north of the greenway trail will help stabilize steep slopes leading up to the Lower Meadow path, while providing seating for groups of all sizes and formalizing the existing “cow path” in this location. An ADA-accessible path will traverse the slope via a series of switchbacks that cut through the stone terraces and meet the Lower Meadow trail to the east.

Seating and gathering areas are also planned to provide visitors with the best vantage points over the new landscape features of the Museum Park. Terraced stone seating will be integrated into the hill connecting the Lower Meadow with the confluence area, providing an informal gathering area and a space to watch people passing by on the greenway trail. Seating areas along the elevated greenway path will provide opportunities to view wildlife in the stream corridors and fully experience the restored floodplain ecosystem.

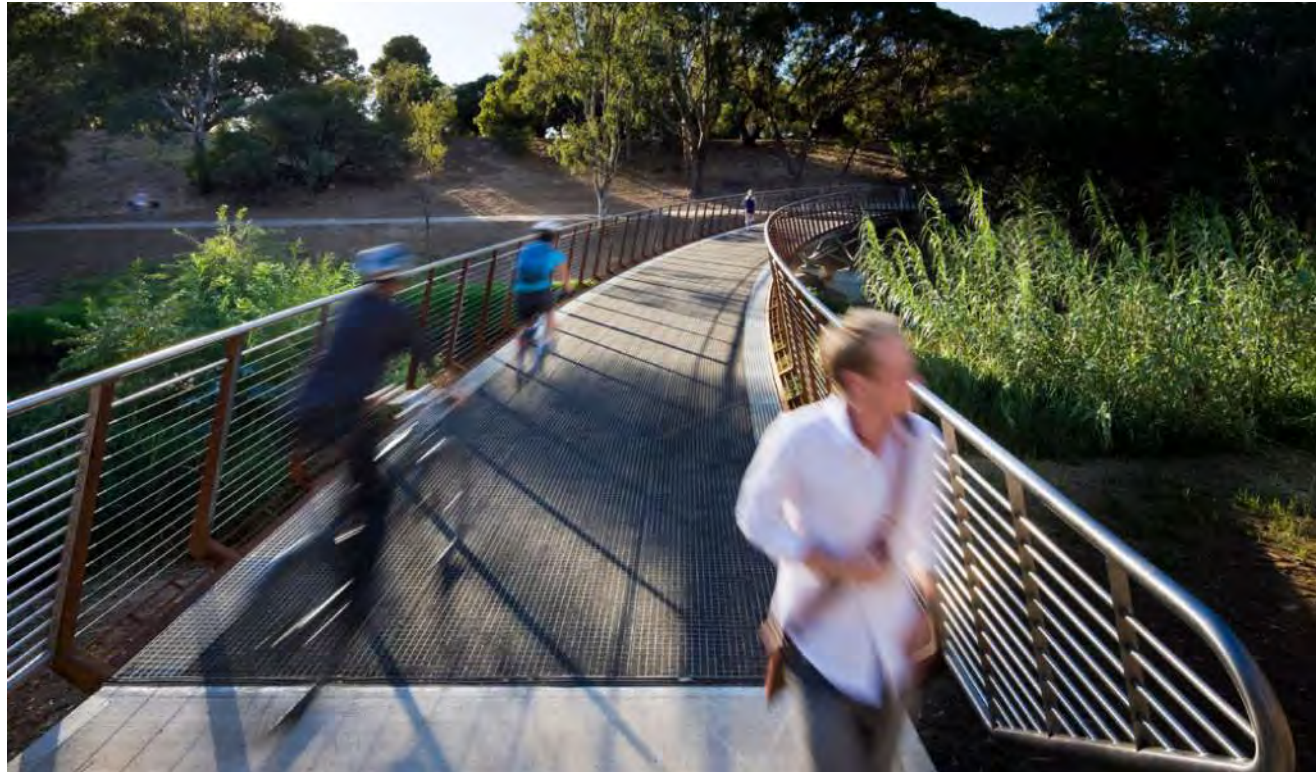
Pervious metal grating and curved span, Torrens Bridge, Australia; Photo: Sam Noonan

The bridges and elevated walkways must first and foremost be constructed of highly durable materials. While these materials may initially require a greater fiscal investment, materials that can withstand hurricane damage, such as trees falling, will prove more valuable over time. Choosing higher quality and longer-living materials will also help operations return to normal following extreme weather events, as repairs can be completed more quickly than a full replacement.

design of the bridges. While the Vision Plan calls for upgraded bridges that span the entire flood plain below, some flooding may occur on the bridges during extreme weather events. To minimize maintenance effort following large storm events, bridge structures should be permeable enough to allow water and mud to be washed off easily. The texture of the path surface should prevent hazardous, slippery conditions during wet weather and allow for leaves and other debris to be easily swept away.

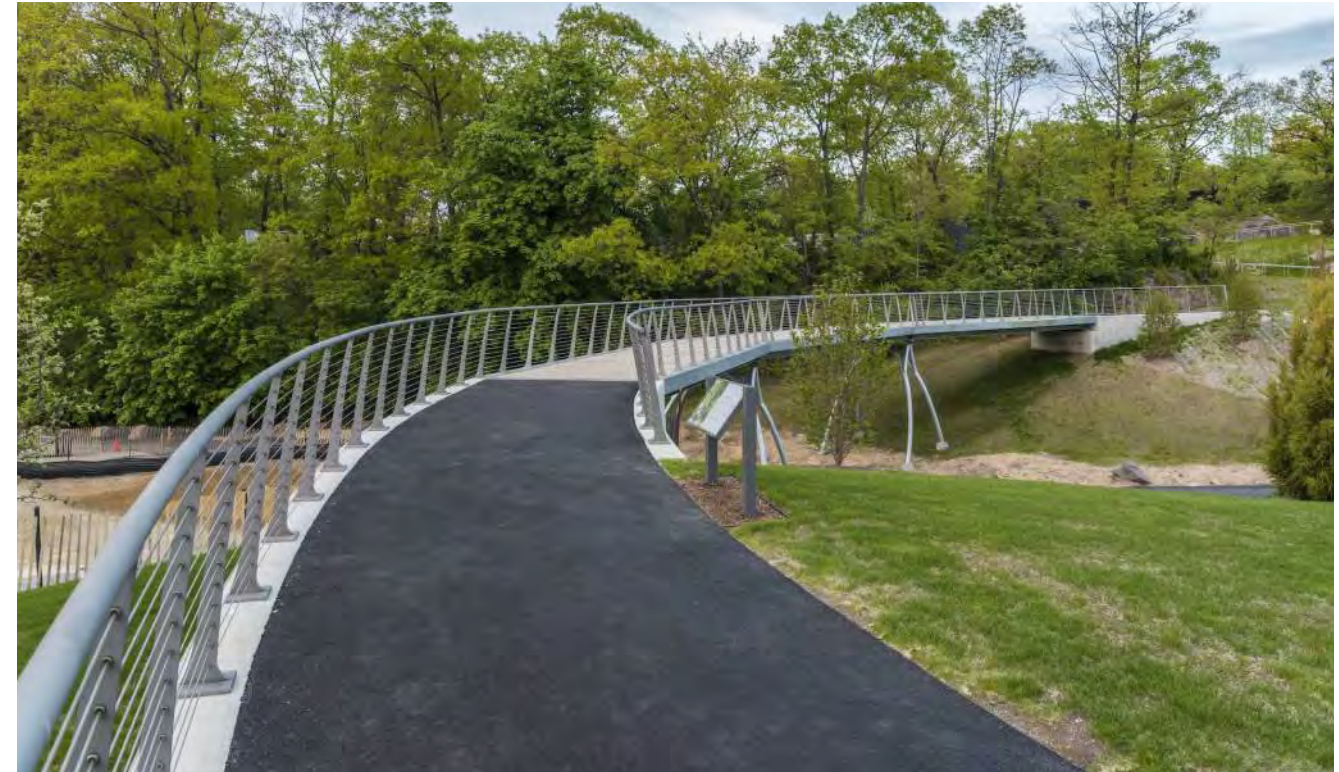
Curved span and full floodplain clearance; New York Botanical Gardens; Photo: Synergi

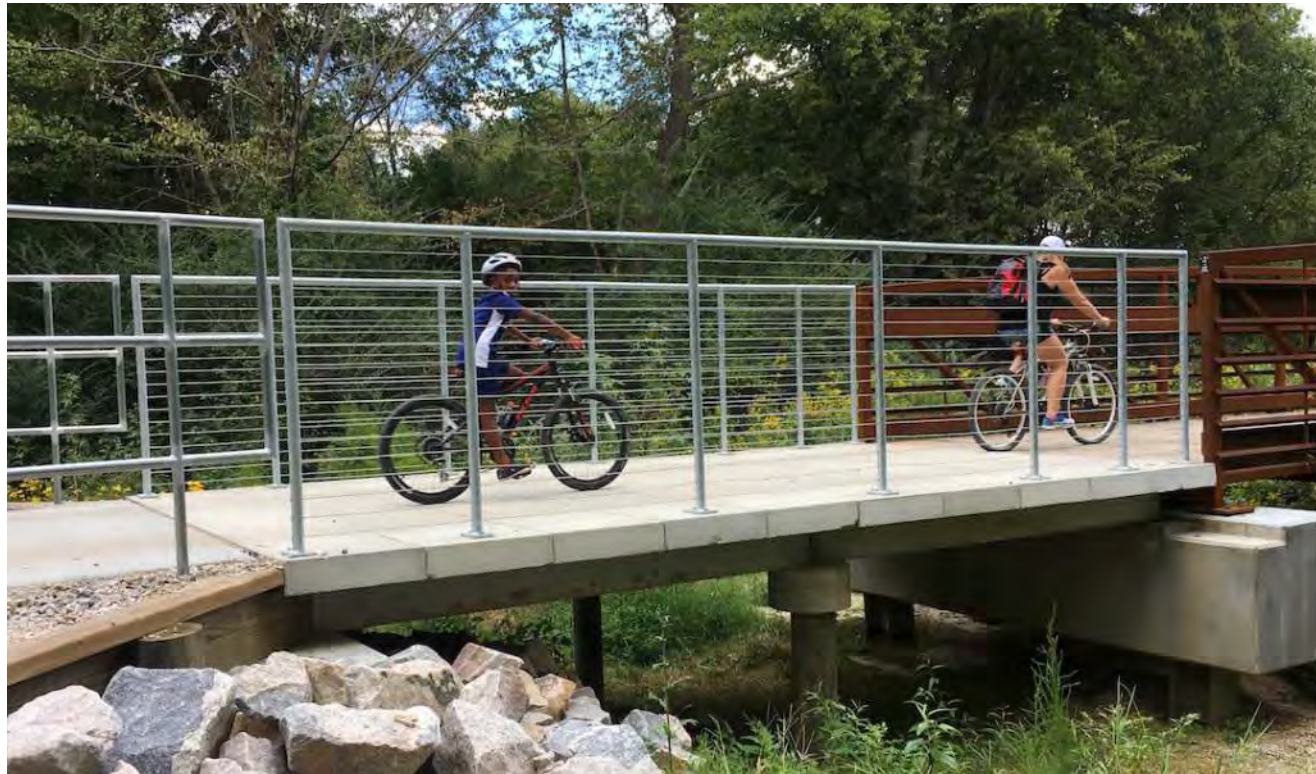
Bridge spanning the entire floodplain, Sanford Creek Greenway, Wake Forest, NC; Photo: PermaTrak

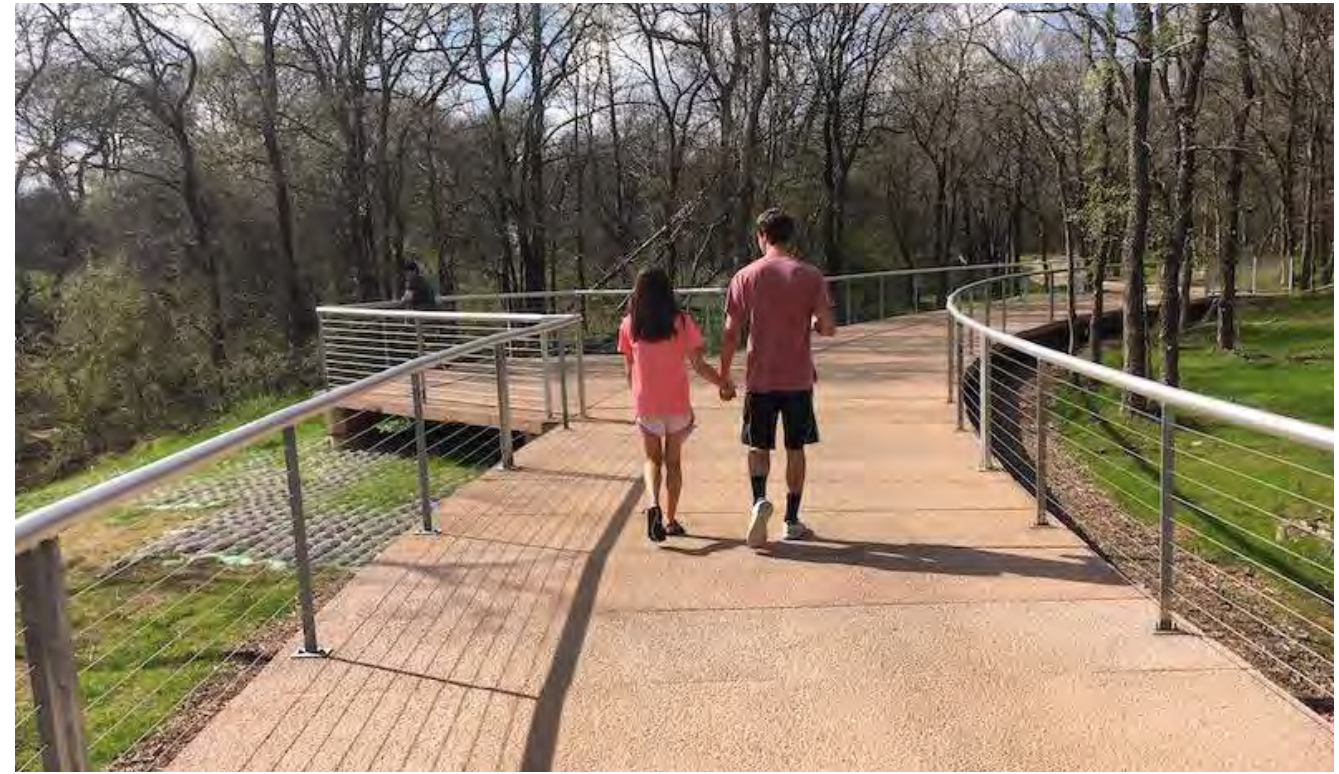
Concrete boardwalk, Walnut Creek Trail, Texas; Photo: PermaTrak

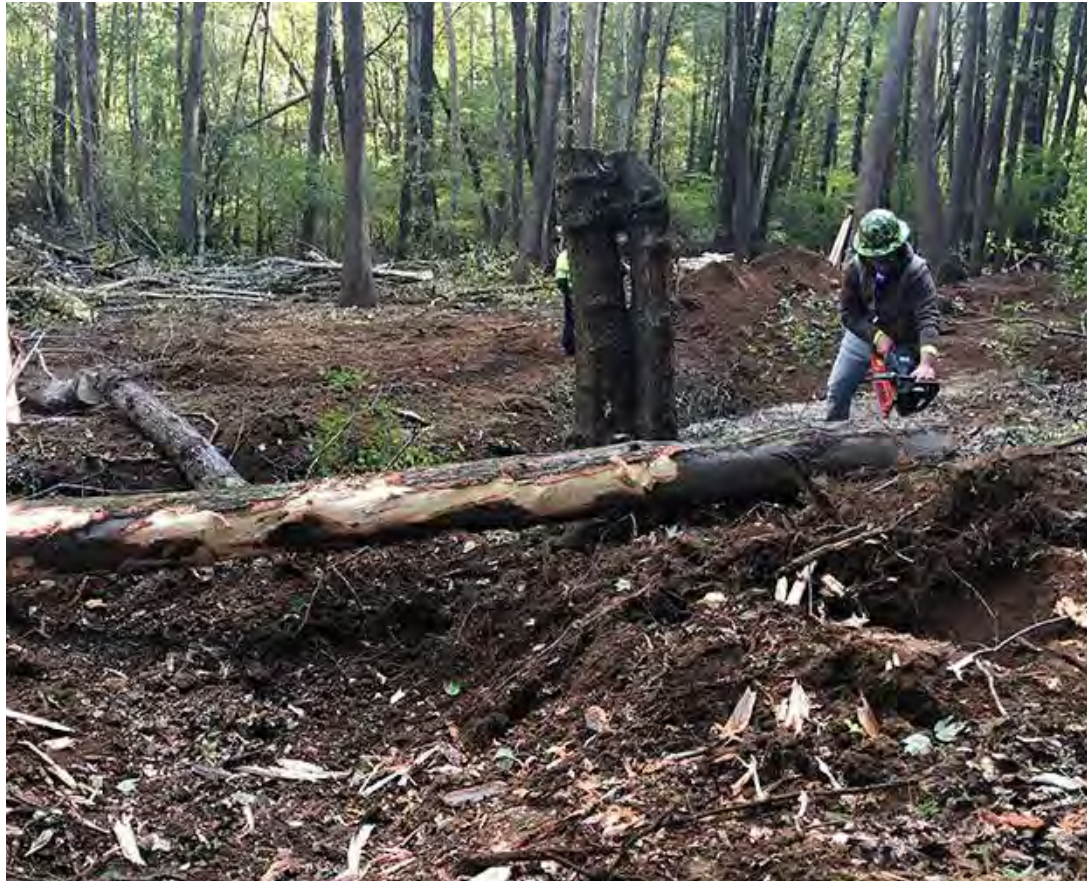
Prepping Red Maple logs for reuse on site; Photo: Biohabitats

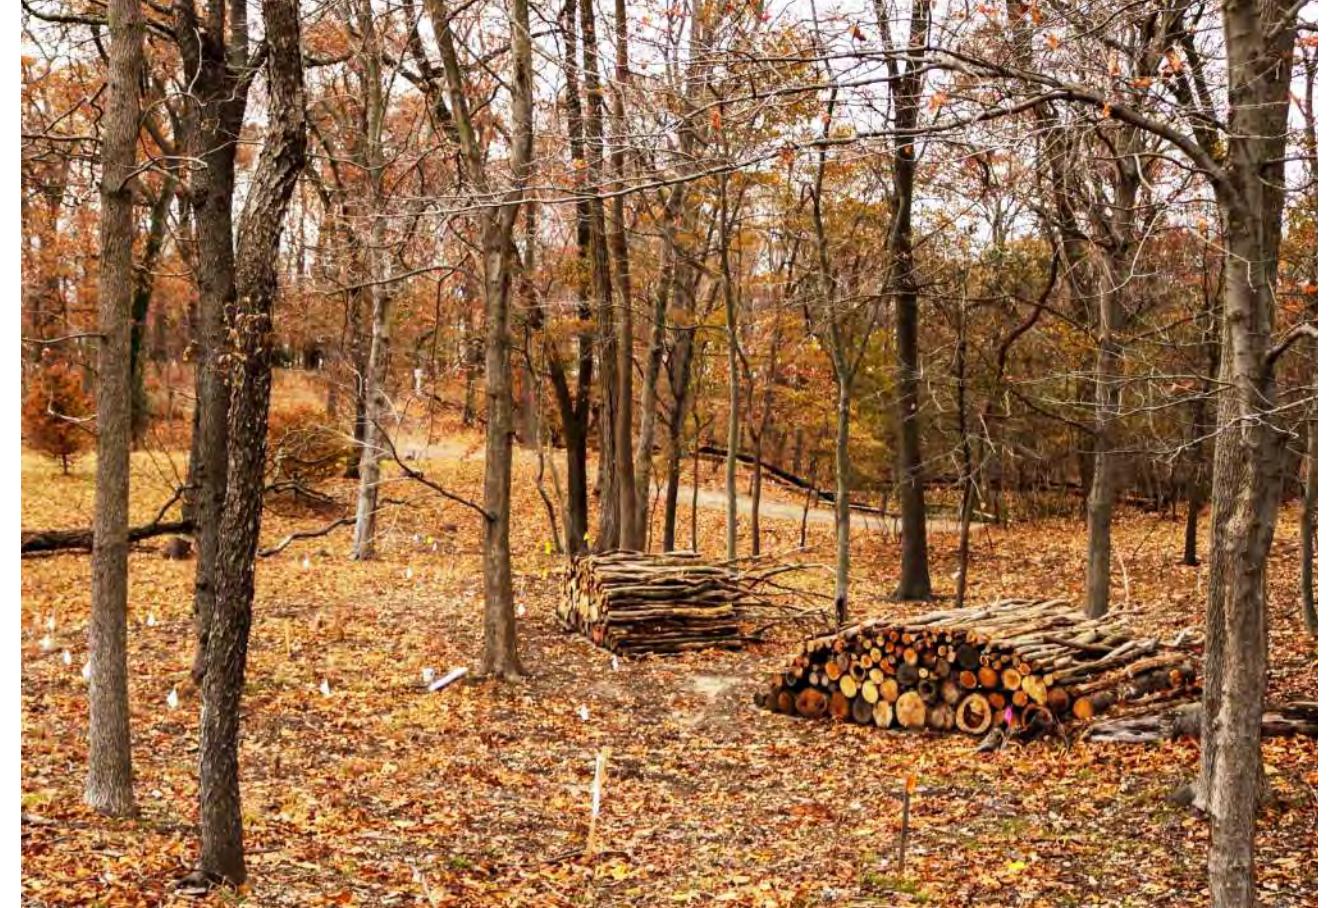
Hugelkultur construction, Avalon Nature Preserve; Photo: Andropogon

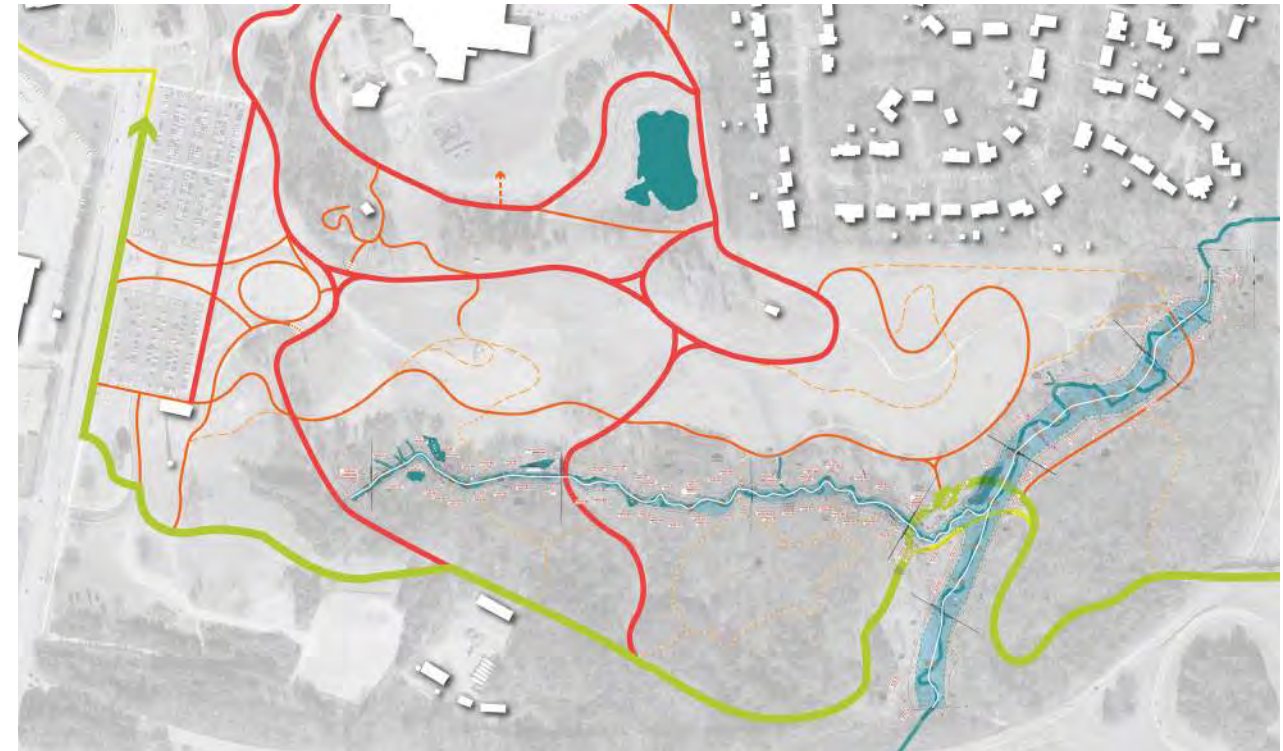
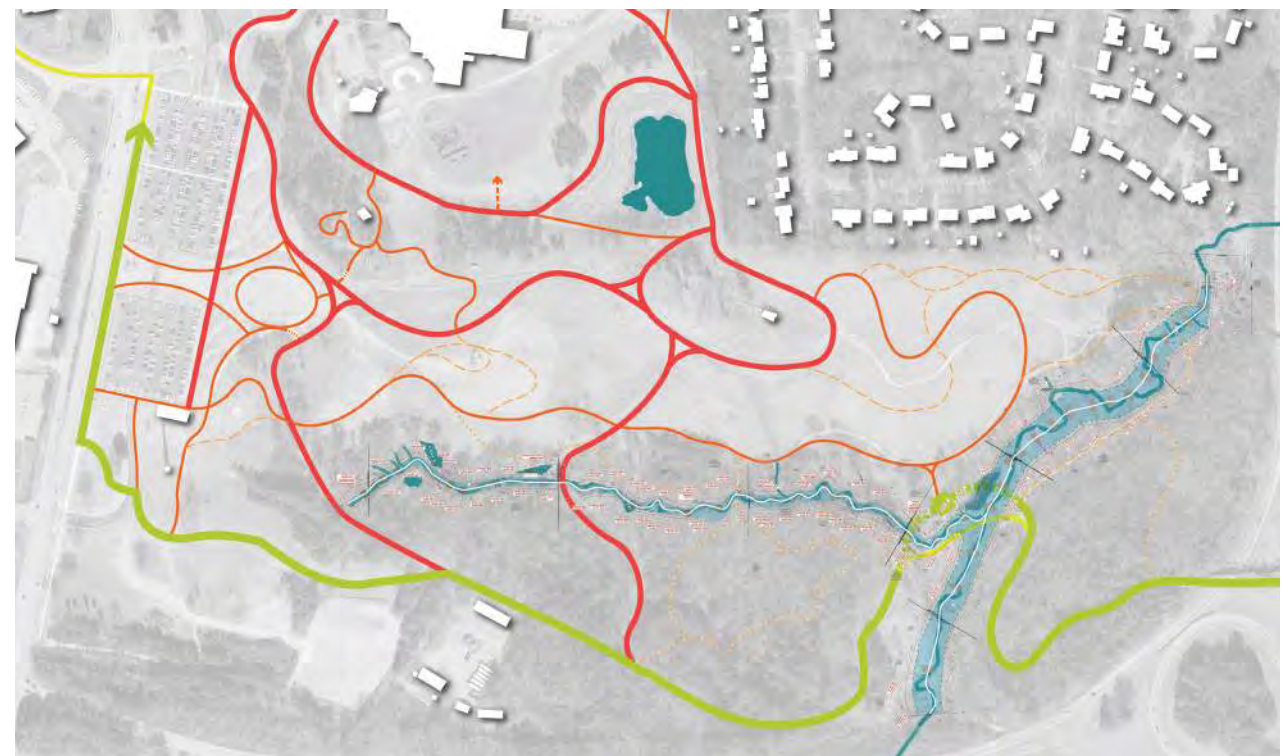
Blue Loop and Lower Meadow Trail alignments (3/21)
