North Carolina Museum of Art

MUSEUM PARK VISION PLAN

Prepared by Andropogon Associates, Ltd.
with contributions from Biohabitats, Inc., and WK Dickson
December 2021

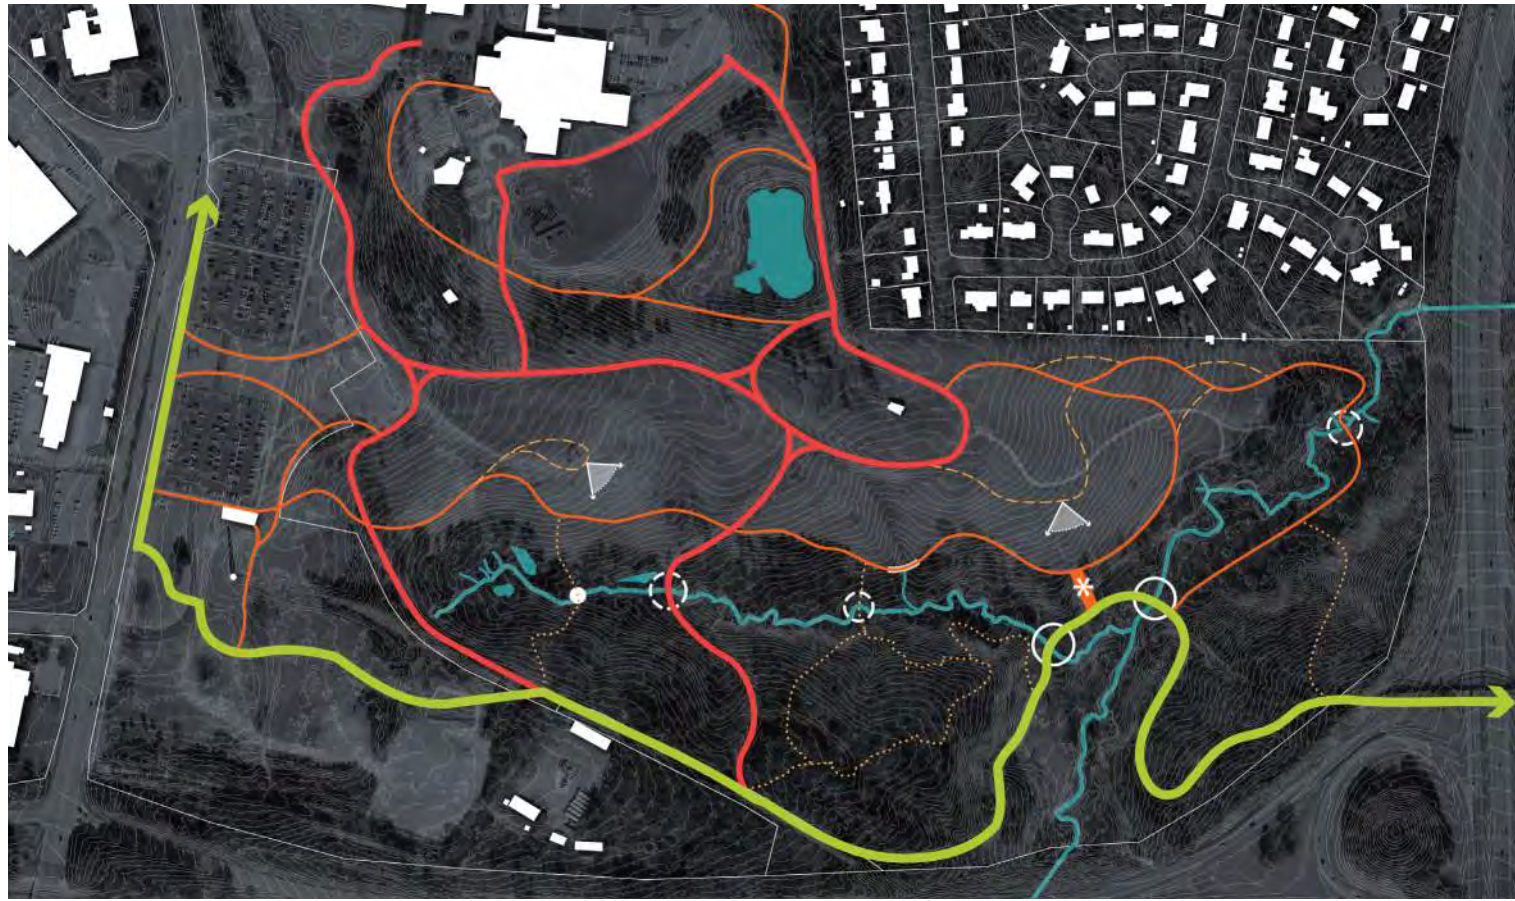
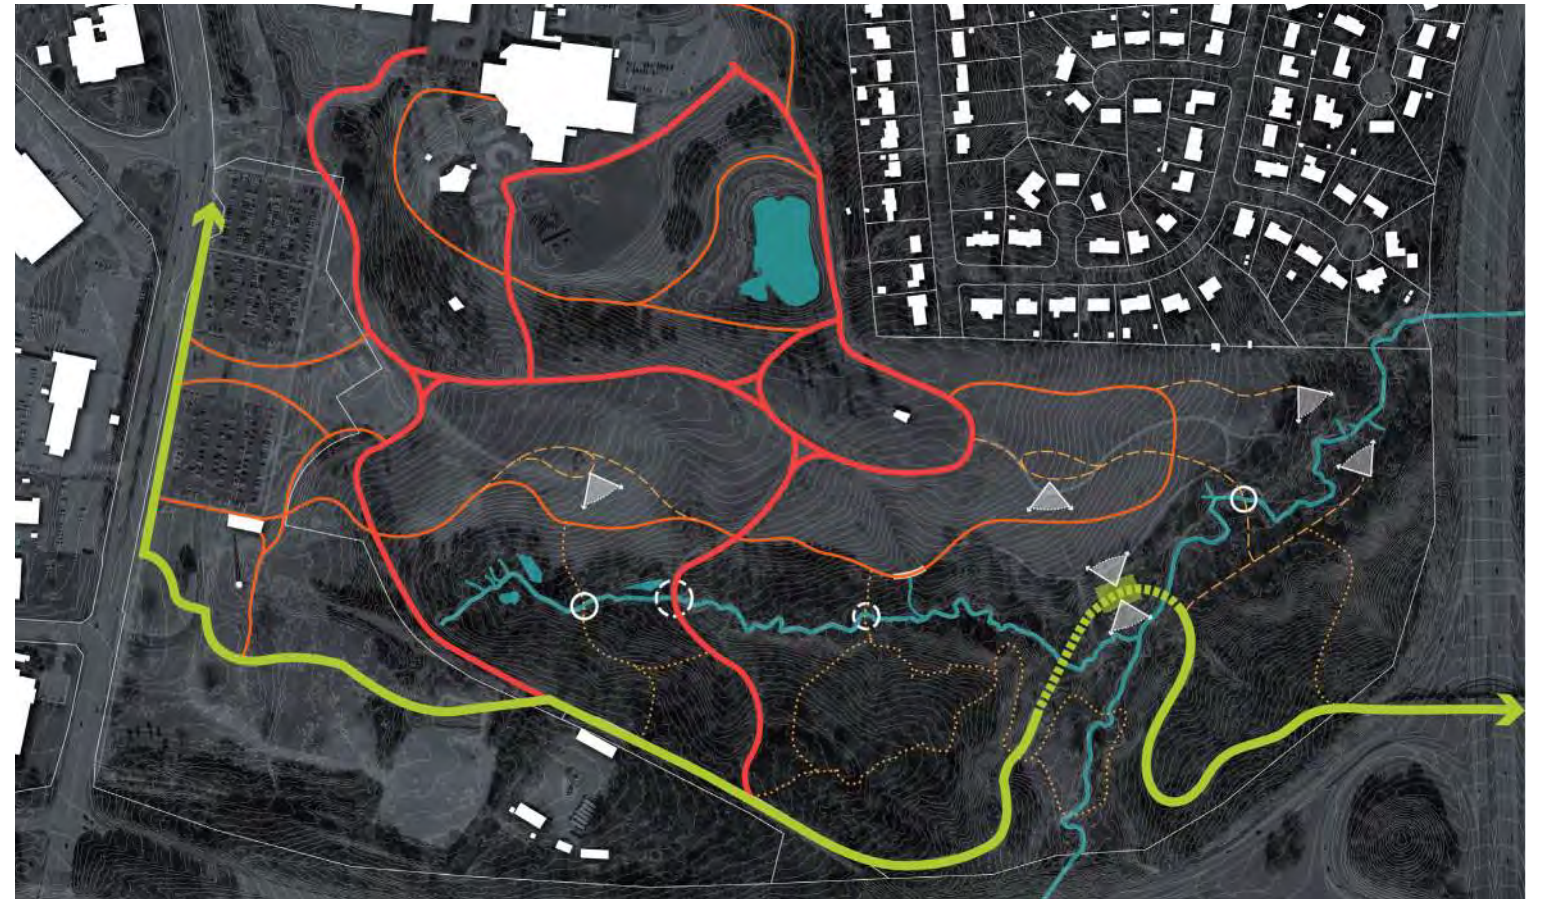
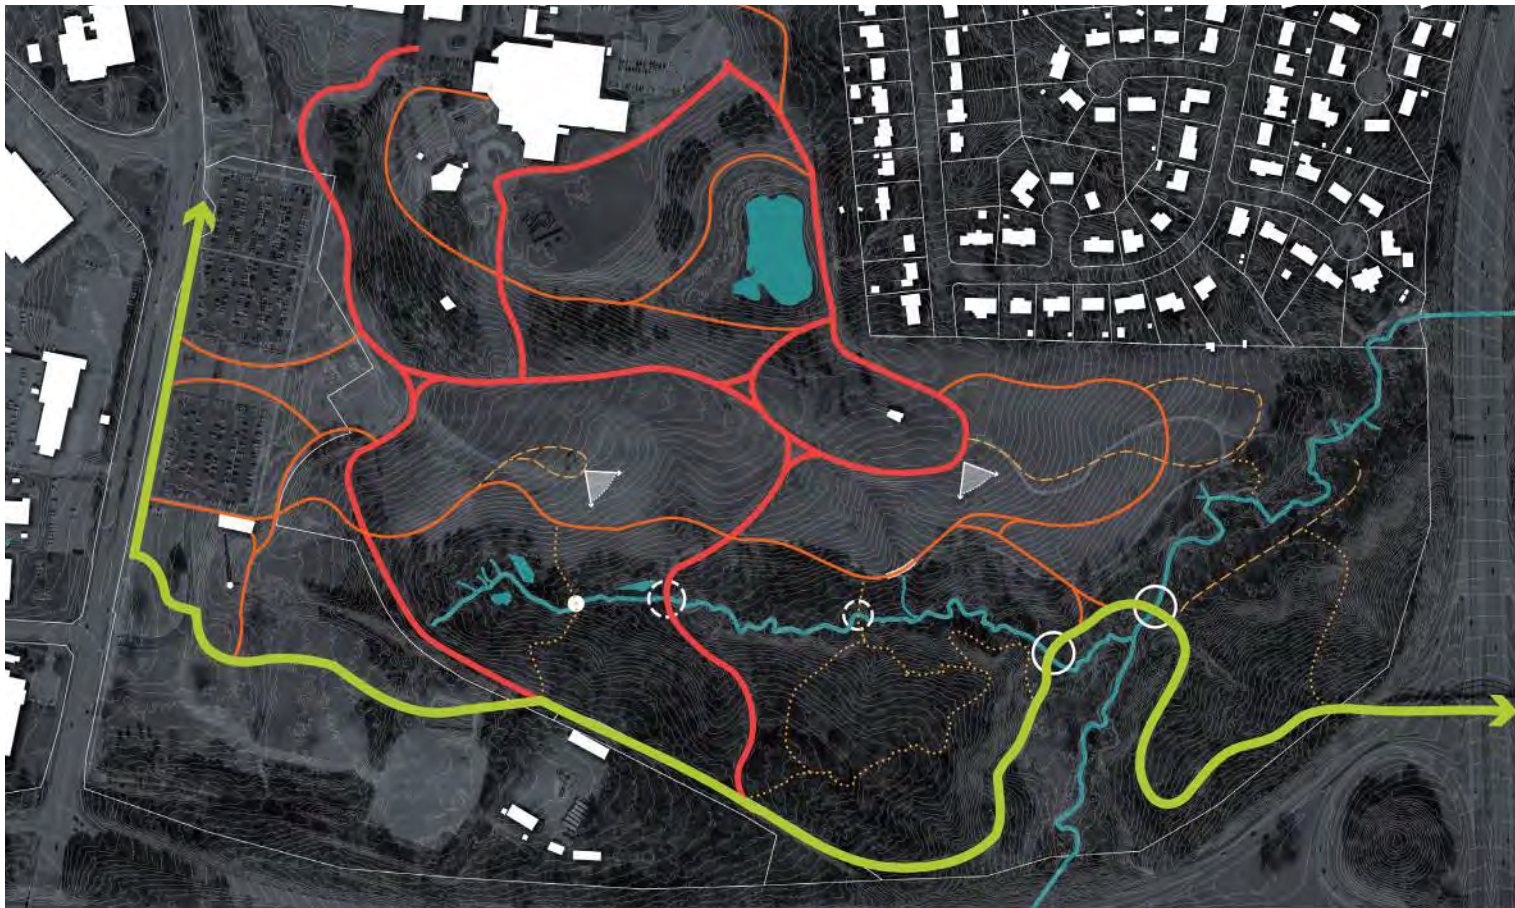
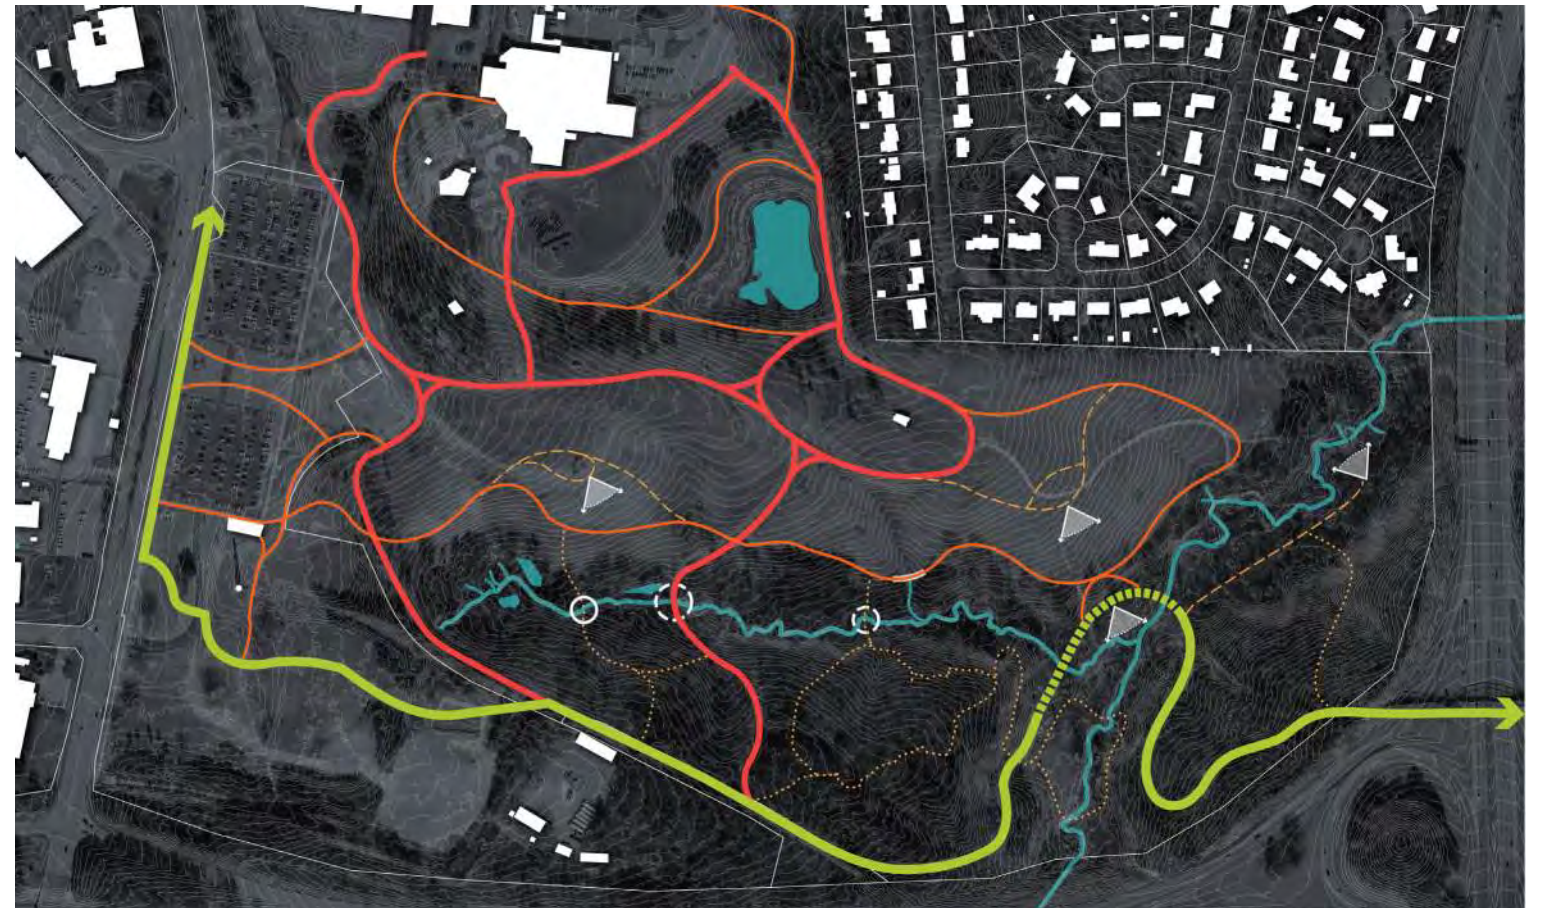
Confluence gateway/Lower Meadow connection alternatives (2/21)

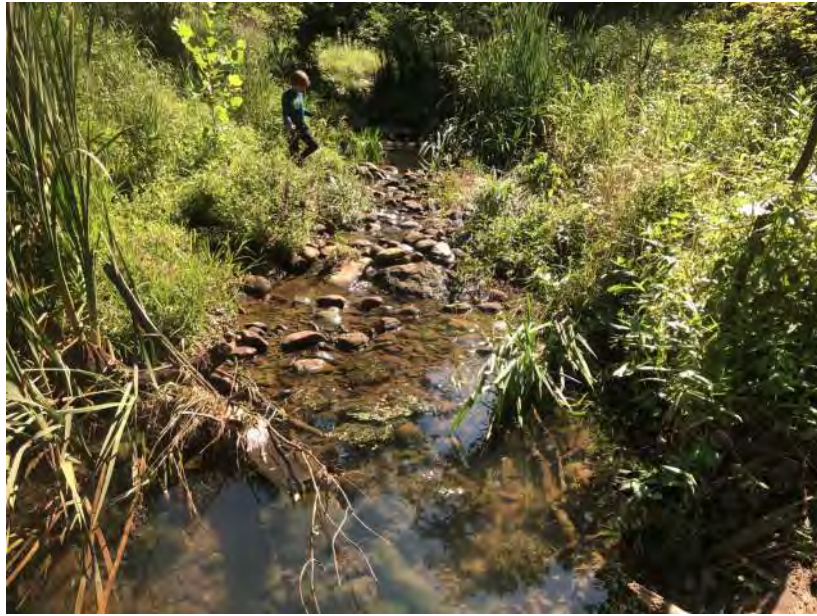
1 Tributary riffle structure

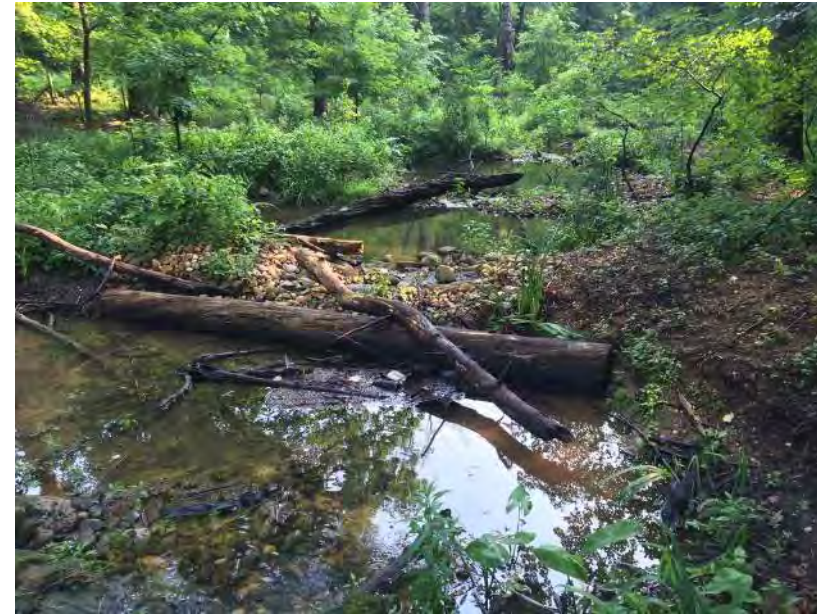
2 Trees and woody debris incorporated into stream and riparian wetland areas

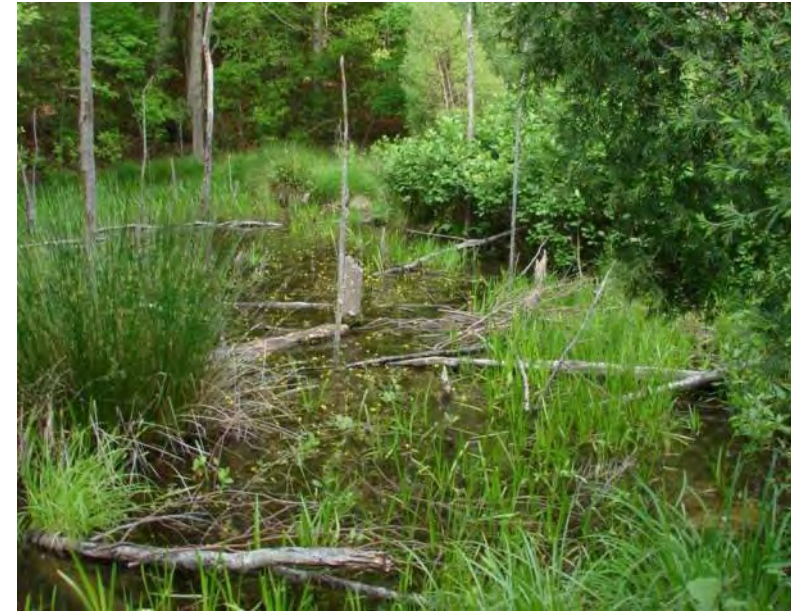
3 Floodplain depression wetlands

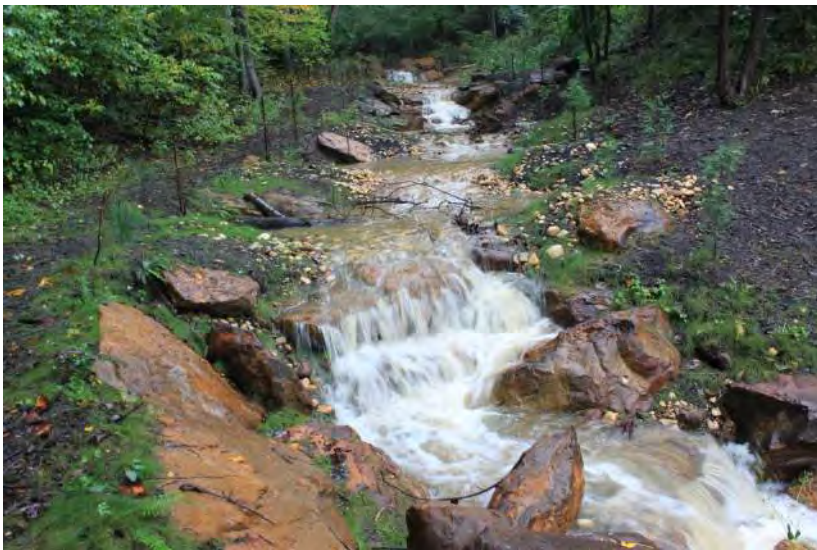
4 Cascade drop structure

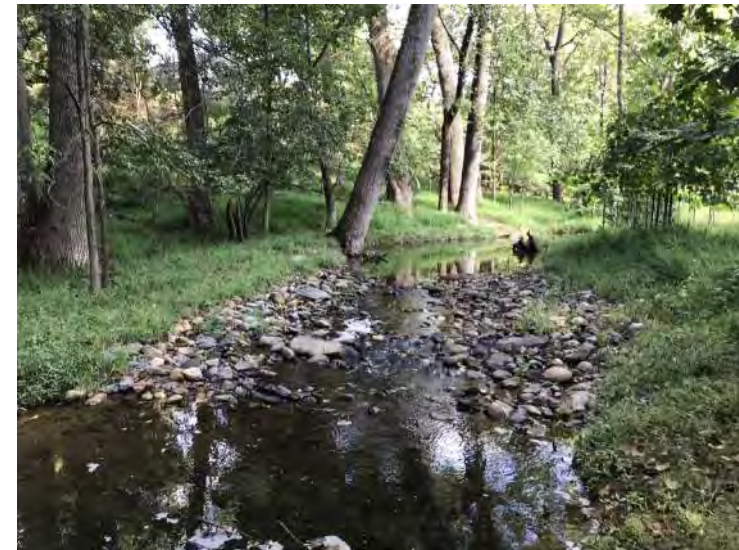
5 House Creek riffle structure

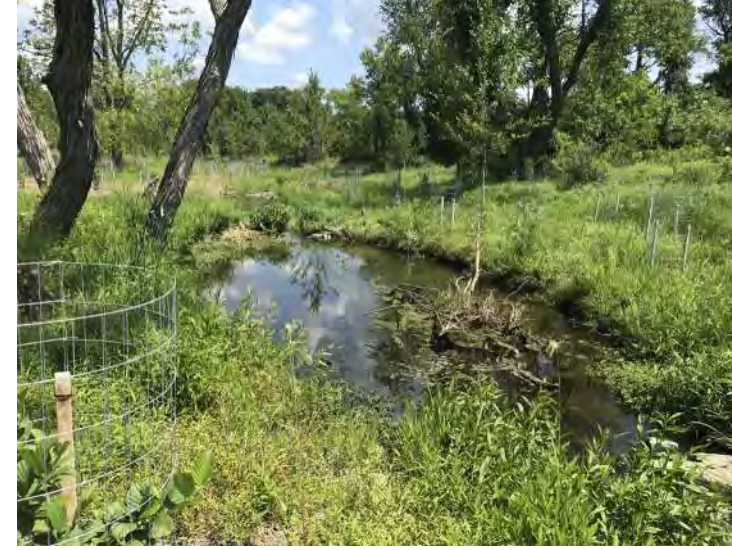
6 Floodplain bench with adjacent wetland

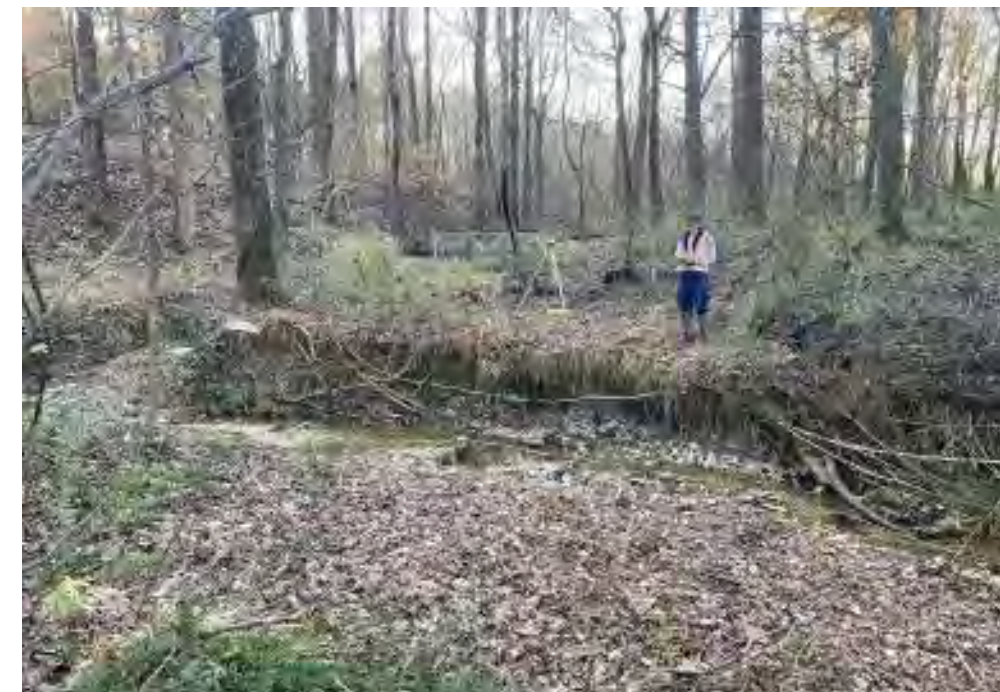
PROFILE OF FULL-REACH, UNNAMED TRIBUTARY TO HOUSE CREEK

- Bankfull, or the level of frequently occurring peak flow, does not reach the top of the bank, causing erosion within the stream channel.
- Highly incised/entrenched system
- Evidence of continually rejuvenated bank erosion
- Poor streambed pattern (riffles, pools) diversity
- Predominately gravel substrate

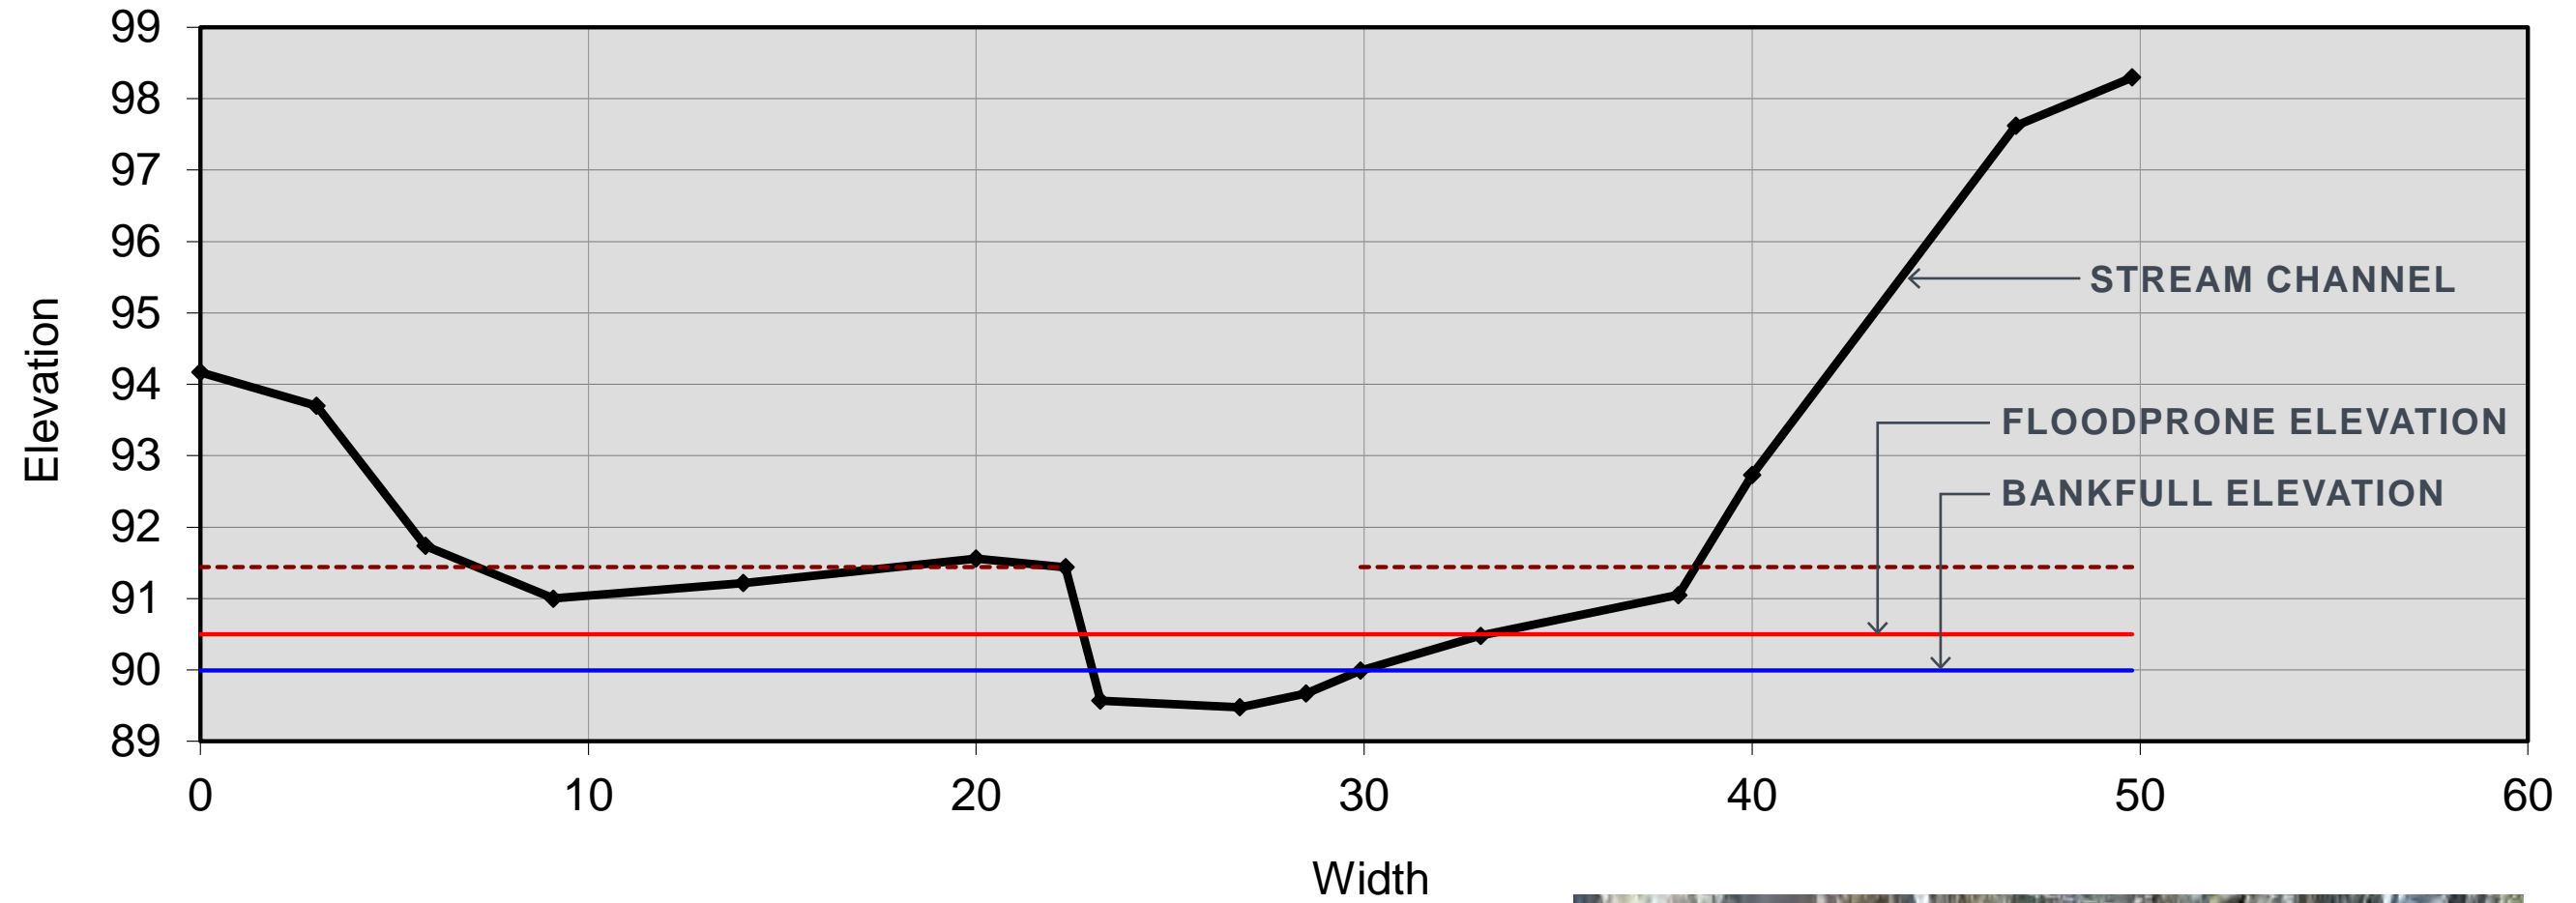
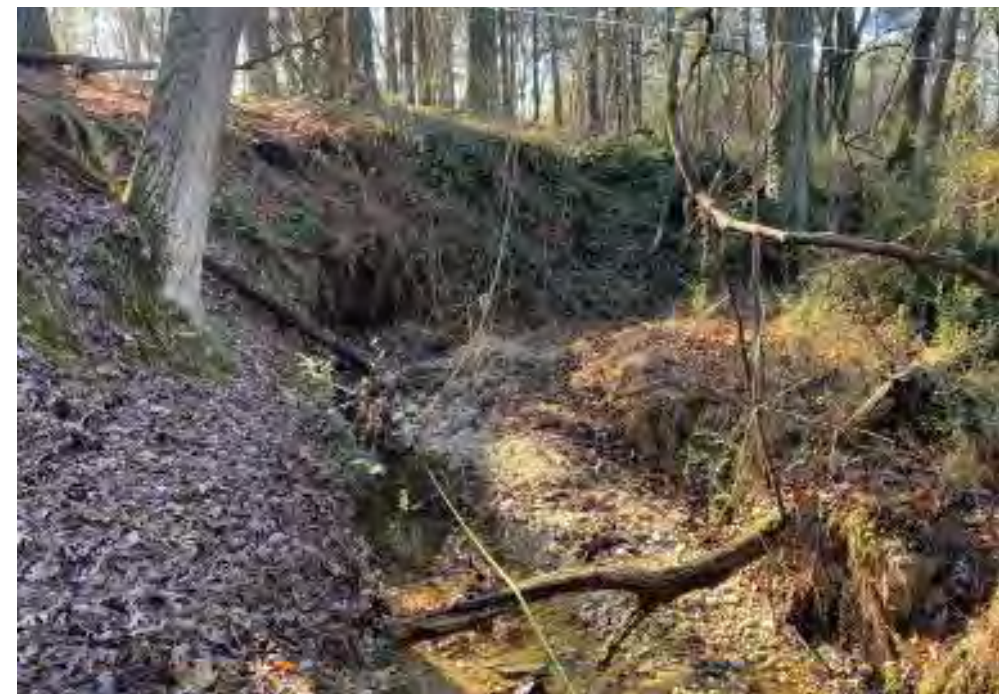
SECTION OF RIFFLE, UNNAMED TRIBUTARY TO HOUSE CREEK

- Floodprone elevation resides within channel cross-section
- Lack of floodplain connectivity

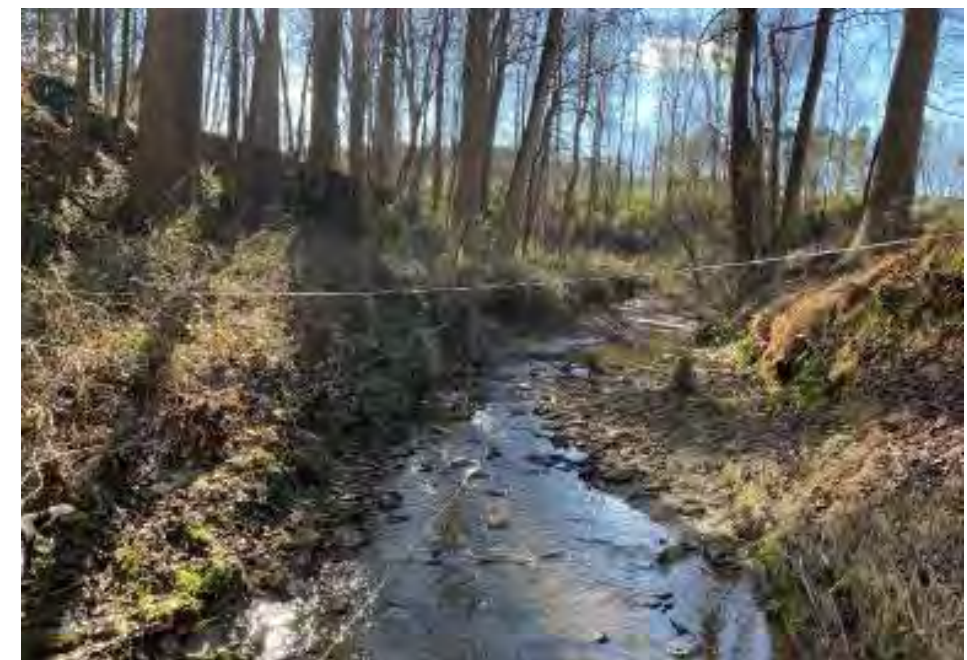
PROFILE OF FULL REACH, HOUSE CREEK

- Bankfull, or the level of frequently occurring peak flow, does not reach the top of the bank, causing erosion within the stream channel.
- Highly incised/entrenched system
- Evidence of continually rejuvenated bank erosion
- Hydraulically influenced by NCDOT structures
- Predominately gravel substrate

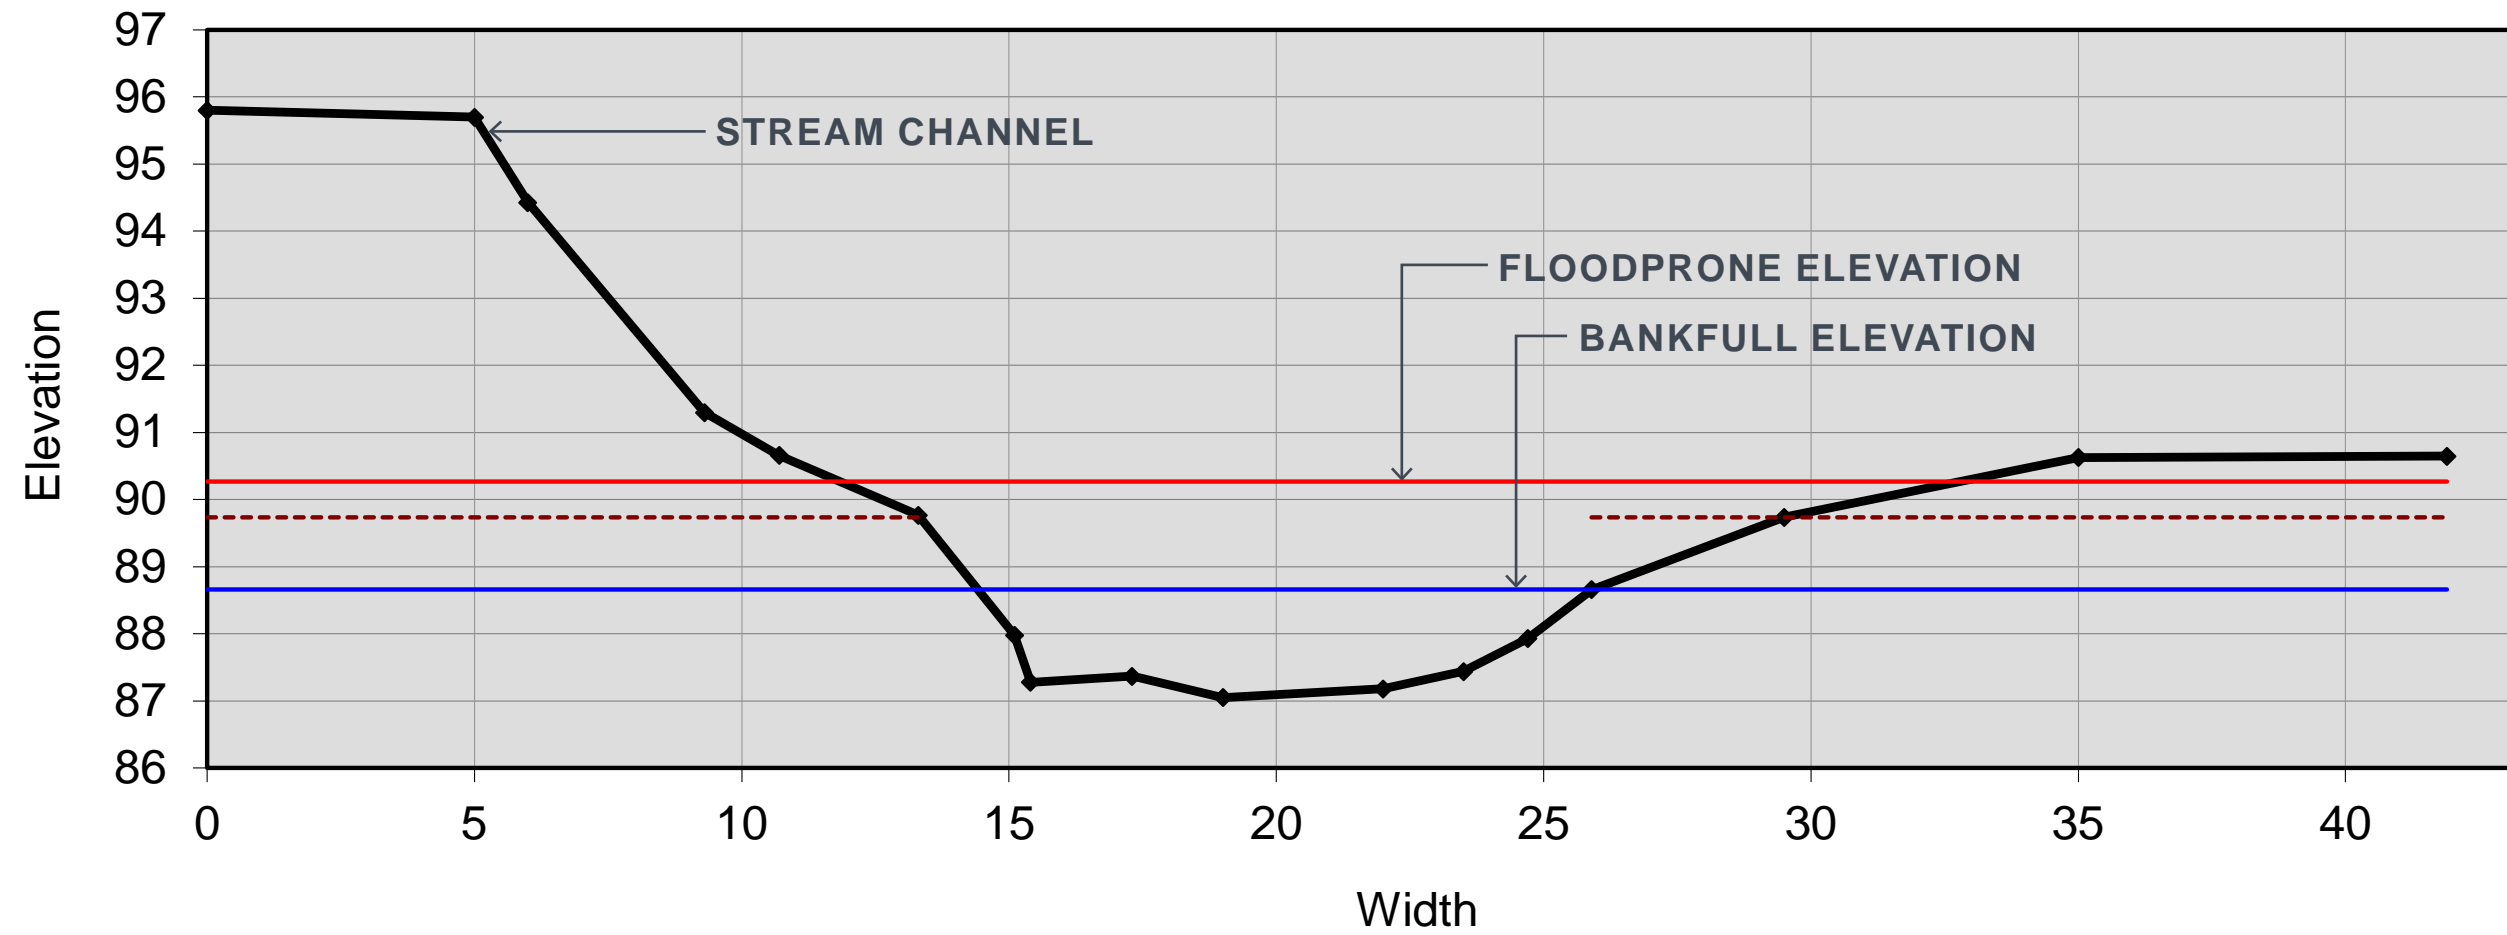
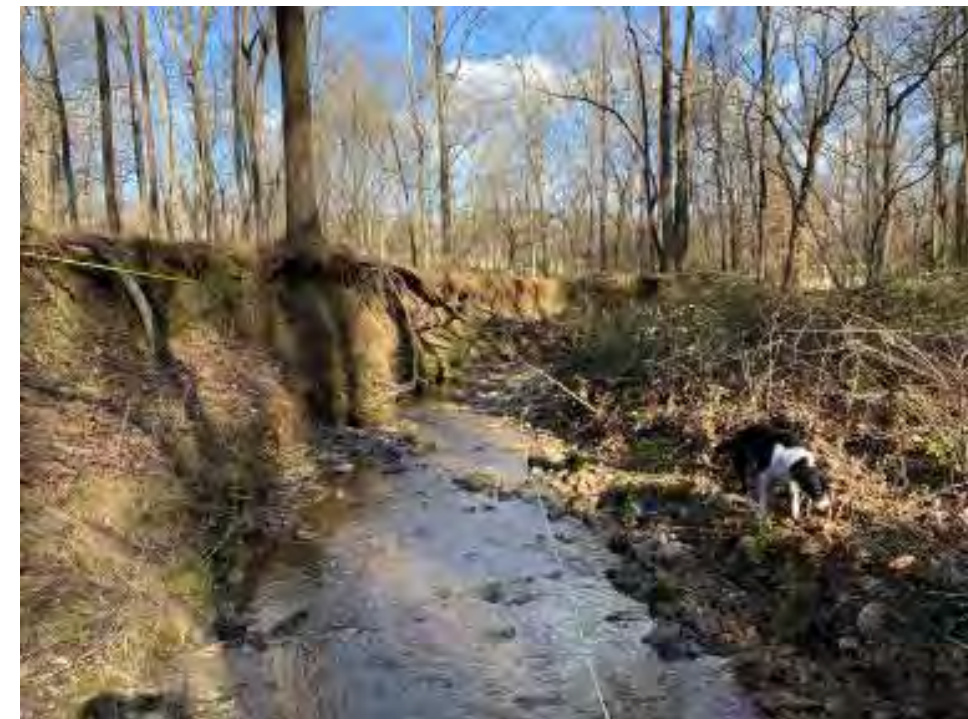
SECTION OF RIFFLE, HOUSE CREEK

- Floodprone elevation within channel cross-section
- Lack of floodplain connectivity
- Significantly high bank heights

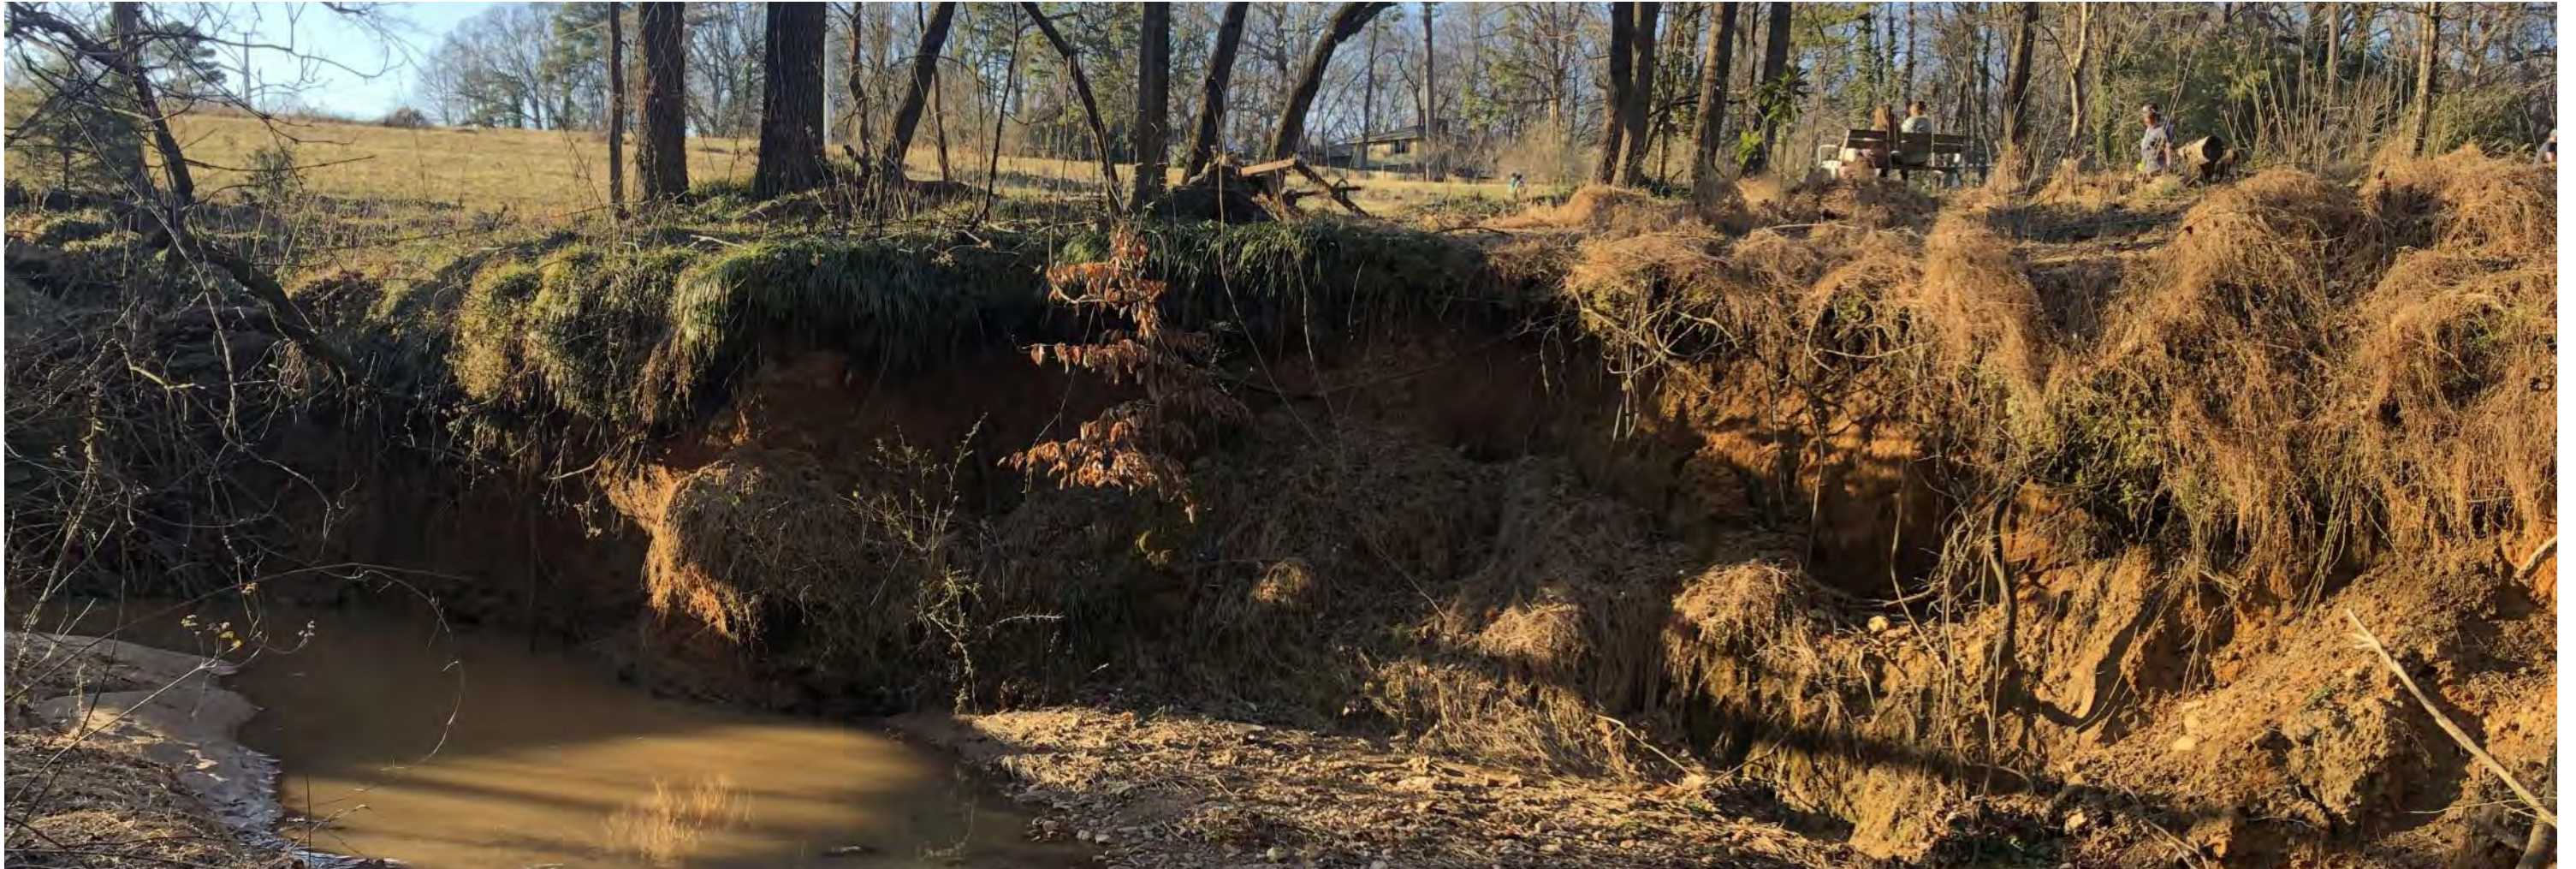
GEOMORPHIC STUDY SUMMARY

- All NCMA stream reaches are laterally eroding as a result of past land use and fluvial dynamics.
- Tree loss along stream banks will continue, absent restoration activities.
- Bank erosion is significantly contributing to adverse downstream water quality, resulting in high turbidity under storm flow events.
- NCDOT structures (culverts) may present constraints to House Creek design.

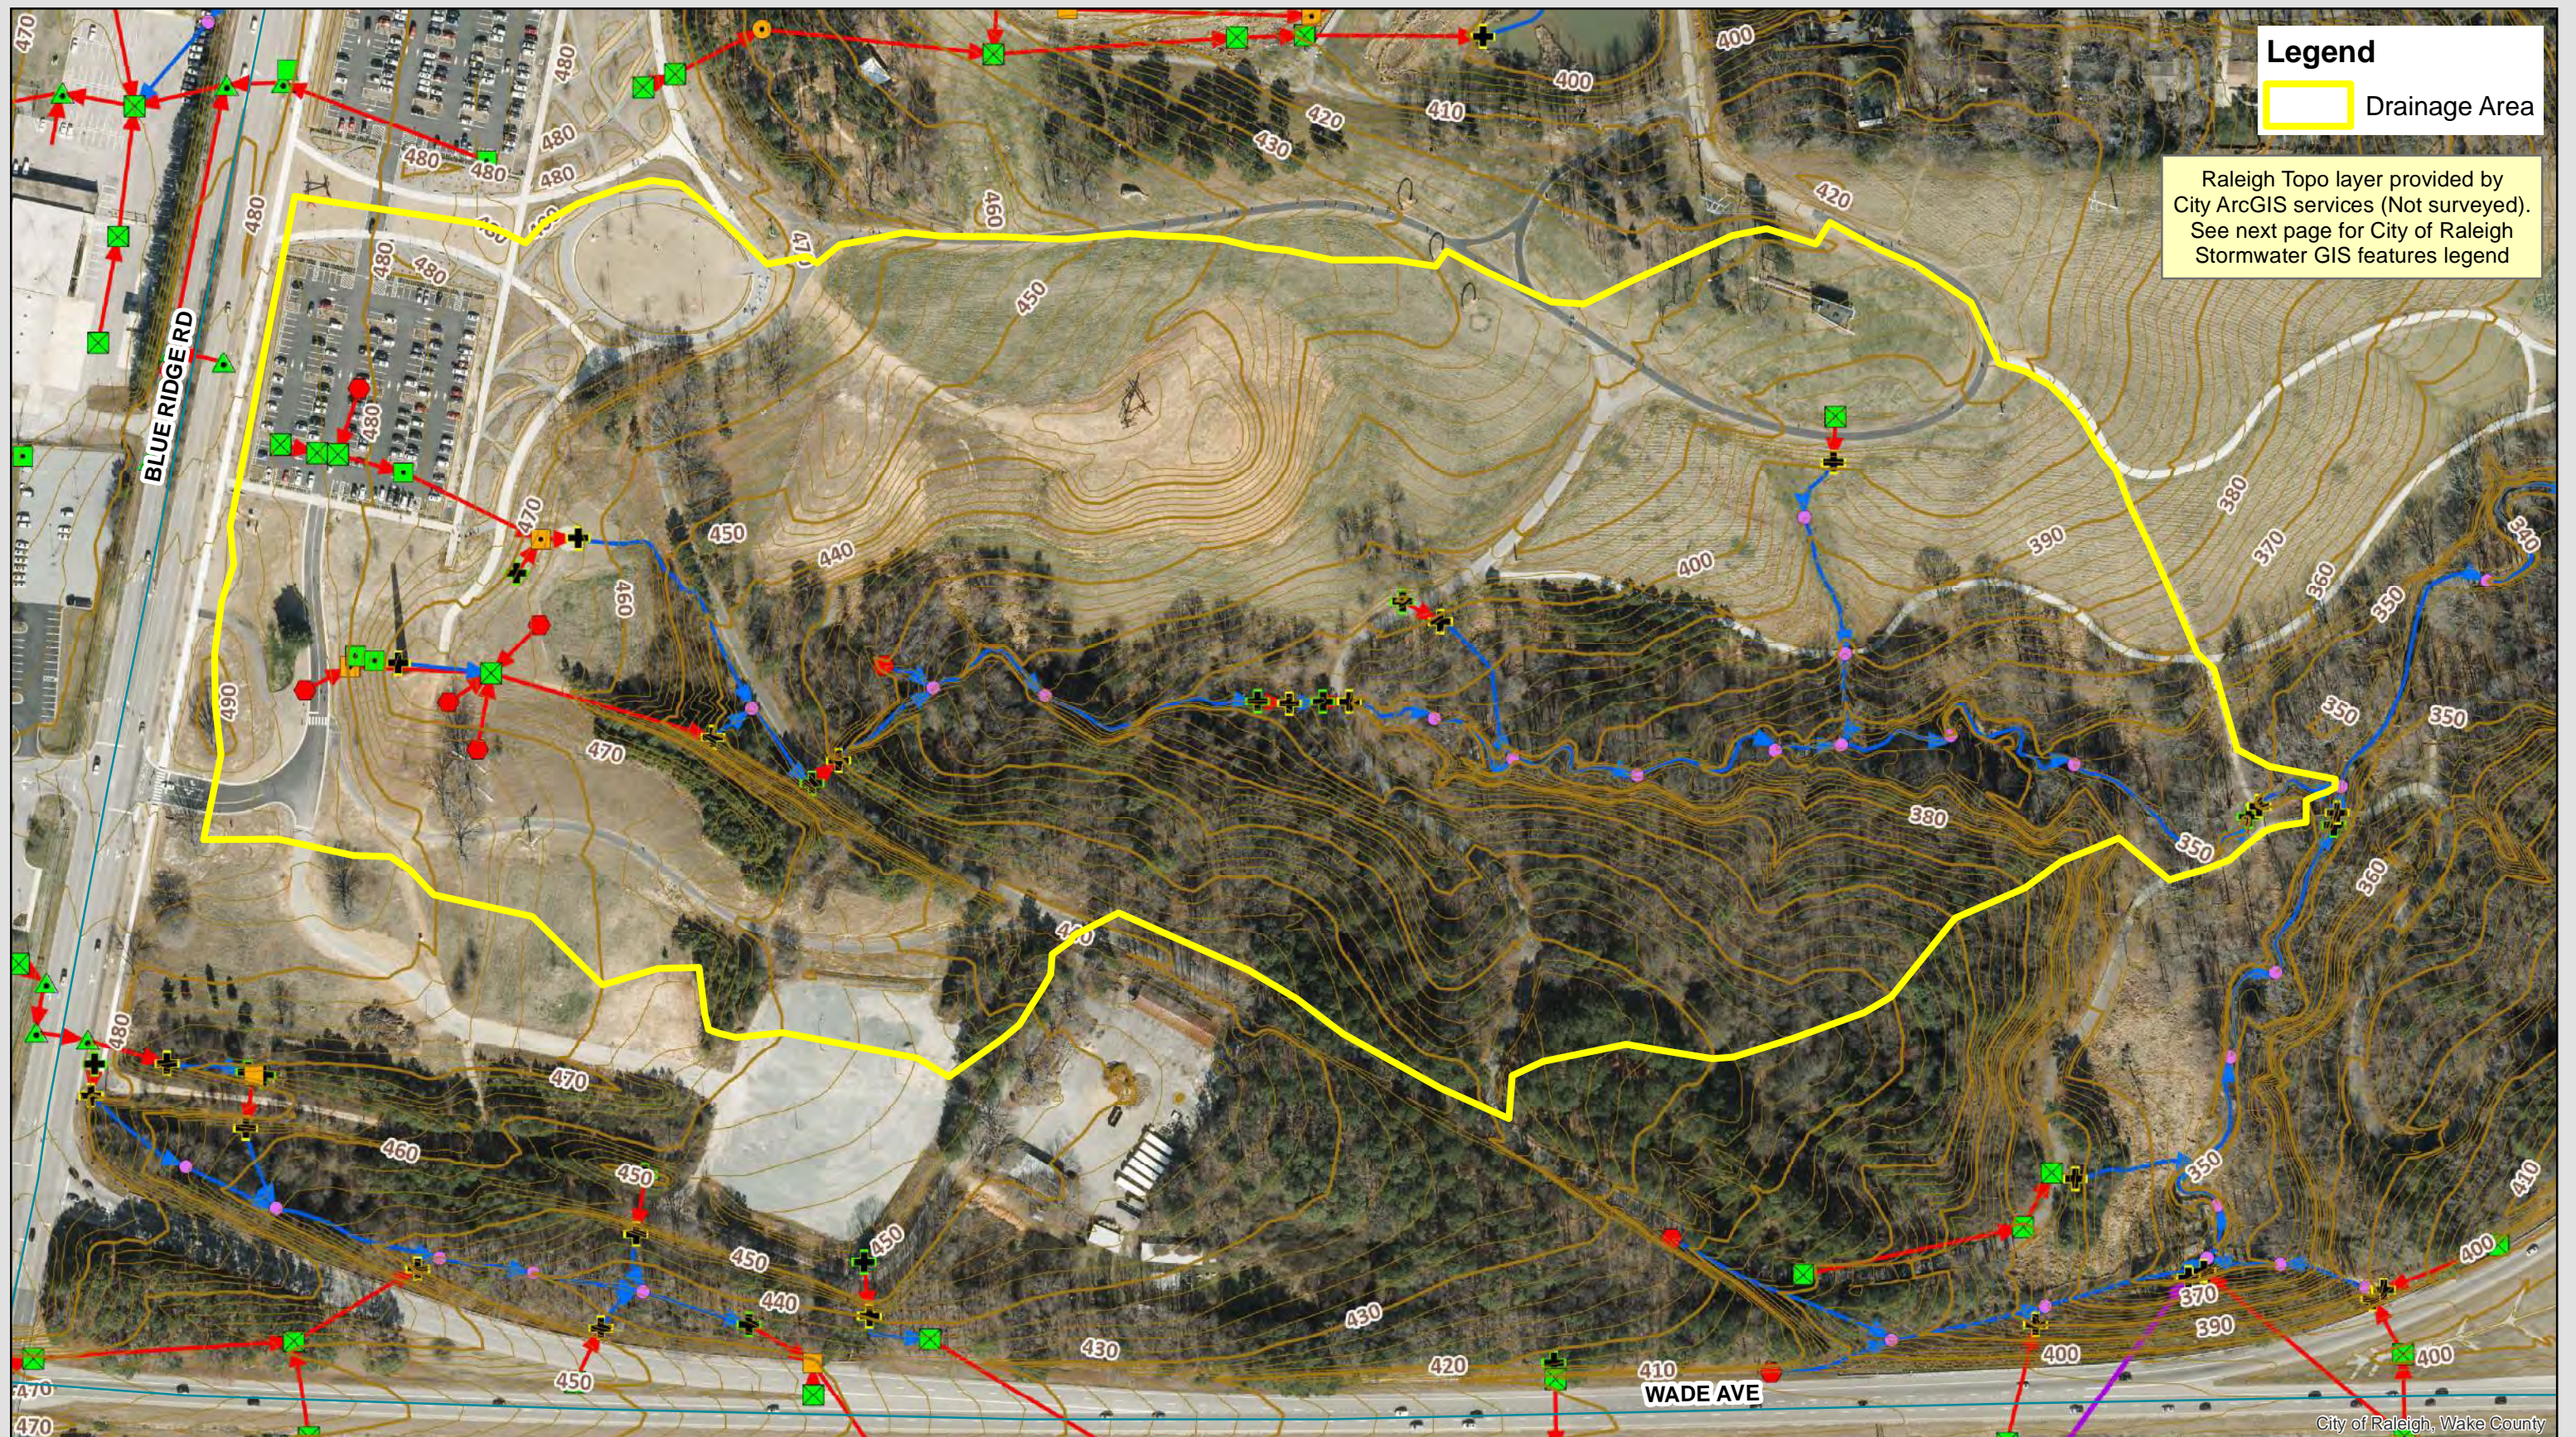
Legend
 Drainage Area

Figure 2: Watershed Map
 North Carolina Museum of Art

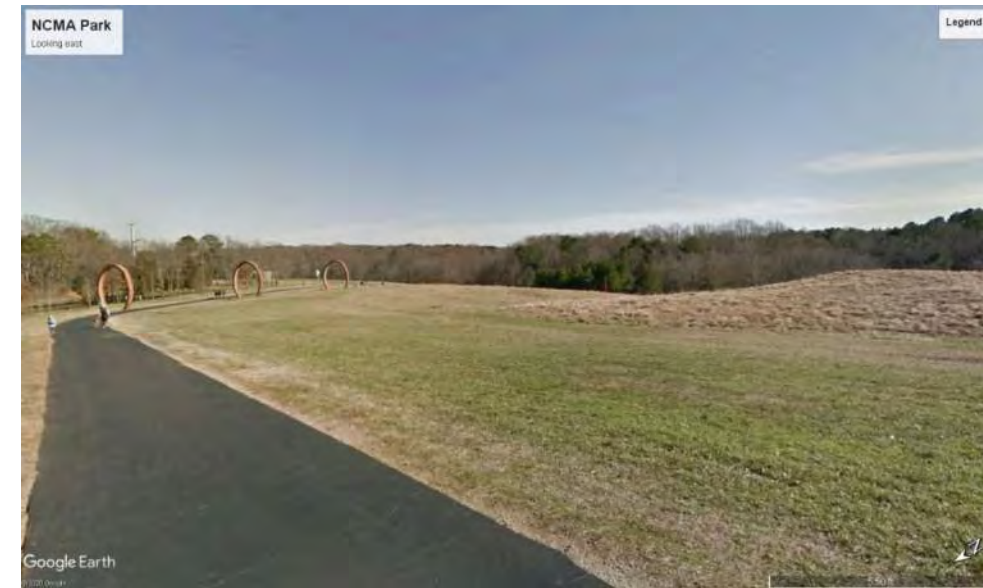
Photo 1. Grassy uplands north of tributary (Google Earth 2018)

Photo 1 illustrates the typical grassland land cover used in hydrologic calculations for the composite rational coefficient. Comprehensive land cover calculations are detailed in Appendix A on a per sub-watershed basis. Peak flows were calculated for each sub-watershed and are shown below in Table 1. Flow values for sub-watersheds 2 and 3 are cumulative flows based on the in-line condition of the sub-watershed delineation.
