North Carolina Museum of Art

MUSEUM PARK VISION PLAN

Prepared by Andropogon Associates, Ltd.
with contributions from Biohabitats, Inc., and WK Dickson
December 2021

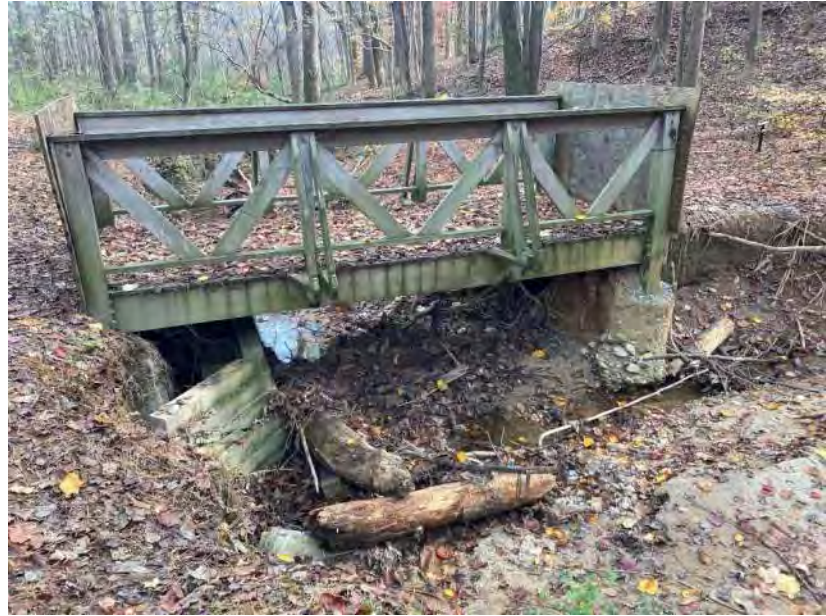
Photo 3. Abandoned footbridge at Sta. 11+75 (WKD 2020-11-29)

An abandoned footbridge crossing the tributary at station 11+75 was encountered in the field and was chosen not to be evaluated with the existing conditions HEC-RAS model. This exclusion assumes that this structure would be removed in a future phase of stream improvement regardless of other proposed improvements. Please refer to Photo 3 containing the derelict bridge looking downstream.

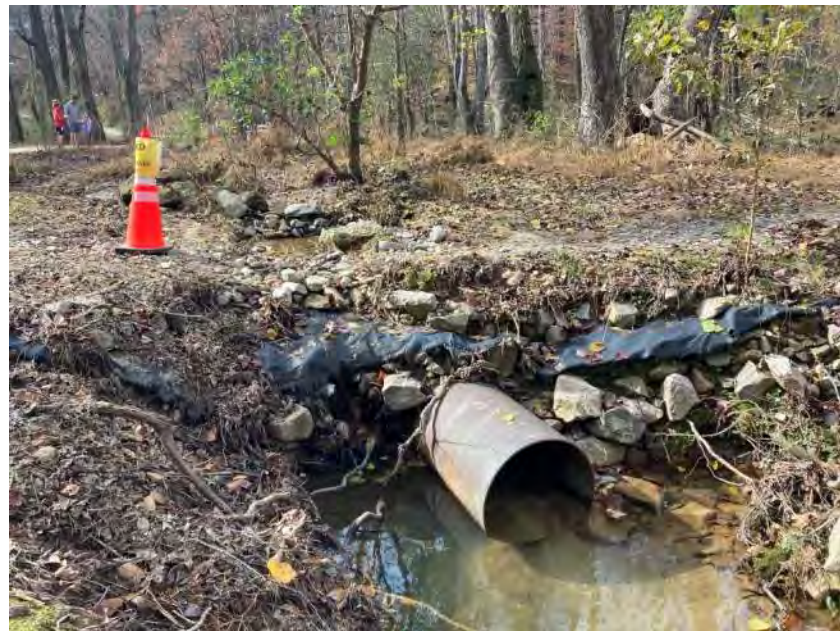
Photo 4. Failed 24" DIP culvert at Sta. ~1+30 (WKD 2020-11-29)

A failed 24" Ductile Iron Pipe (DIP) culvert was discovered at the downstream portion of the tributary at approximately station 1+30. The upstream invert of this pipe is completely buried and filled-in with several feet of depositional material. The current site conditions require streamflow to pass across some cobble cover on top of the buried culvert as shown in Photo 4.

The existing hydrologic and hydraulic conditions for the tributary to House Creek were evaluated and summarized in this memorandum. WK Dickson performed site visits over the course of this effort to field verify hydraulic features. The existing channel was found to have extensive erosion along both banks throughout the reach. In some cases, the stream banks were vertical and had root exposure as shown in Photos 2, 3, and 4. Both functioning culverts (30" CMP and 36" HDPE) along the tributary were evaluated and found to be performing at a less than 2-year LOS. The 24" culvert downstream has completely failed, and the channel flow is bypassing overtop as shown in Photo 4. This is likely causing the neighboring asphalt footpath to flood in minor storm events.

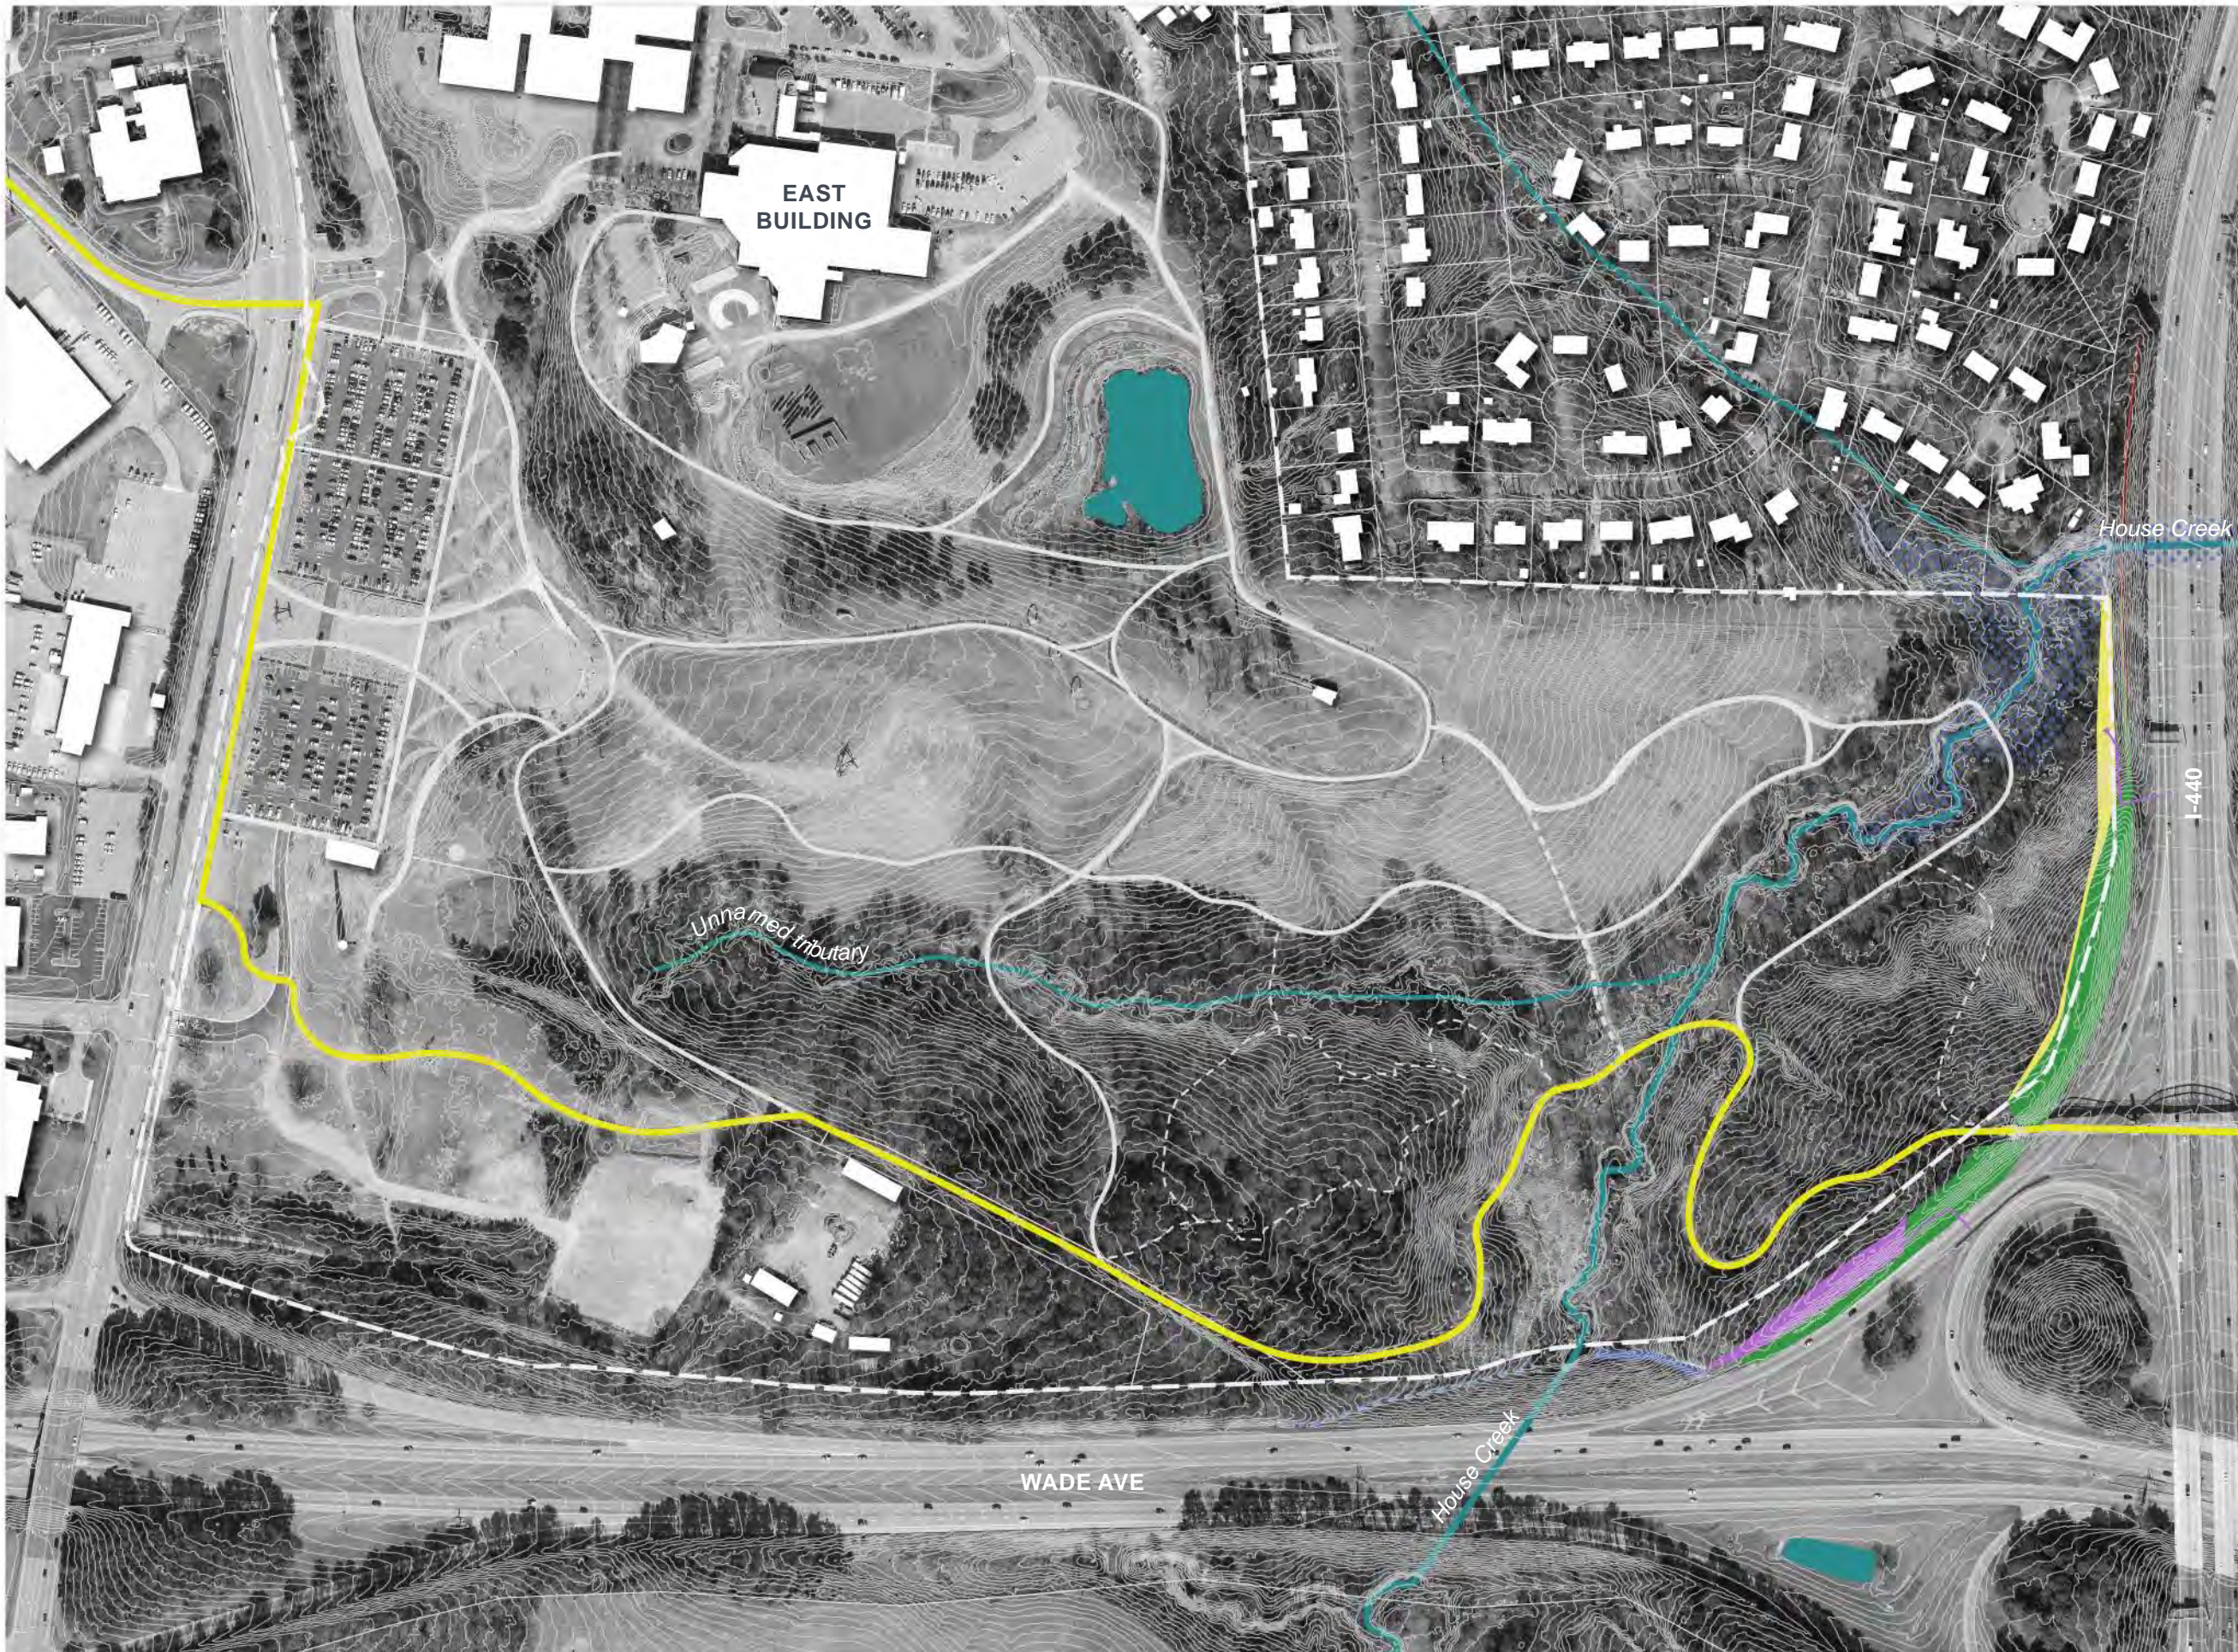
DOT IMPACTS

-   Existing Channel to Remain
-   DOT ROW Expansion
-   Riprap Channel
-   Stormwater Impacts
-   Clearing Impacts
-   100-Year Floodplain

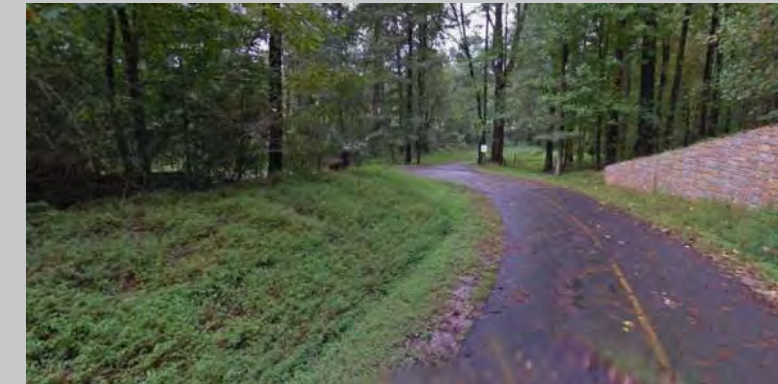
Removal of vegetation on the inside of the curve as you are descending to existing Bridge 70 would allow for better sight lines for users of the trail. Extent of vegetation removal would be minimal. Removing the existing stump closest to the trail along with some underbrush and/or pruning or "limbing" select trees could be considered. It is suggested that City Staff coordinate with the NC Museum of Art to discuss the range of options that would accomplish the goal of improving sight lines.

Figure 9. Limited sight lines
(Source: Google Maps)

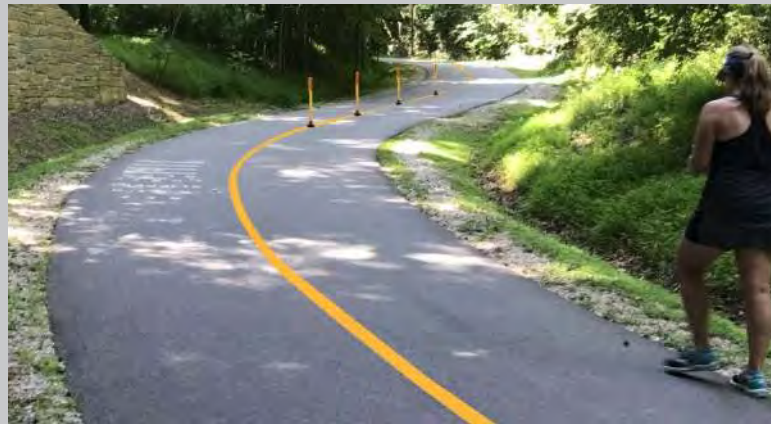
Delineators are used on solid lines to discourage or prohibit crossing. They have the negative impact of narrowing trail users' operating space and limiting passing maneuvers. However, this option is recommended in the interim to keep cyclists in their lane and give a visual narrowing cue to slow down. It is recommended flexible delineators be placed on the center stripe in advance of the curve on the downgrade but not in the curve for safety reasons. Lane striping should be refreshed and extended back prior to the first curve. Delineators must match the color of the striping and should be placed at a consistent spacing, with 10-foot intervals recommended.

Figure 11. An illustration of delineator posts on the Reedy Creek Greenway

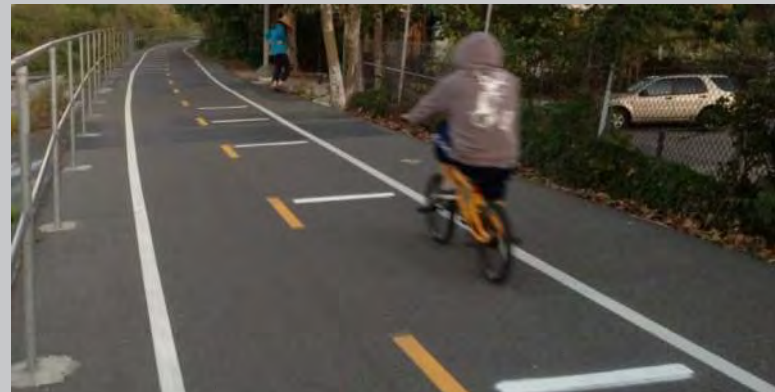
Rumble strips are commonly used on rural roads to provide a tactile and audible warning of an upcoming intersection or horizontal curve. The strips typically consist of depressed grooves crossing the lane surface. It is recommended that rumble strips be placed on the trail prior the downslope. Rumble strips can be hazardous for cyclists, so care should be exercised and best practices consulted when determining size and placement.

Figure 12. Rumble Strips on L.A.'s Riverwalk Bike Path

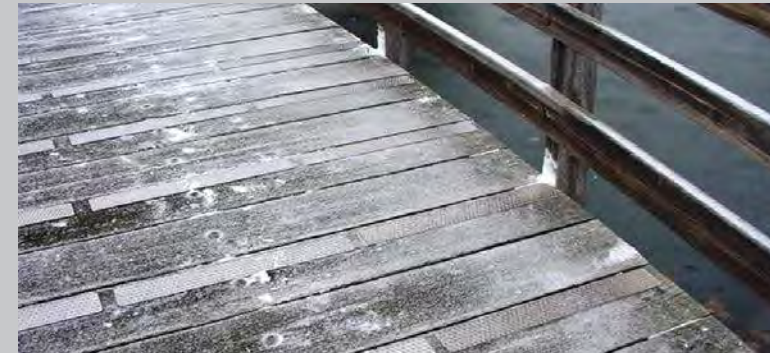
Expanded metal grating or non-skid metal tread is recommended to add texture and prevent slipping on the bridge surface. Chicken wire, hardware cloth, or non-galvanized metal coverings are not recommended due to the potential for accelerated wear in high-use areas and potential for punctures to bicycle tires. Urethane coatings with grit such as sand are an inexpensive substitute, though may not wear as well.

Figure 13. An example of metal tread used on boardwalk in wet/icy conditions

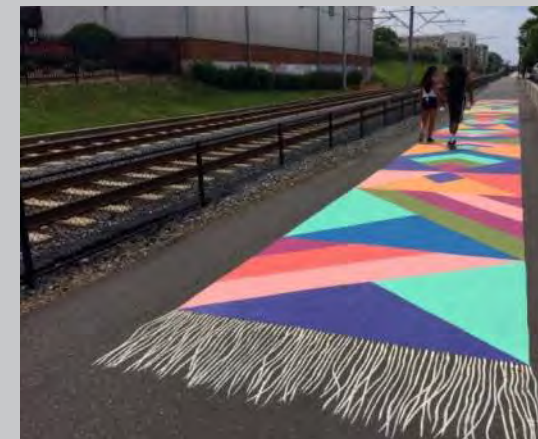
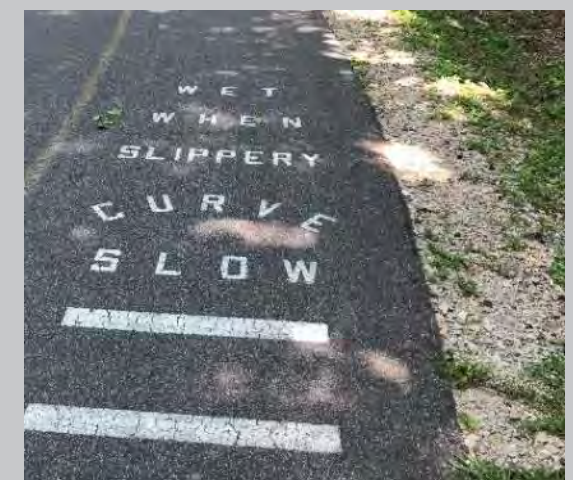
Existing pavement markings that read "Slow Curve Slippery When Wet" could be removed, refreshed or revised. Warnings as pavement markings are less effective than overhead signs, but could be included in an overall interim improvement. Farther up the trail towards the top of the hill, before the steepest part of the descent and in the curve at the bottom of the trail, art murals can be installed that include a visual effect to alert and slow cyclists. The location and design of the mural should be carefully selected to be skid resistant and minimize conflicts.

Figure 14. The "Magic Carpet" art installation on the Charlotte Rail Trail (top left) and example of a speed reduction markings (bottom left). Existing pavement markings (right).

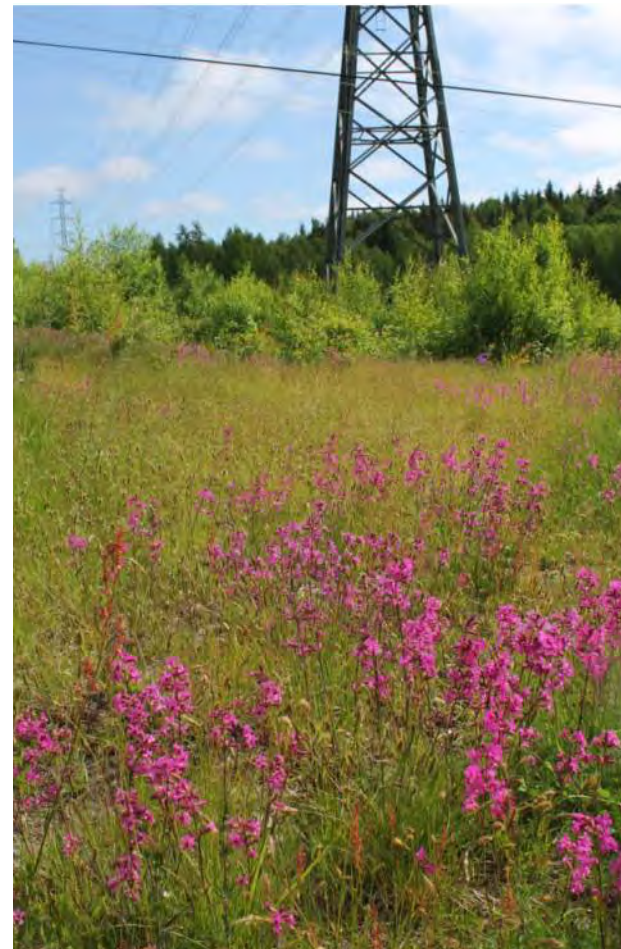
Meadow planting within power line easement, Finland; Photo: Jussi Lampinen, Kalle Ruokolainen, Ari-Pekka Huhta

- 1 Convert fescue meadow to arrested succession planting with mowed paths to maintain clear height and maintenance access beneath power lines
- 2 Maintain an at-grade connection between greenway and trail over sewer line
- 3 Provide maintenance access to sewer line at House Creek crossing via former greenway trail bed
- 4 Minimize grade changes in House Creek floodplain above sewer line
